Appendix M – Summary of Exceedance

Reporting Month: March 2023

- Notification of Exceedances

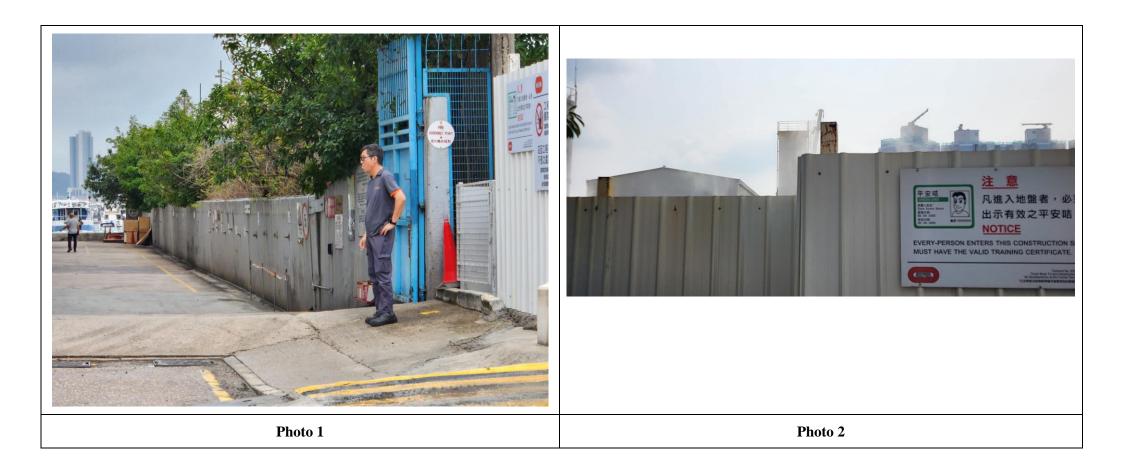
- 1. Kerry staff was smoking near the High Volume Sampler (HVS), which may cause the dust nuisance and affect the result (Photo 1).
- 2. The vehicle which entering the Kerry DG Warehouse was observed.
- 3. No environmental deficiencies were observed at KER1 during monitoring and audit, the contractor has implemented adequate dust mitigation measure, i.e. watering and install spraying system at the site entrance, covering the stockpile of dusty material. (Photo 2-4)

Based on the finding(s) and observation(s) above, we deduce the Action Level exceedance of 24-hour TSP recorded at station KER1 on 1 March 2023 is due to smoking near the HVS, therefore, the exceedance is considered as **non-project related**.

Although the exceedance is considered as non-project related, contractor is reminded that the following construction dust mitigation measures shall always to be implemented on site to reduce/ minimize the generation of dust due to the construction activities.

- 1. Watering of the construction areas 12 times per day to reduce dust emissions.
- 2. Side enclosure and covering of any aggregate or dusty material storage piles to reduce emissions.
- 3. Open stockpiles shall be avoided or covered.
- 4. Tarpaulin covering of all dusty vehicle loads transported to, from and between site locations.
- 5. Establishment and use of vehicle wheel and body washing facilities at the exit points of the site.
- 6. Imposition of speed controls for vehicles on unpaved site roads, 8 km per hour is the recommended limit.
- 7. Use of regular watering to reduce dust emissions from exposed site surfaces and unpaved roads, particularly during dry weather.

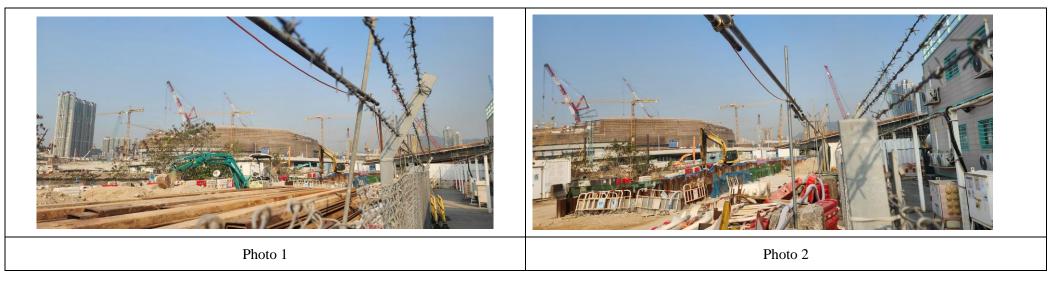
Photo Record (Photo Taken by ET)

1. It observed that a stockpile of excavated dusty material with impervious sheet was not covered thoroughly from the construction site which did not belong to BTP. (See Photo 1 & 2)

2. Dry weather

Based on the finding(s) and observation(s) above, we deduce the Action Level exceedance of 24-hour TSP recorded at station KTD2d on 1 March 2023 is due to the construction activities which does not belong to BTP Therefore, the exceedance is considered as **<u>non-project related</u>**.

The following construction dust mitigation measures shall always to be implemented on site to reduce/ minimize the generation of dust due to the construction activities.

- 1. Watering of the construction areas 12 times per day to reduce dust emissions.
- 2. Side enclosure and covering of any aggregate or dusty material storage piles to reduce emissions.
- 3. Open stockpiles shall be avoided or covered.
- 4. Tarpaulin covering of all dusty vehicle loads transported to, from and between site locations
- 5. Establishment and use of vehicle wheel and body washing facilities at the exit points of the site.
- 6. Imposition of speed controls for vehicles on unpaved site roads, 8 km per hour is the recommended limit

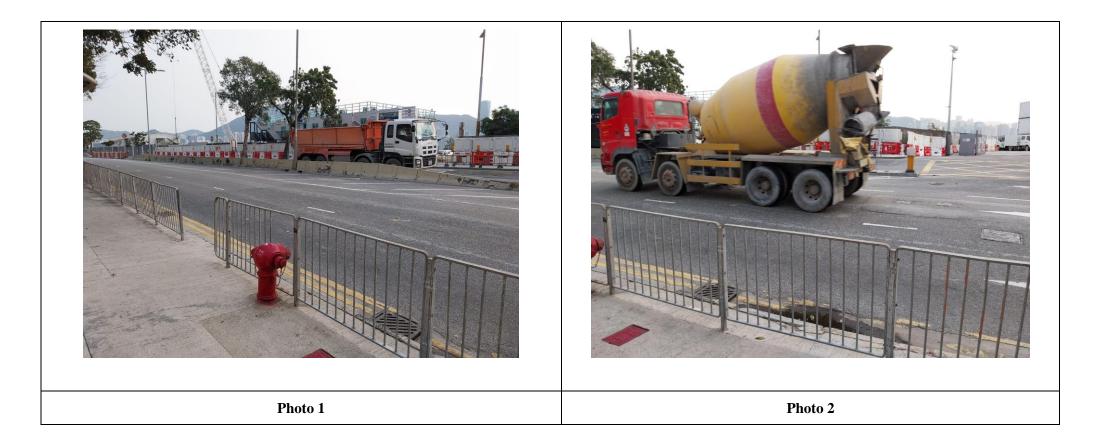
- 1. Fluctuation of road traffic along the Cha Kwo Ling Road, a numerous of dump trucks and concrete mixer lorries passed by and raise the dust to the surrounding (Photo 1 & 2).
- 2. No major project related construction activities was observed during monitoring at CKL1.

Based on the finding(s) and observation(s) above, we deduce the Action Level exceedance of 24-hour TSP recorded at station CKL1 on 1 March 2023 is due to fluctuation of road traffic, therefore, the exceedance is considered as **non-project related**.

Although the exceedance is considered as non-project related, contractor is reminded that the following construction dust mitigation measures shall always to be implemented on site to reduce/ minimize the generation of dust due to the construction activities.

- 1. Watering of the construction areas 12 times per day to reduce dust emissions.
- 2. Side enclosure and covering of any aggregate or dusty material storage piles to reduce emissions.
- 3. Open stockpiles shall be avoided or covered.
- 4. Tarpaulin covering of all dusty vehicle loads transported to, from and between site locations.
- 5. Establishment and use of vehicle wheel and body washing facilities at the exit points of the site.
- 6. Imposition of speed controls for vehicles on unpaved site roads, 8 km per hour is the recommended limit.
- 7. Use of regular watering to reduce dust emissions from exposed site surfaces and unpaved roads, particularly during dry weather.

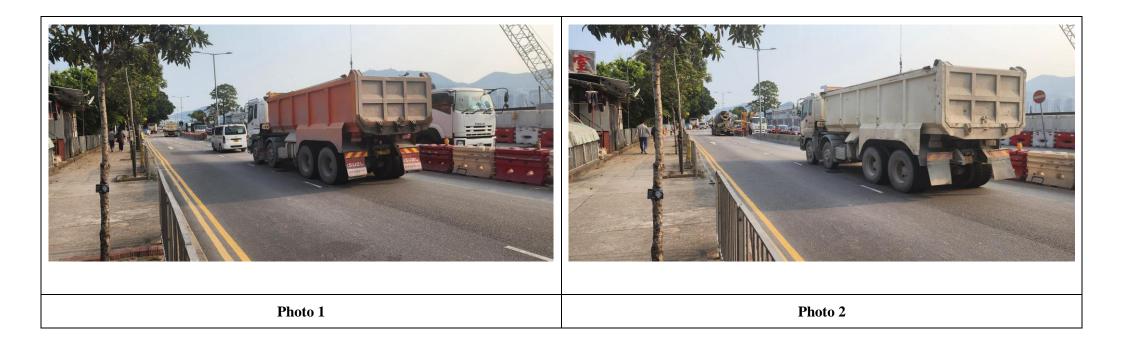
- 1. Fluctuation of road traffic along the Cha Kwo Ling Road, a numerous of dump trucks and concrete mixer lorries passed by and raise the dust to the surrounding (Photo 1 & 2).
- 2. No major project related construction activities was observed during monitoring at CKL2.

Based on the finding(s) and observation(s) above, we deduce the Limit Level exceedance of 24-hour TSP recorded at station CKL2 on 1 March 2023 is due to fluctuation of road traffic, therefore, the exceedance is considered as **<u>non-project related</u>**.

Although the exceedance is considered as non-project related, contractor is reminded that the following construction dust mitigation measures shall always to be implemented on site to reduce/ minimize the generation of dust due to the construction activities.

- 1. Watering of the construction areas 12 times per day to reduce dust emissions.
- 2. Side enclosure and covering of any aggregate or dusty material storage piles to reduce emissions.
- 3. Open stockpiles shall be avoided or covered.
- 4. Tarpaulin covering of all dusty vehicle loads transported to, from and between site locations.
- 5. Establishment and use of vehicle wheel and body washing facilities at the exit points of the site.
- 6. Imposition of speed controls for vehicles on unpaved site roads, 8 km per hour is the recommended limit.
- 7. Use of regular watering to reduce dust emissions from exposed site surfaces and unpaved roads, particularly during dry weather.

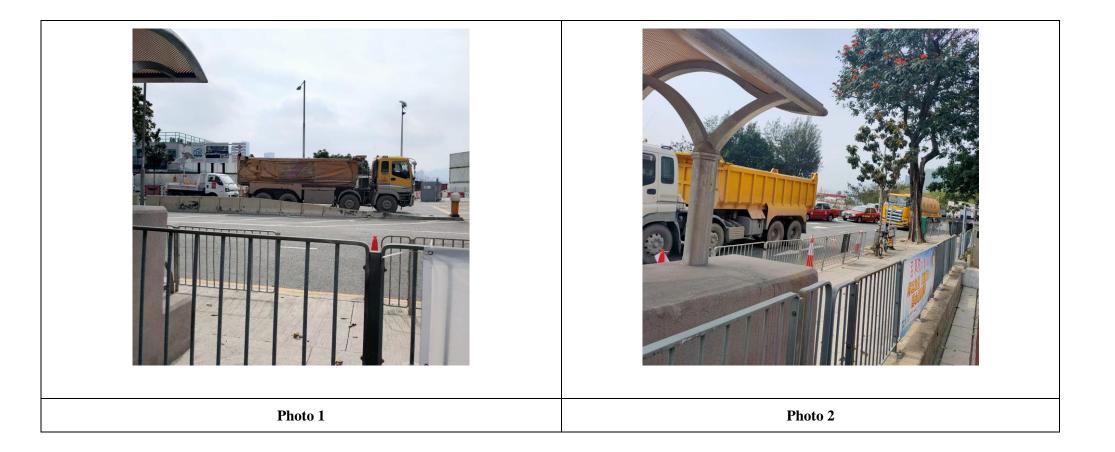
- 1. Fluctuation of road traffic along the Cha Kwo Ling Road, especially the completion of TKOLTT, a numerous of dump trucks from other construction site transport their C&D material through Cha Kwo Ling Road to TKO Area 137 via TKOLTT (Photo 1 & 2).
- 2. Steel work was performed at Portion Q (near CKL2), no dusty activities (i.e Excavation, loading or unloading of C&D material) were performed at this section.

Based on the finding(s) and observation(s) above, we deduce the Limit Level exceedance of 24-hour TSP recorded at station CKL2 on 7 March 2023 is due to fluctuation of road traffic, therefore, the exceedance is considered as **<u>non-project related</u>**.

Although the exceedance is considered as non-project related, contractor is reminded that the following construction dust mitigation measures shall always to be implemented on site to reduce/ minimize the generation of dust due to the construction activities.

- 1. Watering of the construction areas 12 times per day to reduce dust emissions.
- 2. Side enclosure and covering of any aggregate or dusty material storage piles to reduce emissions.
- 3. Open stockpiles shall be avoided or covered.
- 4. Tarpaulin covering of all dusty vehicle loads transported to, from and between site locations.
- 5. Establishment and use of vehicle wheel and body washing facilities at the exit points of the site.
- 6. Imposition of speed controls for vehicles on unpaved site roads, 8 km per hour is the recommended limit.
- 7. Use of regular watering to reduce dust emissions from exposed site surfaces and unpaved roads, particularly during dry weather.

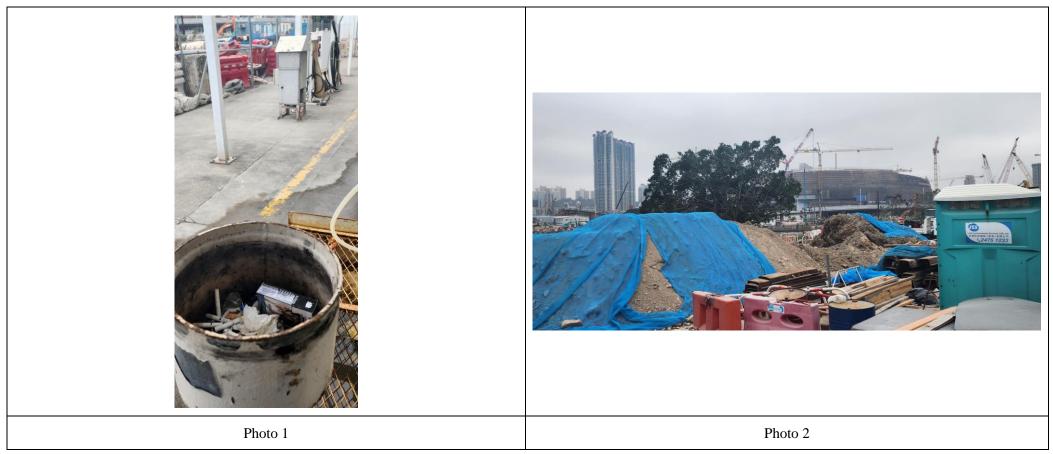
Photo Record (Photo Taken by ET)

1. It observed that a stockpile of excavated dusty material with impervious sheet was not covered thoroughly from the construction site which did not belong to BTP. (See Photo 1)

2. There was an ashtray next to the HVS, which may cause dust nuisance and affect the result. (See Photo 2)

Based on the finding(s) and observation(s) above, we deduce the Action Level exceedance of 24-hour TSP recorded at station KTD2d on 13 March 2023 is due to the construction activities which does not belong to BTP and the ashtray. Therefore, the exceedance is considered as **<u>non-project related</u>**.

The following construction dust mitigation measures shall always to be implemented on site to reduce/ minimize the generation of dust due to the construction activities.

- 1. Watering of the construction areas 12 times per day to reduce dust emissions.
- 2. Side enclosure and covering of any aggregate or dusty material storage piles to reduce emissions.
- 3. Open stockpiles shall be avoided or covered.
- 4. Tarpaulin covering of all dusty vehicle loads transported to, from and between site locations
- 5. Establishment and use of vehicle wheel and body washing facilities at the exit points of the site.
- 6. Imposition of speed controls for vehicles on unpaved site roads, 8 km per hour is the recommended limit

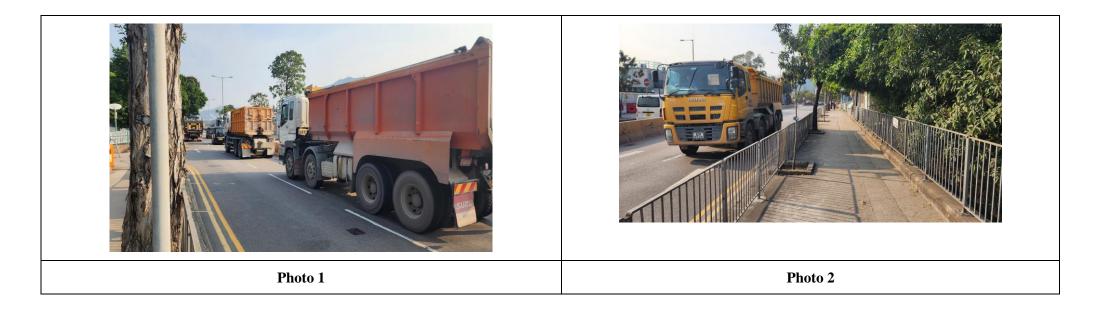
- 1. Fluctuation of road traffic along the Cha Kwo Ling Road, especially the completion of TKOLTT, a numerous of dump trucks from other construction site transport their C&D material through Cha Kwo Ling Road to TKO Area 137 via TKOLTT (Photo 1 & 2).
- 2. Steel work was performed at Portion Q (near CKL2), no dusty activities (i.e Excavation, loading or unloading of C&D material) were performed at this section.

Based on the finding(s) and observation(s) above, we deduce the Limit Level exceedance of 24-hour TSP recorded at station CKL2 on 13 March 2023 is due to fluctuation of road traffic, therefore, the exceedance is considered as **non-project related**.

Although the exceedance is considered as non-project related, contractor is reminded that the following construction dust mitigation measures shall always to be implemented on site to reduce/ minimize the generation of dust due to the construction activities.

- 1. Watering of the construction areas 12 times per day to reduce dust emissions.
- 2. Side enclosure and covering of any aggregate or dusty material storage piles to reduce emissions.
- 3. Open stockpiles shall be avoided or covered.
- 4. Tarpaulin covering of all dusty vehicle loads transported to, from and between site locations.
- 5. Establishment and use of vehicle wheel and body washing facilities at the exit points of the site.
- 6. Imposition of speed controls for vehicles on unpaved site roads, 8 km per hour is the recommended limit.
- 7. Use of regular watering to reduce dust emissions from exposed site surfaces and unpaved roads, particularly during dry weather.

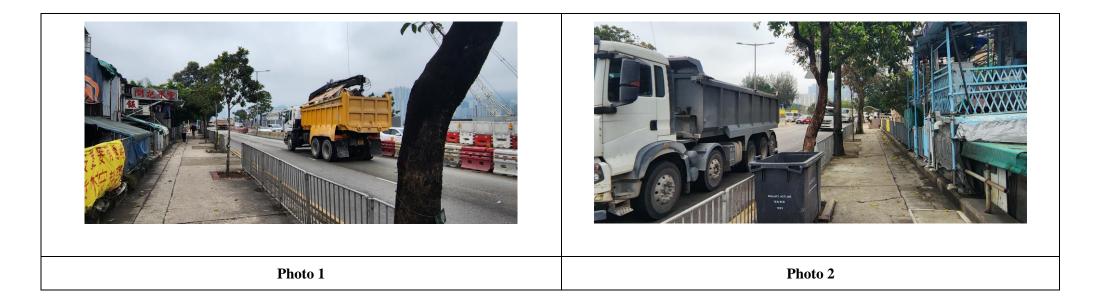
- 1. Fluctuation of road traffic along the Cha Kwo Ling Road, especially the completion of TKOLTT, a numerous of dump trucks from other construction site transport their C&D material through Cha Kwo Ling Road to TKO Area 137 via TKOLTT (Photo 1 & 2).
- 2. Steel work was performed at Portion Q (near CKL2), no dusty activities (i.e Excavation, loading or unloading of C&D material) were performed at this section.

Based on the finding(s) and observation(s) above, we deduce the Action Level exceedance of 24-hour TSP recorded at station CKL2 on 17 March 2023 is due to fluctuation of road traffic, therefore, the exceedance is considered as **non-project related**.

Although the exceedance is considered as non-project related, contractor is reminded that the following construction dust mitigation measures shall always to be implemented on site to reduce/ minimize the generation of dust due to the construction activities.

- 1. Watering of the construction areas 12 times per day to reduce dust emissions.
- 2. Side enclosure and covering of any aggregate or dusty material storage piles to reduce emissions.
- 3. Open stockpiles shall be avoided or covered.
- 4. Tarpaulin covering of all dusty vehicle loads transported to, from and between site locations.
- 5. Establishment and use of vehicle wheel and body washing facilities at the exit points of the site.
- 6. Imposition of speed controls for vehicles on unpaved site roads, 8 km per hour is the recommended limit.
- 7. Use of regular watering to reduce dust emissions from exposed site surfaces and unpaved roads, particularly during dry weather.

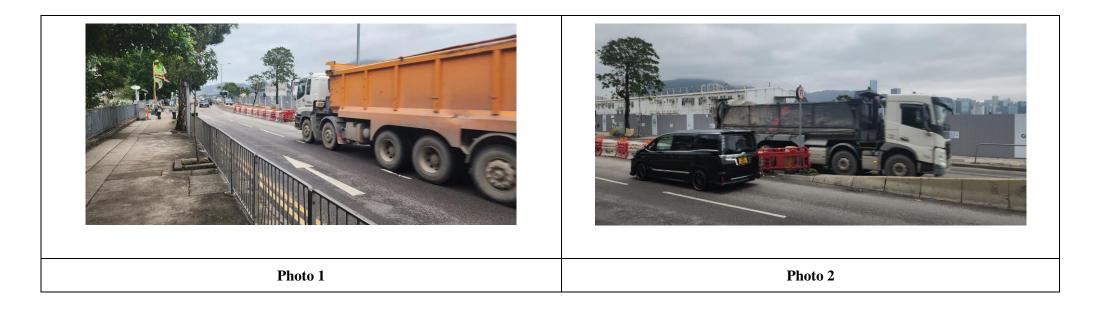
- 1. Fluctuation of road traffic along the Cha Kwo Ling Road, especially the completion of TKOLTT, a numerous of dump trucks from other construction site transport their C&D material through Cha Kwo Ling Road to TKO Area 137 via TKOLTT (Photo 1 & 2).
- 2. Steel work was performed at Portion Q (near CKL2), no dusty activities (i.e Excavation, loading or unloading of C&D material) were performed at this section.

- 1. Watering of the construction areas 12 times per day to reduce dust emissions.
- 2. Side enclosure and covering of any aggregate or dusty material storage piles to reduce emissions.
- 3. Open stockpiles shall be avoided or covered.
- 4. Tarpaulin covering of all dusty vehicle loads transported to, from and between site locations.
- 5. Establishment and use of vehicle wheel and body washing facilities at the exit points of the site.
- 6. Imposition of speed controls for vehicles on unpaved site roads, 8 km per hour is the recommended limit.
- 7. Use of regular watering to reduce dust emissions from exposed site surfaces and unpaved roads, particularly during dry weather.
