**Environmental Complaints Log**

# Investigation Report for the Complaint Received on 7<sup>th</sup> December 2016

Reference No.:	20161207_complaint_c	
Project:	Contract KL/2014/03 – Kai Tak Development – Stage 3 Infrastructure Works for Developments at the Southern Part of the Former Runway	
Date of Complaint:	7 <sup>th</sup> December 2016	
Background:	A compliant received on 7 <sup>th</sup> December 2016 was referred from EPD on 15 <sup>th</sup> December 2016 regarding the sand and mud dropped from the vehicle that caused Cheung Yip Street and Shing Cheong dusty. The notification of complaint was received by ET on 27 <sup>th</sup> January 2017.	
Investigation Results:	On 7 <sup>th</sup> December 2016 (the date of the complaint), some wet soil and mud resulted from diaphragm wall construction were removed from the site of KL/2014/03 to disposal grounds.	
	All site vehicles, including dump trucks were thoroughly washed at site entrances before leaving the site to ensure no silt and mud stuck on wheels and vehicle body be delivered to the public road in their journey to the destination.

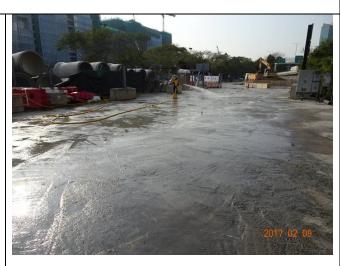
Vehicle washing facilities were observed at the Site on 9<sup>th</sup> February 2017. The area where vehicle washing takes place and the section of road between the washing facilities and the exit point were paved with hardcores.

Vehicles were washed at site exit before leaving the Site.

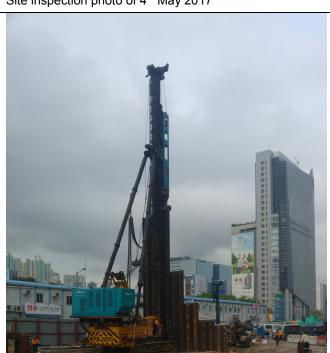
Site inspection photo of 4<sup>th</sup> May 2017

• From the site inspection record of 4 <sup>th</sup> and 11 <sup>th</sup> May 2017, only one unit of specified piling machine was operating within the permitted hours. The piling works on the inspection dates complied with all conditions of the CNP.	
Conclusion	The complaint received on 2 <sup>nd</sup> May 2017 is not valid.

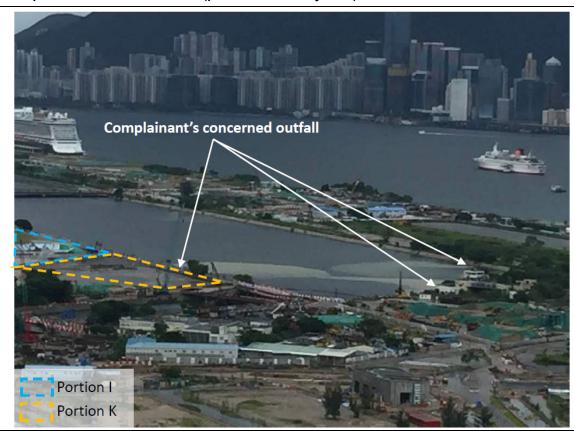
### Complainant's concerned outfall (photo date: 16 July 2017)

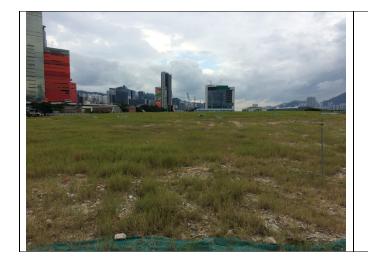
Site inspection photos (27 July 2017)\_Portion I

<ul> <li>A sedimentation tank was provided and operated at Portion I;</li> </ul>	
	<ul> <li>Some muddy water and surface runoff were accumulated at the low lying area at Portion I for sedimentation. No overflow or leakage of muddy water was observed.</li> </ul>	
	<ul> <li>A dye test at the discharge point at Portion I was carried out by CRBC, under HMJV's supervision, on 25 July 2017. The dye was traced and observed at the 7-cell box culvert outfall. No dye was found at the complainant's concerned outfall.</li> </ul>	
	According to HMJV, Portion K was handed over to this Contract on 13 July 2017. No works were carried out by this Contract at Portion K since handing over.	
Conclusion	The complaint received on 16 July 2017 is not related to this Contract.

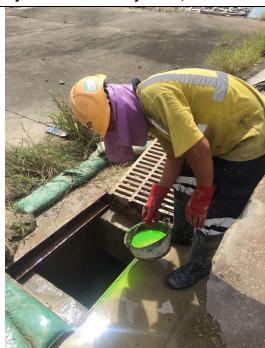
### Dye test carried out by CRBC, under HMJV's supervision, on 25 July 2017

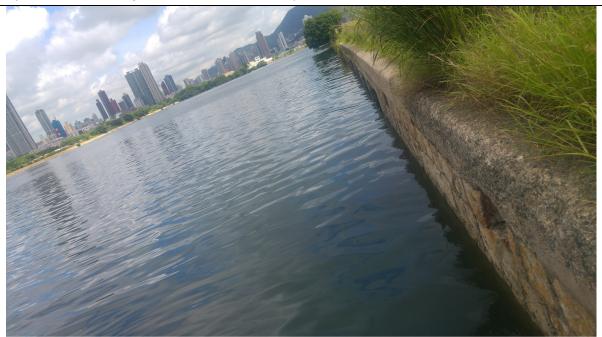
Dye test at the discharge point carried out on 25 July 2017

Existing 7-cell box culvert outfall

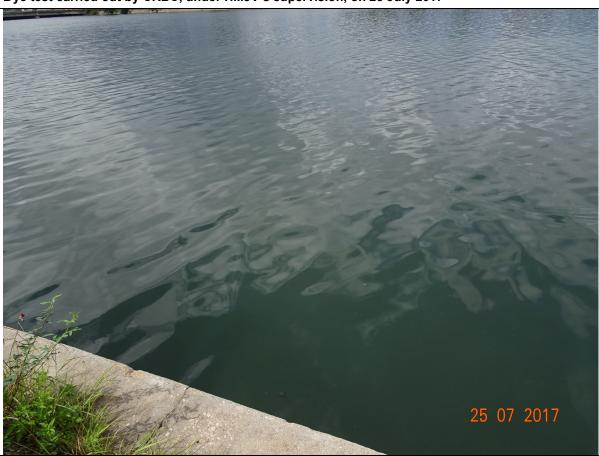
### Dye test carried out by CRBC, under HMJV's supervision, on 25 July 2017

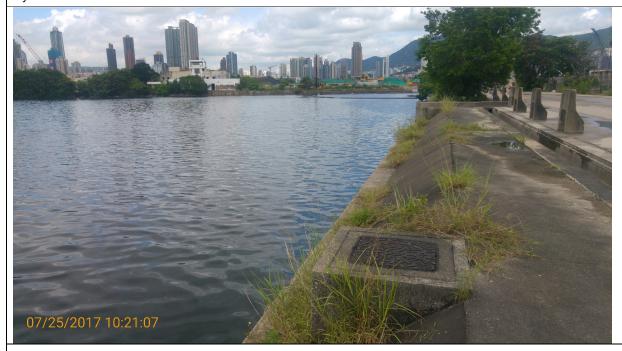
Dye traced at the 7-cell box culvert outfall

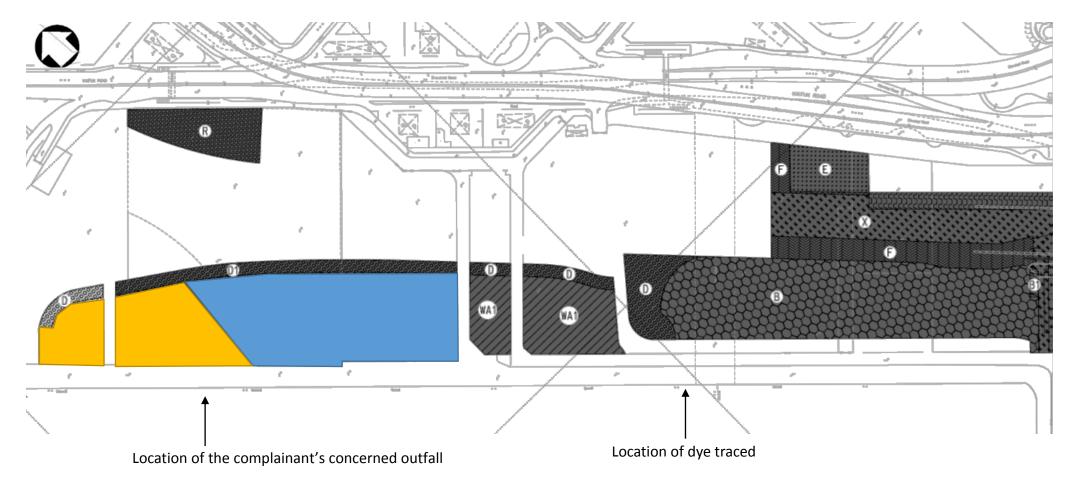
The complainant's concerned outfall

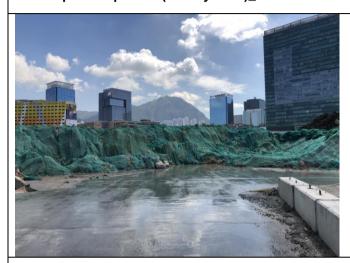
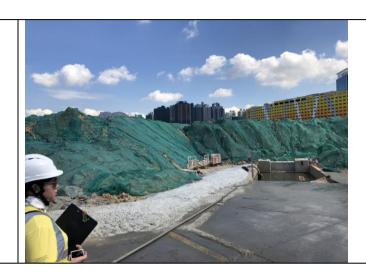
### Site inspection photos (31 May 2018)\_Portion I

Reference No.:	20180530_complaint		
Project:	Contract KL/2014/03 – Kai Tak Development – Stage 3 Infrastructure Works for Developments at the Southern Part of the Former Runway		
Date of Complaint:	30 May 2018		
Background:	A complaint received on 30 May 2018 was referred from EPD regarding some large stockpiles were found uncovered and dust emission was observed during excavation (the site between Kai Fuk Road and Shing Cheong Road, Southwest of Kowloon Bay International Trade & Exhibition Center).		
	The notification of complaint was received by ET on 9 June 2018.		
Action taken during the investigation and the investigation results	<ul> <li>Joint site inspection was carried out by ET, HMJV and CRBC on 31 May 2018, by ET, IEC, HMJV and CRBC on 7 and 14 June 2018.         It was observed that:         <ul> <li>Open stockpiles of construction materials at Portion I were covered with impermeable sheeting and kept moist to prevent the dust emission;</li> <li>Hydroseeding was provided and developed on the surface of the stockpiling materials to protect the soil surface to reduce dust emission;</li> <li>No dust emission was observed during excavation.</li> </ul> </li> </ul>
