Appendix M – Summary of Exceedance

Reporting Month: February 2023

NOE No. 230213_24hrTSP (CKL2) Exceedance Level: Action

NOE No. 230223_24hrTSP (CKL2) Exceedance Level: Action

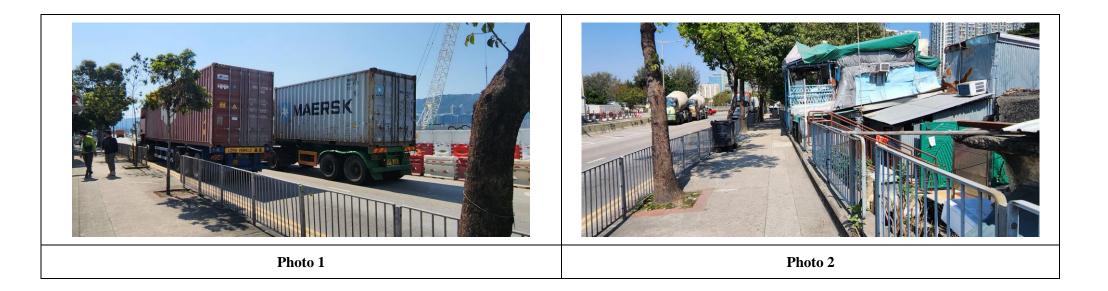
- 1. Fluctuation of road traffic along the Cha Kwo Ling Road, a numerous of dump trucks and concrete mixer lorries passed by and raise the dust to the surrounding (Photo 1 & 2).
- 2. Steel work was performed at Portion Q (near CKL2), no dusty activities (i.e Excavation, loading or unloading of C&D material) were performed at this section.

Based on the finding(s) and observation(s) above, we deduce the Action Level exceedance of 24-hour TSP recorded at station CKL2 on 13 February 2023 is due to fluctuation of road traffic, therefore, the exceedance is considered as **non-project related**.

- 1. Watering of the construction areas 12 times per day to reduce dust emissions.
- 2. Side enclosure and covering of any aggregate or dusty material storage piles to reduce emissions.
- 3. Open stockpiles shall be avoided or covered.
- 4. Tarpaulin covering of all dusty vehicle loads transported to, from and between site locations.
- 5. Establishment and use of vehicle wheel and body washing facilities at the exit points of the site.
- 6. Imposition of speed controls for vehicles on unpaved site roads, 8 km per hour is the recommended limit.
- 7. Use of regular watering to reduce dust emissions from exposed site surfaces and unpaved roads, particularly during dry weather.

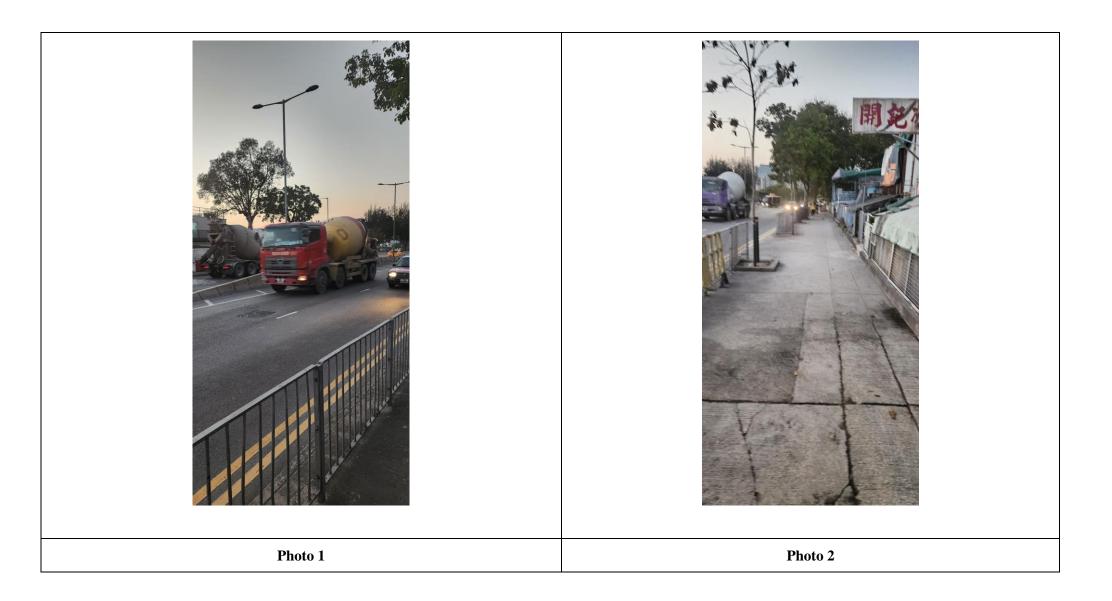
- 1. Fluctuation of road traffic along the Cha Kwo Ling Road, a numerous of dump trucks and concrete mixer lorries passed by and raise the dust to the surrounding (Photo 1 & 2).
- 2. Steel work was performed at Portion Q (near CKL2), no dusty activities (i.e Excavation, loading or unloading of C&D material) were performed at this section.

Based on the finding(s) and observation(s) above, we deduce the Action Level exceedance of 24-hour TSP recorded at station CKL2 on 23 February 2023 is due to fluctuation of road traffic, therefore, the exceedance is considered as **non-project related**.

- 1. Watering of the construction areas 12 times per day to reduce dust emissions.
- 2. Side enclosure and covering of any aggregate or dusty material storage piles to reduce emissions.
- 3. Open stockpiles shall be avoided or covered.
- 4. Tarpaulin covering of all dusty vehicle loads transported to, from and between site locations.
- 5. Establishment and use of vehicle wheel and body washing facilities at the exit points of the site.
- 6. Imposition of speed controls for vehicles on unpaved site roads, 8 km per hour is the recommended limit.
- 7. Use of regular watering to reduce dust emissions from exposed site surfaces and unpaved roads, particularly during dry weather.
