Contract No. ED/2018/04

Trunk Road T2 and Infrastructure Works for Developments at the Former South Apron

Appendix I – Summary of Exceedance

Reporting Quarter: February 2023 – April 2023

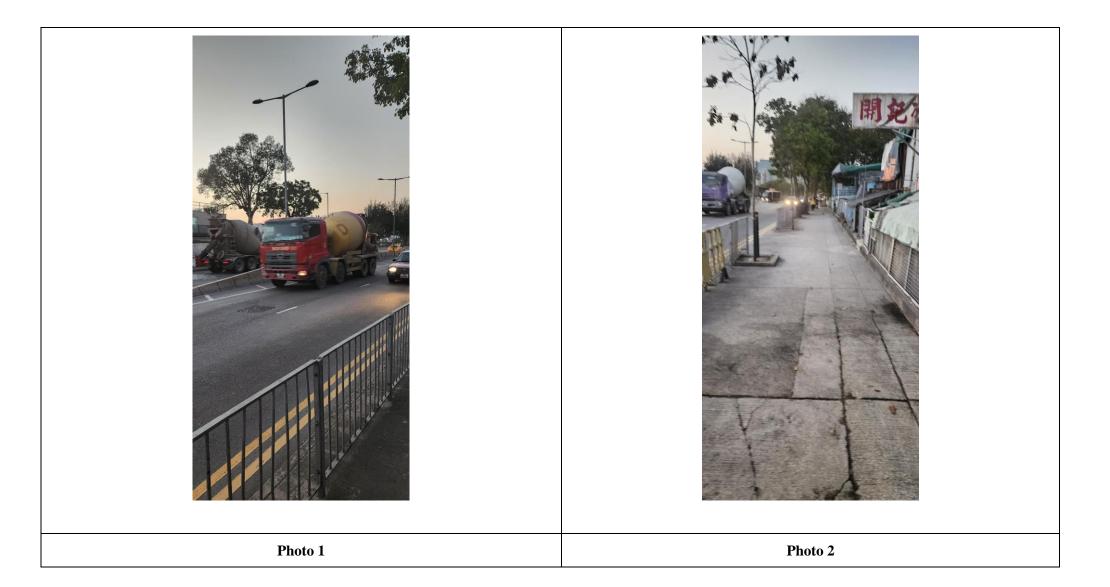
- 1. Fluctuation of road traffic along the Cha Kwo Ling Road, a numerous of dump trucks and concrete mixer lorries passed by and raise the dust to the surrounding (Photo 1 & 2).
- 2. Steel work was performed at Portion Q (near AM4(B)), no dusty activities (i.e Excavation, loading or unloading of C&D material) were performed at this section.

Based on the finding(s) and observation(s) above, we deduce the Action Level exceedance of 24-hour TSP recorded at station AM4(B) on 23 February 2023 is due to fluctuation of road traffic, therefore, the exceedance is considered as **non-project related**.

Although the exceedance is considered as non-project related, contractor is reminded that the following construction dust mitigation measures shall always to be implemented on site to reduce/ minimize the generation of dust due to the construction activities.

- 1. Watering of the construction areas 12 times per day to reduce dust emissions.
- 2. Side enclosure and covering of any aggregate or dusty material storage piles to reduce emissions.
- 3. Open stockpiles shall be avoided or covered.
- 4. Tarpaulin covering of all dusty vehicle loads transported to, from and between site locations.
- 5. Establishment and use of vehicle wheel and body washing facilities at the exit points of the site.
- 6. Imposition of speed controls for vehicles on unpaved site roads, 8 km per hour is the recommended limit.
- 7. Use of regular watering to reduce dust emissions from exposed site surfaces and unpaved roads, particularly during dry weather.

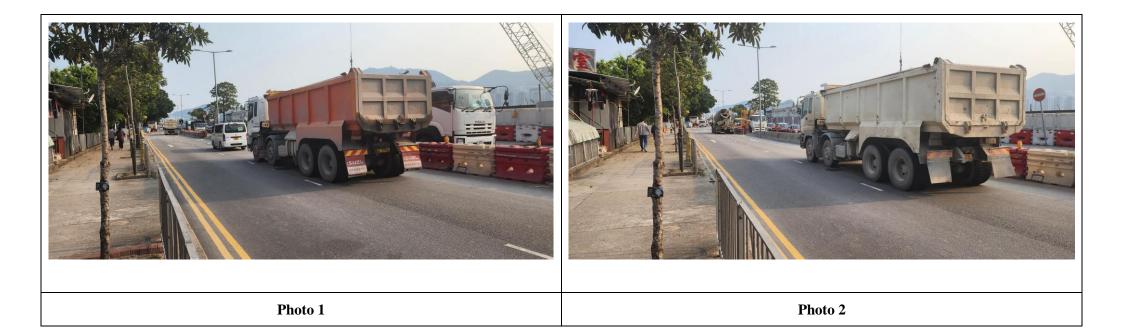
- 1. Fluctuation of road traffic along the Cha Kwo Ling Road, a numerous of dump trucks and concrete mixer lorries passed by and raise the dust to the surrounding (Photo 1 & 2).
- 2. No major project related construction activities was observed during monitoring at AM4(B).

Based on the finding(s) and observation(s) above, we deduce the Limit Level exceedance of 24-hour TSP recorded at station AM4(B) on 1 March 2023 is due to fluctuation of road traffic, therefore, the exceedance is considered as **non-project related**.

Although the exceedance is considered as non-project related, contractor is reminded that the following construction dust mitigation measures shall always to be implemented on site to reduce/ minimize the generation of dust due to the construction activities.

- 1. Watering of the construction areas 12 times per day to reduce dust emissions.
- 2. Side enclosure and covering of any aggregate or dusty material storage piles to reduce emissions.
- 3. Open stockpiles shall be avoided or covered.
- 4. Tarpaulin covering of all dusty vehicle loads transported to, from and between site locations.
- 5. Establishment and use of vehicle wheel and body washing facilities at the exit points of the site.
- 6. Imposition of speed controls for vehicles on unpaved site roads, 8 km per hour is the recommended limit.
- 7. Use of regular watering to reduce dust emissions from exposed site surfaces and unpaved roads, particularly during dry weather.

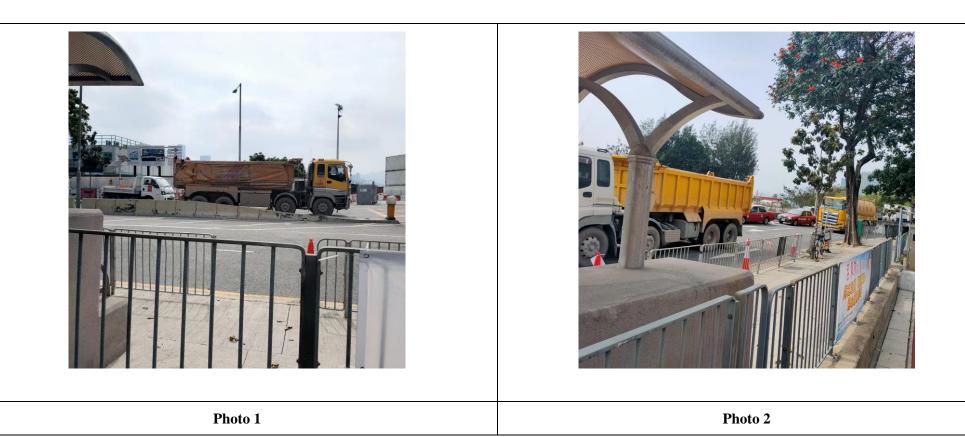
- 1. Fluctuation of road traffic along the Cha Kwo Ling Road, especially the completion of TKOLTT, a numerous of dump trucks from other construction site transport their C&D material through Cha Kwo Ling Road to TKO Area 137 via TKOLTT (Photo 1 & 2).
- 2. Steel work was performed at Portion Q (near AM4(B)), no dusty activities (i.e Excavation, loading or unloading of C&D material) were performed at this section.

Based on the finding(s) and observation(s) above, we deduce the Limit Level exceedance of 24-hour TSP recorded at station AM4(B) on 7 March 2023 is due to fluctuation of road traffic, therefore, the exceedance is considered as **non-project related**.

Although the exceedance is considered as non-project related, contractor is reminded that the following construction dust mitigation measures shall always to be implemented on site to reduce/ minimize the generation of dust due to the construction activities.

- 1. Watering of the construction areas 12 times per day to reduce dust emissions.
- 2. Side enclosure and covering of any aggregate or dusty material storage piles to reduce emissions.
- 3. Open stockpiles shall be avoided or covered.
- 4. Tarpaulin covering of all dusty vehicle loads transported to, from and between site locations.
- 5. Establishment and use of vehicle wheel and body washing facilities at the exit points of the site.
- 6. Imposition of speed controls for vehicles on unpaved site roads, 8 km per hour is the recommended limit.
- 7. Use of regular watering to reduce dust emissions from exposed site surfaces and unpaved roads, particularly during dry weather.

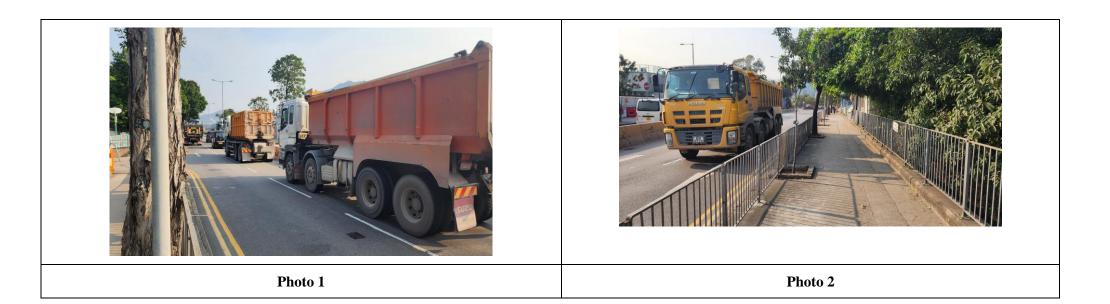
- 1. Fluctuation of road traffic along the Cha Kwo Ling Road, especially the completion of TKOLTT, a numerous of dump trucks from other construction site transport their C&D material through Cha Kwo Ling Road to TKO Area 137 via TKOLTT (Photo 1 & 2).
- 2. Steel work was performed at Portion Q (near AM4(B)), no dusty activities (i.e Excavation, loading or unloading of C&D material) were performed at this section.

Based on the finding(s) and observation(s) above, we deduce the Limit Level exceedance of 24-hour TSP recorded at station AM4(B) on 13 March 2023 is due to fluctuation of road traffic, therefore, the exceedance is considered as **non-project related**.

Although the exceedance is considered as non-project related, contractor is reminded that the following construction dust mitigation measures shall always to be implemented on site to reduce/ minimize the generation of dust due to the construction activities.

- 1. Watering of the construction areas 12 times per day to reduce dust emissions.
- 2. Side enclosure and covering of any aggregate or dusty material storage piles to reduce emissions.
- 3. Open stockpiles shall be avoided or covered.
- 4. Tarpaulin covering of all dusty vehicle loads transported to, from and between site locations.
- 5. Establishment and use of vehicle wheel and body washing facilities at the exit points of the site.
- 6. Imposition of speed controls for vehicles on unpaved site roads, 8 km per hour is the recommended limit.
- 7. Use of regular watering to reduce dust emissions from exposed site surfaces and unpaved roads, particularly during dry weather.

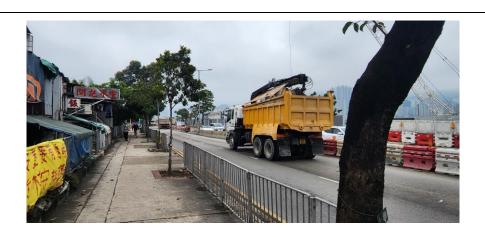
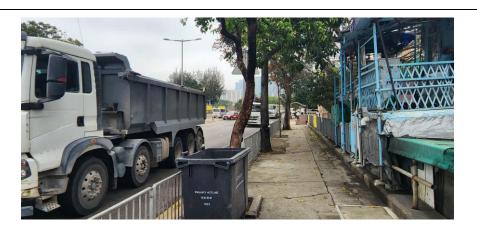
Photo 1 Photo 2

- 1. Fluctuation of road traffic along the Cha Kwo Ling Road, especially the completion of TKOLTT, a numerous of dump trucks from other construction site transport their C&D material through Cha Kwo Ling Road to TKO Area 137 via TKOLTT (Photo 1 & 2).
- 2. Steel work was performed at Portion Q (near AM4(B)), no dusty activities (i.e Excavation, loading or unloading of C&D material) were performed at this section.

Based on the finding(s) and observation(s) above, we deduce the Action Level exceedance of 24-hour TSP recorded at station AM4(B) on 17 March 2023 is due to fluctuation of road traffic, therefore, the exceedance is considered as **non-project related**.

Although the exceedance is considered as non-project related, contractor is reminded that the following construction dust mitigation measures shall always to be implemented on site to reduce/ minimize the generation of dust due to the construction activities.

- 1. Watering of the construction areas 12 times per day to reduce dust emissions.
- 2. Side enclosure and covering of any aggregate or dusty material storage piles to reduce emissions.
- 3. Open stockpiles shall be avoided or covered.
- 4. Tarpaulin covering of all dusty vehicle loads transported to, from and between site locations.
- 5. Establishment and use of vehicle wheel and body washing facilities at the exit points of the site.
- 6. Imposition of speed controls for vehicles on unpaved site roads, 8 km per hour is the recommended limit.
- 7. Use of regular watering to reduce dust emissions from exposed site surfaces and unpaved roads, particularly during dry weather.

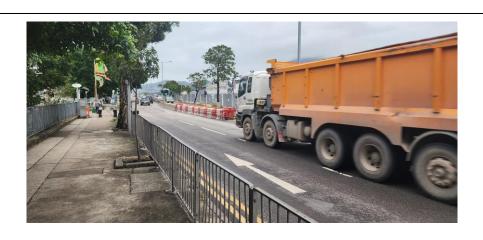
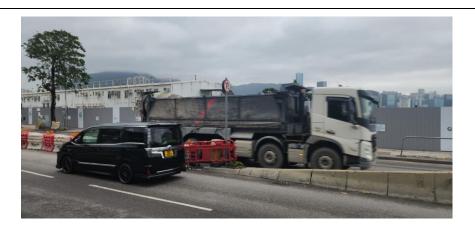
Photo 1 Photo 2

- 1. Fluctuation of road traffic along the Cha Kwo Ling Road, especially the completion of TKOLTT, a numerous of dump trucks from other construction site transport their C&D material through Cha Kwo Ling Road to TKO Area 137 via TKOLTT (Photo 1 & 2).
- 2. Steel work was performed at Portion Q (near AM4(B)), no dusty activities (i.e Excavation, loading or unloading of C&D material) were performed at this section.

Based on the finding(s) and observation(s) above, we deduce the Action Level exceedance of 24-hour TSP recorded at station AM4(B) on 23 March 2023 is due to fluctuation of road traffic, therefore, the exceedance is considered as **non-project related**.

Although the exceedance is considered as non-project related, contractor is reminded that the following construction dust mitigation measures shall always to be implemented on site to reduce/ minimize the generation of dust due to the construction activities.

- 1. Watering of the construction areas 12 times per day to reduce dust emissions.
- 2. Side enclosure and covering of any aggregate or dusty material storage piles to reduce emissions.
- 3. Open stockpiles shall be avoided or covered.
- 4. Tarpaulin covering of all dusty vehicle loads transported to, from and between site locations.
- 5. Establishment and use of vehicle wheel and body washing facilities at the exit points of the site.
- 6. Imposition of speed controls for vehicles on unpaved site roads, 8 km per hour is the recommended limit.
- 7. Use of regular watering to reduce dust emissions from exposed site surfaces and unpaved roads, particularly during dry weather.

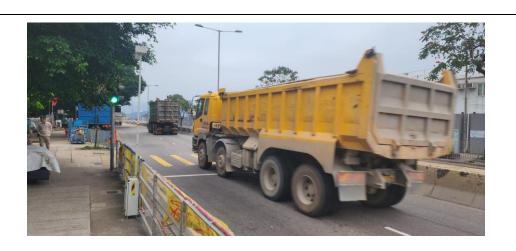
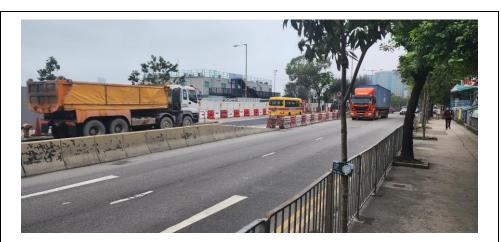
Photo 1 Photo 2

- 1. Fluctuation of road traffic along the Cha Kwo Ling Road, especially the completion of TKOLTT, a numerous of dump trucks from other construction site transport their C&D material through Cha Kwo Ling Road to TKO Area 137 via TKOLTT (Photo 1 & 2).
- 2. Steel work was performed at Portion Q (near AM4(B)), no dusty activities (i.e Excavation, loading or unloading of C&D material) were performed at this section.

Based on the finding(s) and observation(s) above, we deduce the Action Level exceedance of 24-hour TSP recorded at station AM4(B) on 11 April 2023 is due to fluctuation of road traffic, therefore, the exceedance is considered as **non-project related**.

Although the exceedance is considered as non-project related, contractor is reminded that the following construction dust mitigation measures shall always to be implemented on site to reduce/ minimize the generation of dust due to the construction activities.

- 1. Watering of the construction areas 12 times per day to reduce dust emissions.
- 2. Side enclosure and covering of any aggregate or dusty material storage piles to reduce emissions.
- 3. Open stockpiles shall be avoided or covered.
- 4. Tarpaulin covering of all dusty vehicle loads transported to, from and between site locations.
- 5. Establishment and use of vehicle wheel and body washing facilities at the exit points of the site.
- 6. Imposition of speed controls for vehicles on unpaved site roads, 8 km per hour is the recommended limit.
- 7. Use of regular watering to reduce dust emissions from exposed site surfaces and unpaved roads, particularly during dry weather.

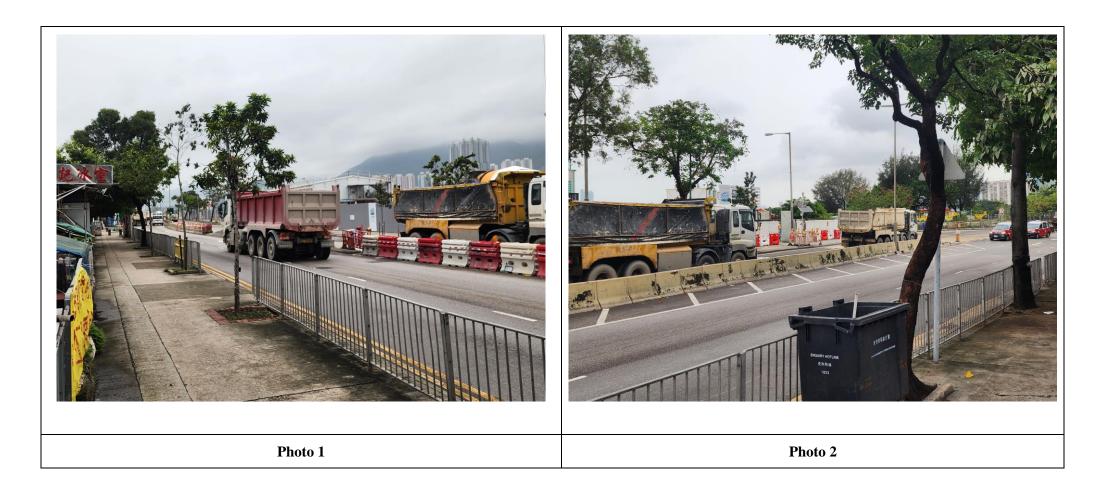
- 1. Fluctuation of road traffic along the Cha Kwo Ling Road, especially the completion of TKOLTT, a numerous of dump trucks from other construction site transport their C&D material through Cha Kwo Ling Road to TKO Area 137 via TKOLTT (Photo 1 & 2).
- 2. Steel work was performed at Portion Q (near AM4(B)), no dusty activities (i.e Excavation, loading or unloading of C&D material) were performed at this section.

Based on the finding(s) and observation(s) above, we deduce the Limit Level exceedance of 24-hour TSP recorded at station AM4(B) on 14 April 2023 is due to fluctuation of road traffic, therefore, the exceedance is considered as **non-project related**.

Although the exceedance is considered as non-project related, contractor is reminded that the following construction dust mitigation measures shall always to be implemented on site to reduce/ minimize the generation of dust due to the construction activities.

- 1. Watering of the construction areas 12 times per day to reduce dust emissions.
- 2. Side enclosure and covering of any aggregate or dusty material storage piles to reduce emissions.
- 3. Open stockpiles shall be avoided or covered.
- 4. Tarpaulin covering of all dusty vehicle loads transported to, from and between site locations.
- 5. Establishment and use of vehicle wheel and body washing facilities at the exit points of the site.
- 6. Imposition of speed controls for vehicles on unpaved site roads, 8 km per hour is the recommended limit.
- 7. Use of regular watering to reduce dust emissions from exposed site surfaces and unpaved roads, particularly during dry weather.
