Report No.: 0405/15/ED/1098A

## MONTHLY EM&A REPORT

August 2018

**Contract Name** : Environmental Monitoring Works for  
Contract KL/2014/03 – Kai Tak Development  
– Stage 3 Infrastructure Works for Developments  
at the Southern Part of the Former Runway

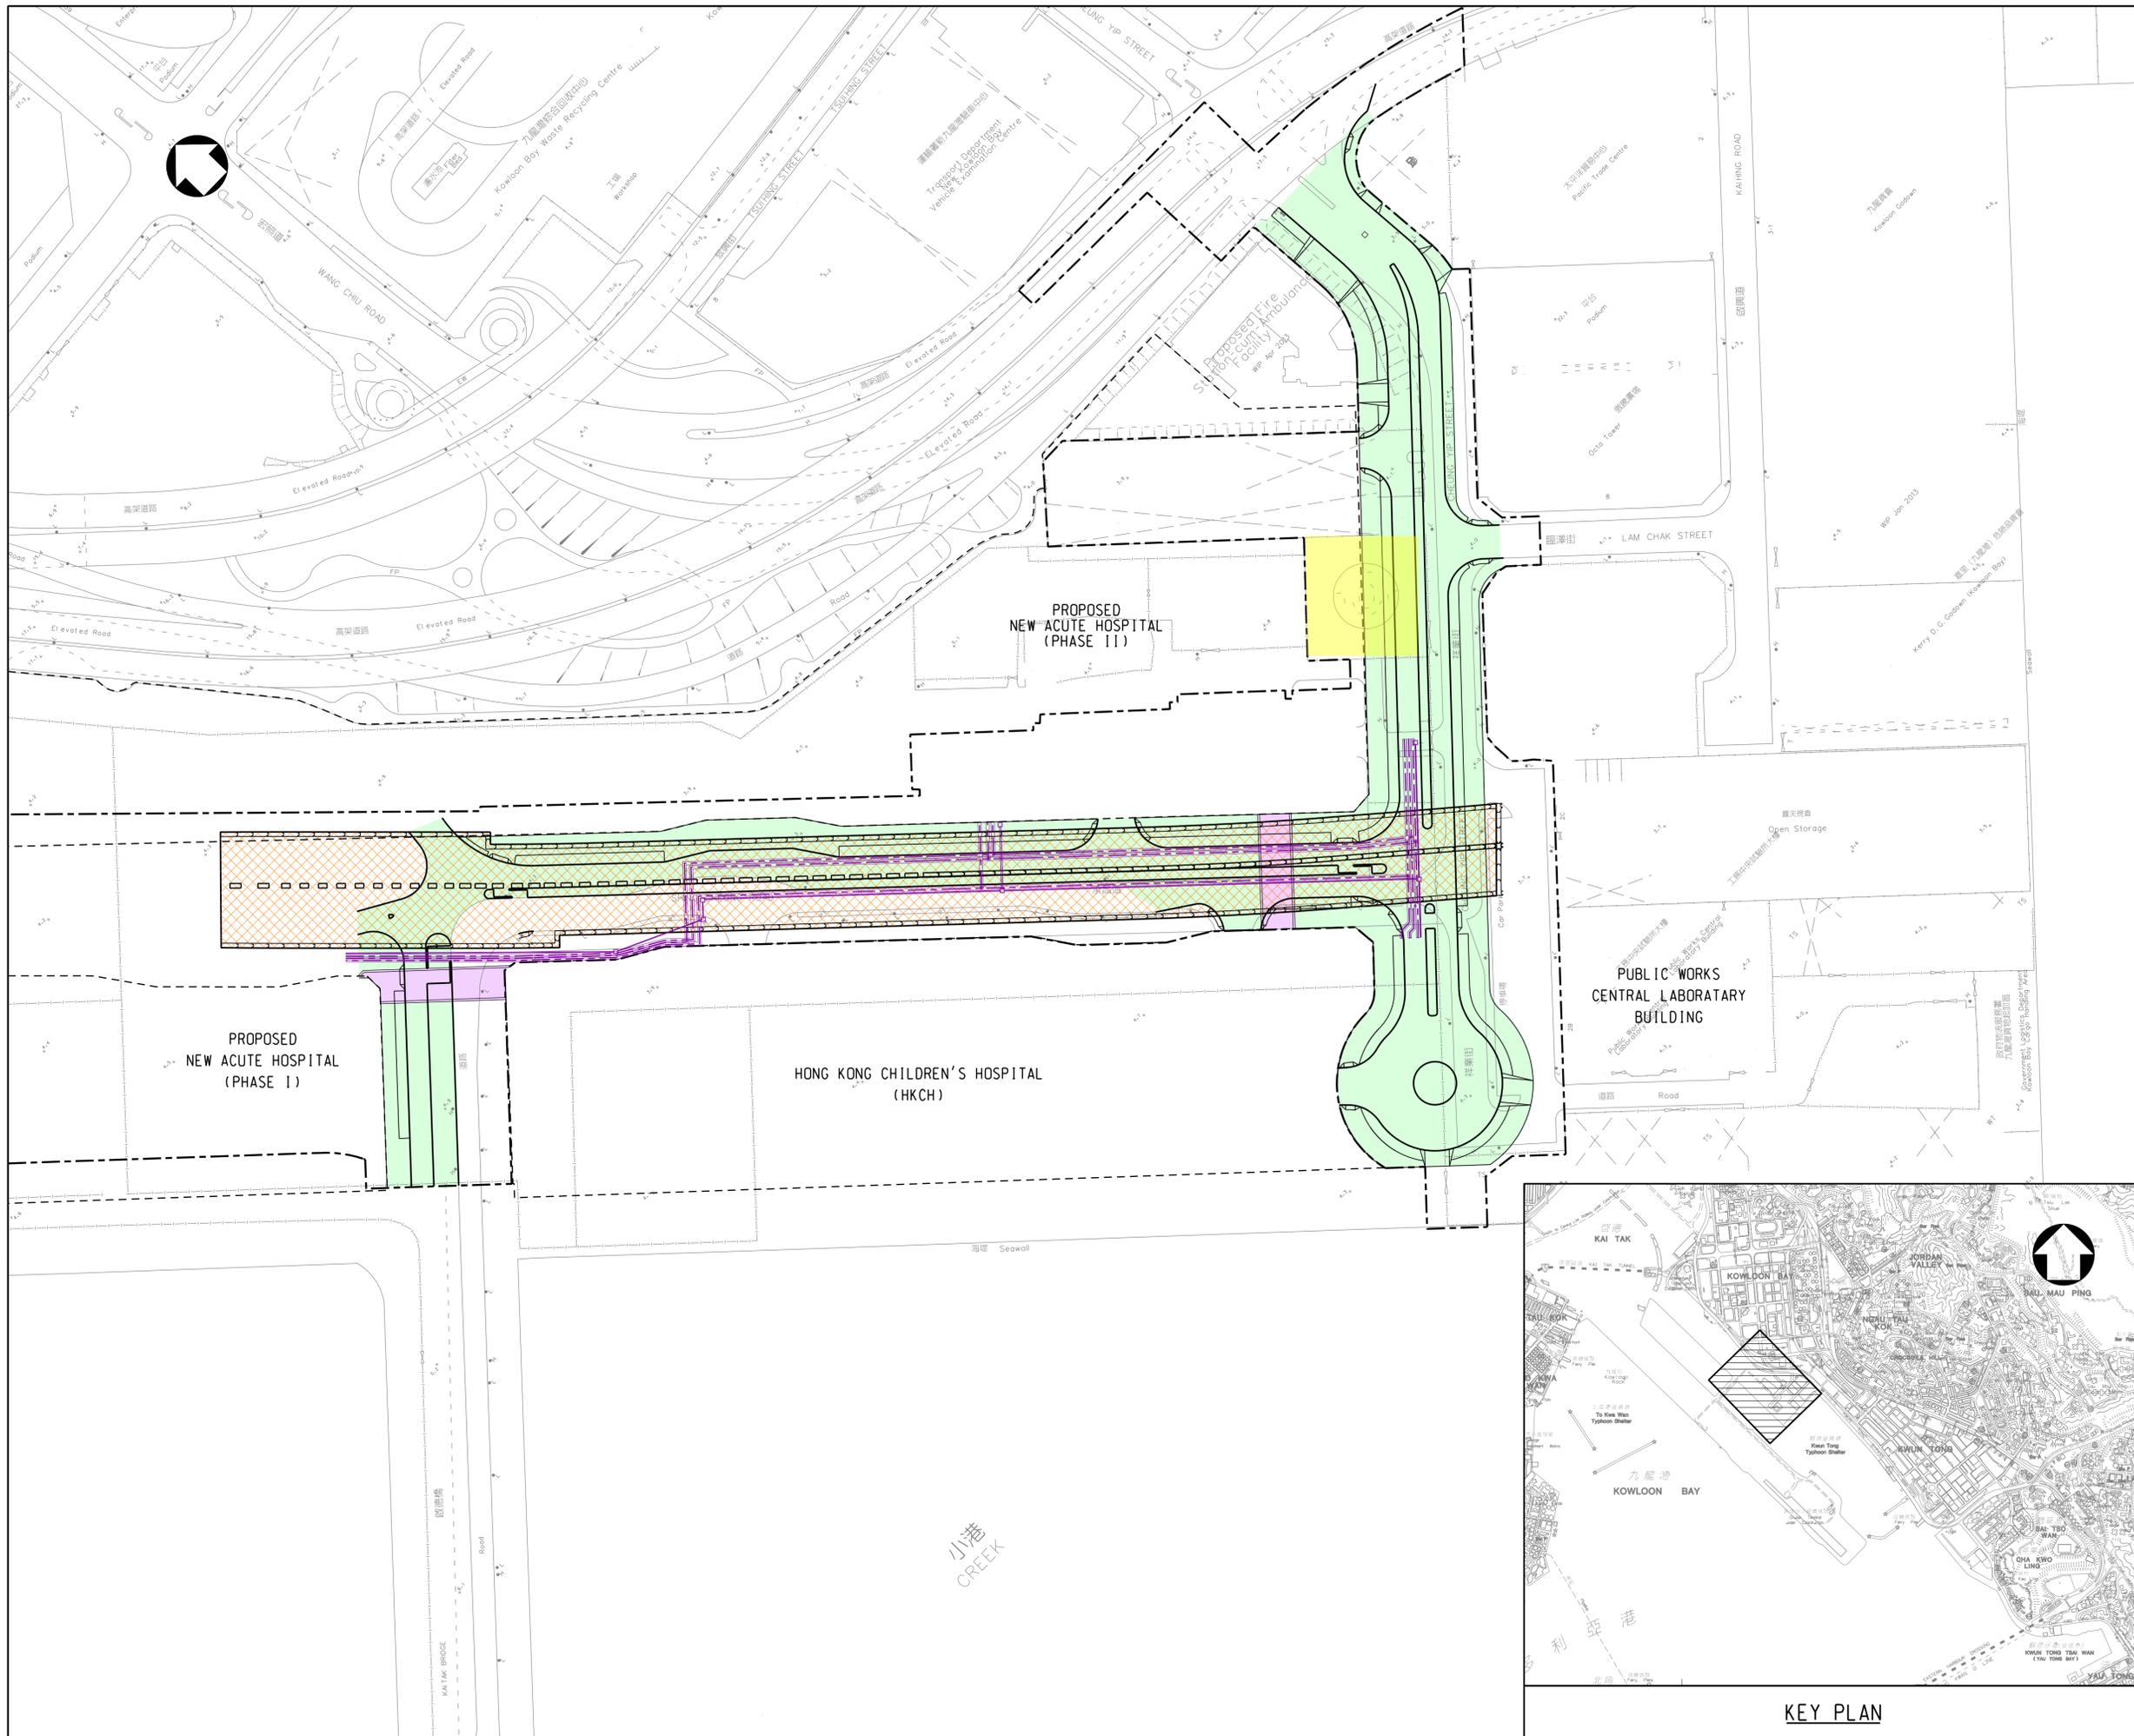
## Figure 1

1.1.3 The location and boundary of the site is shown in **Figure 1**.

### Project General Layout

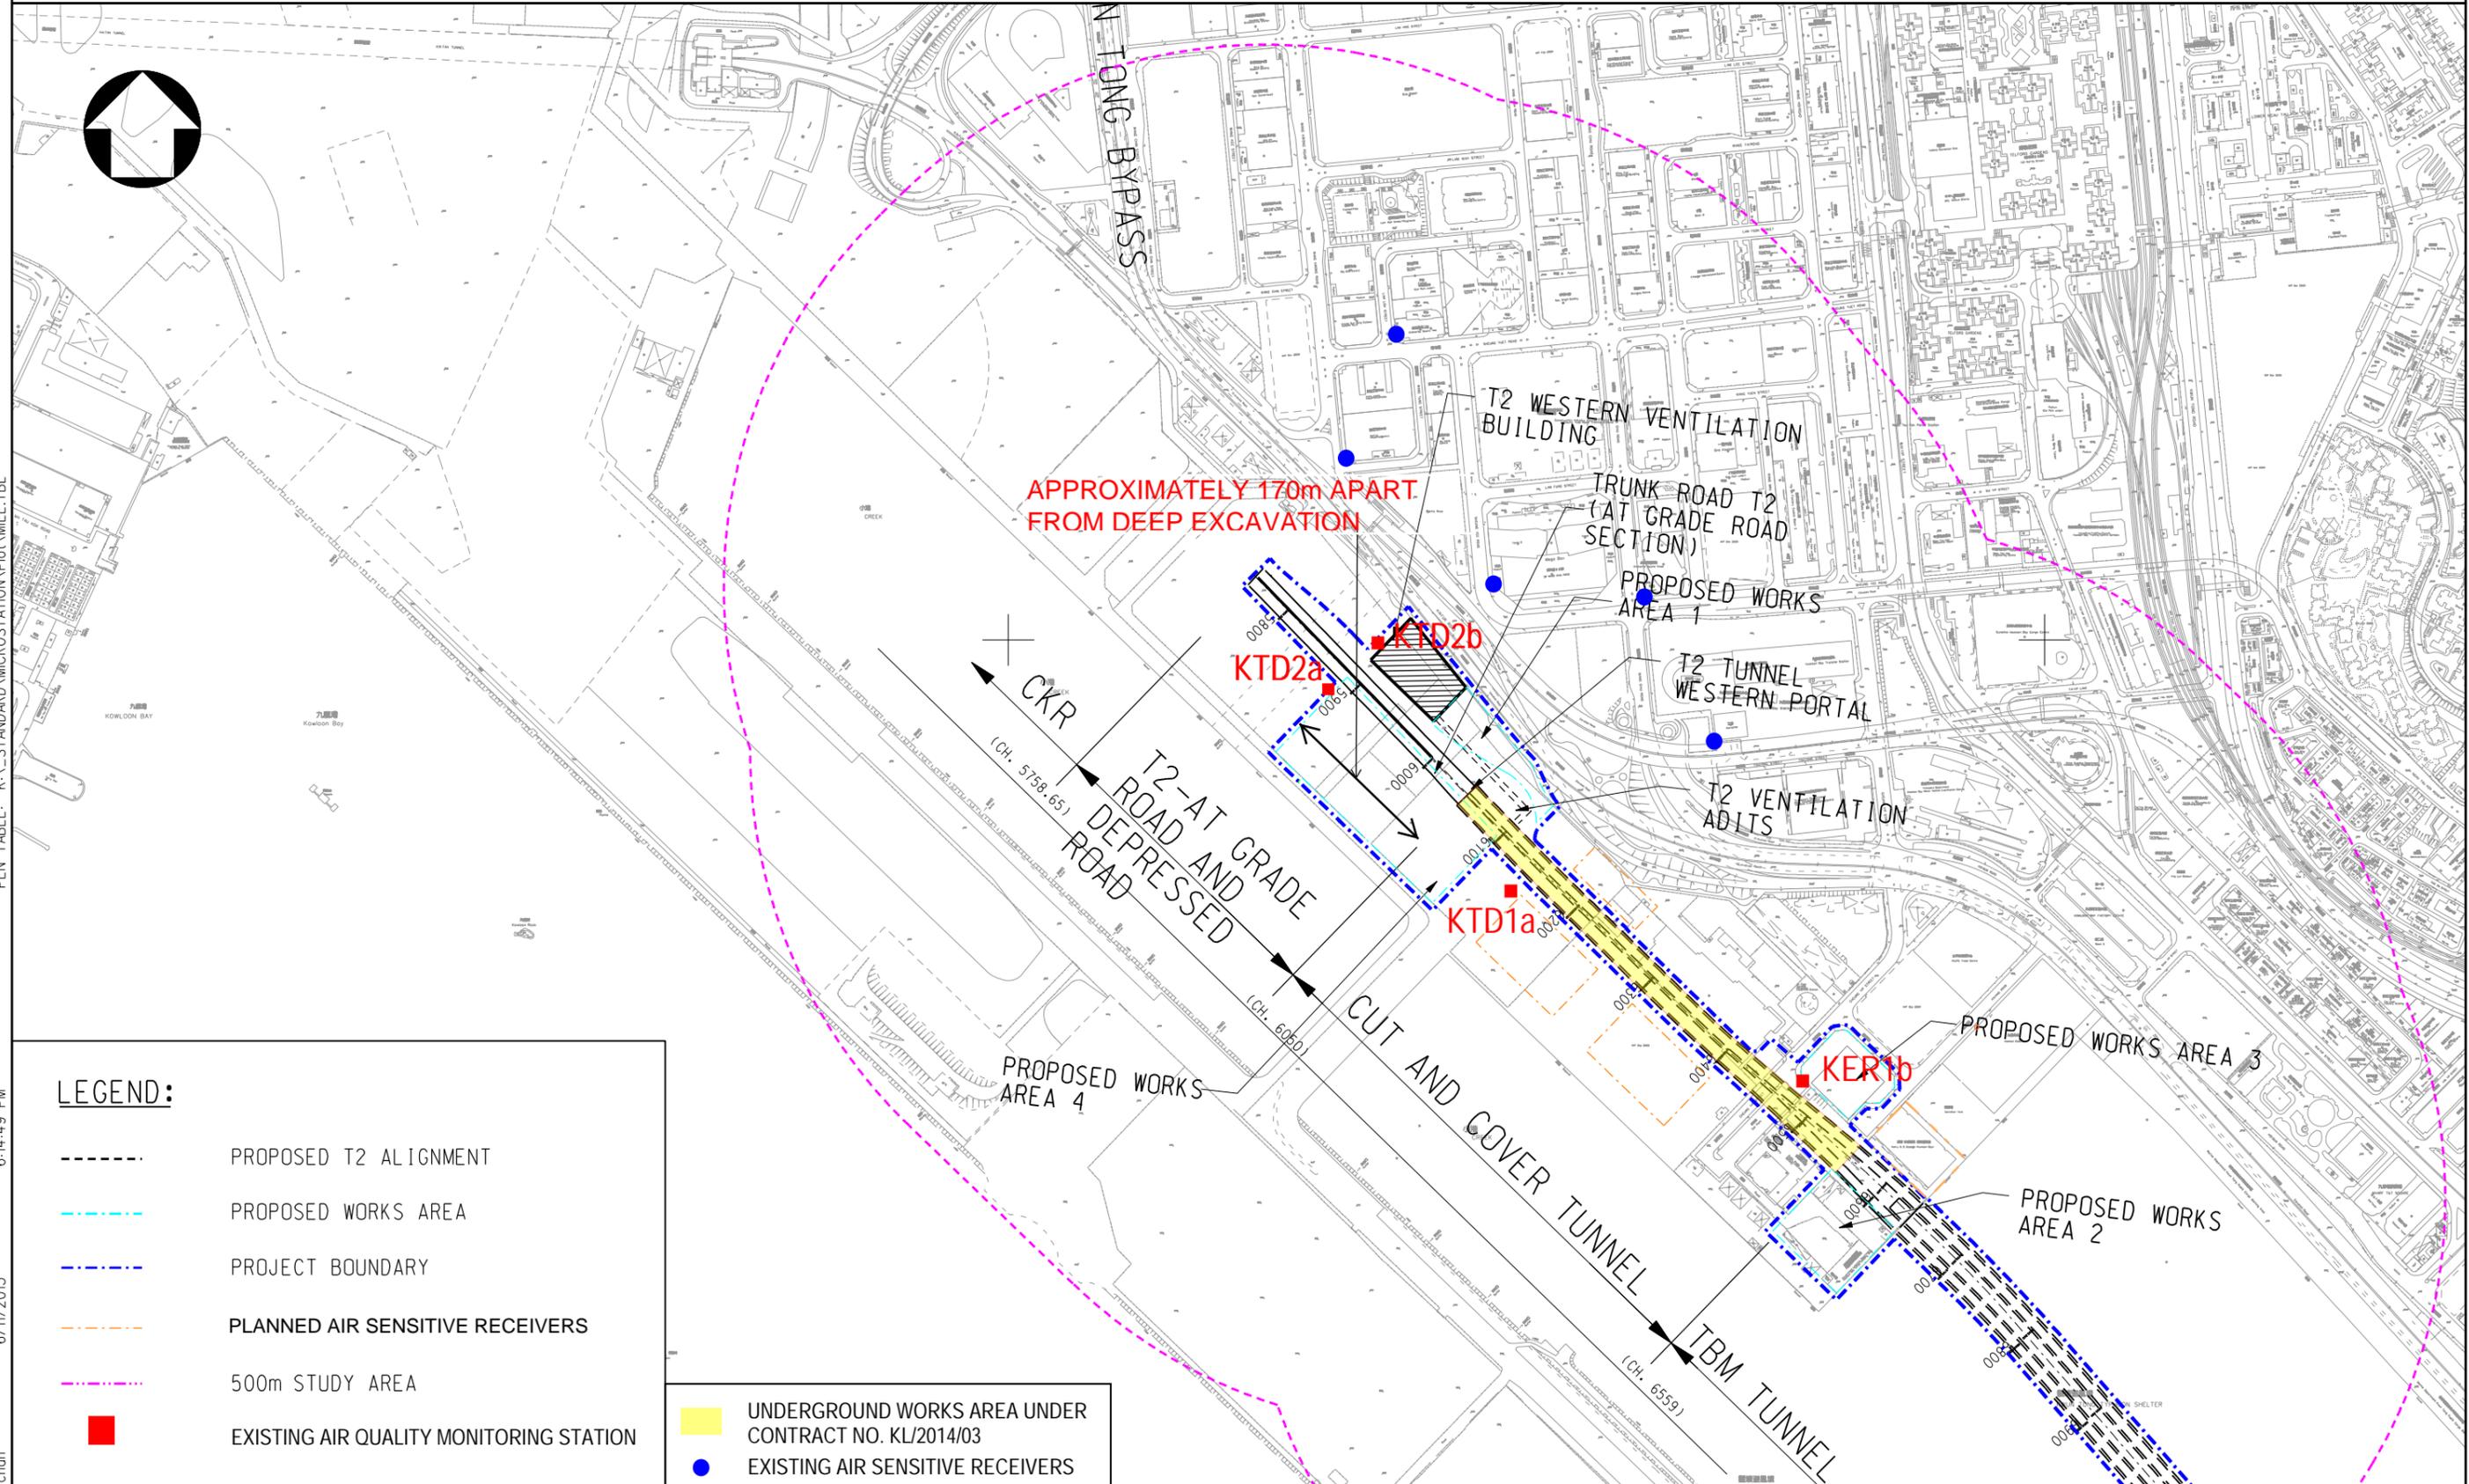
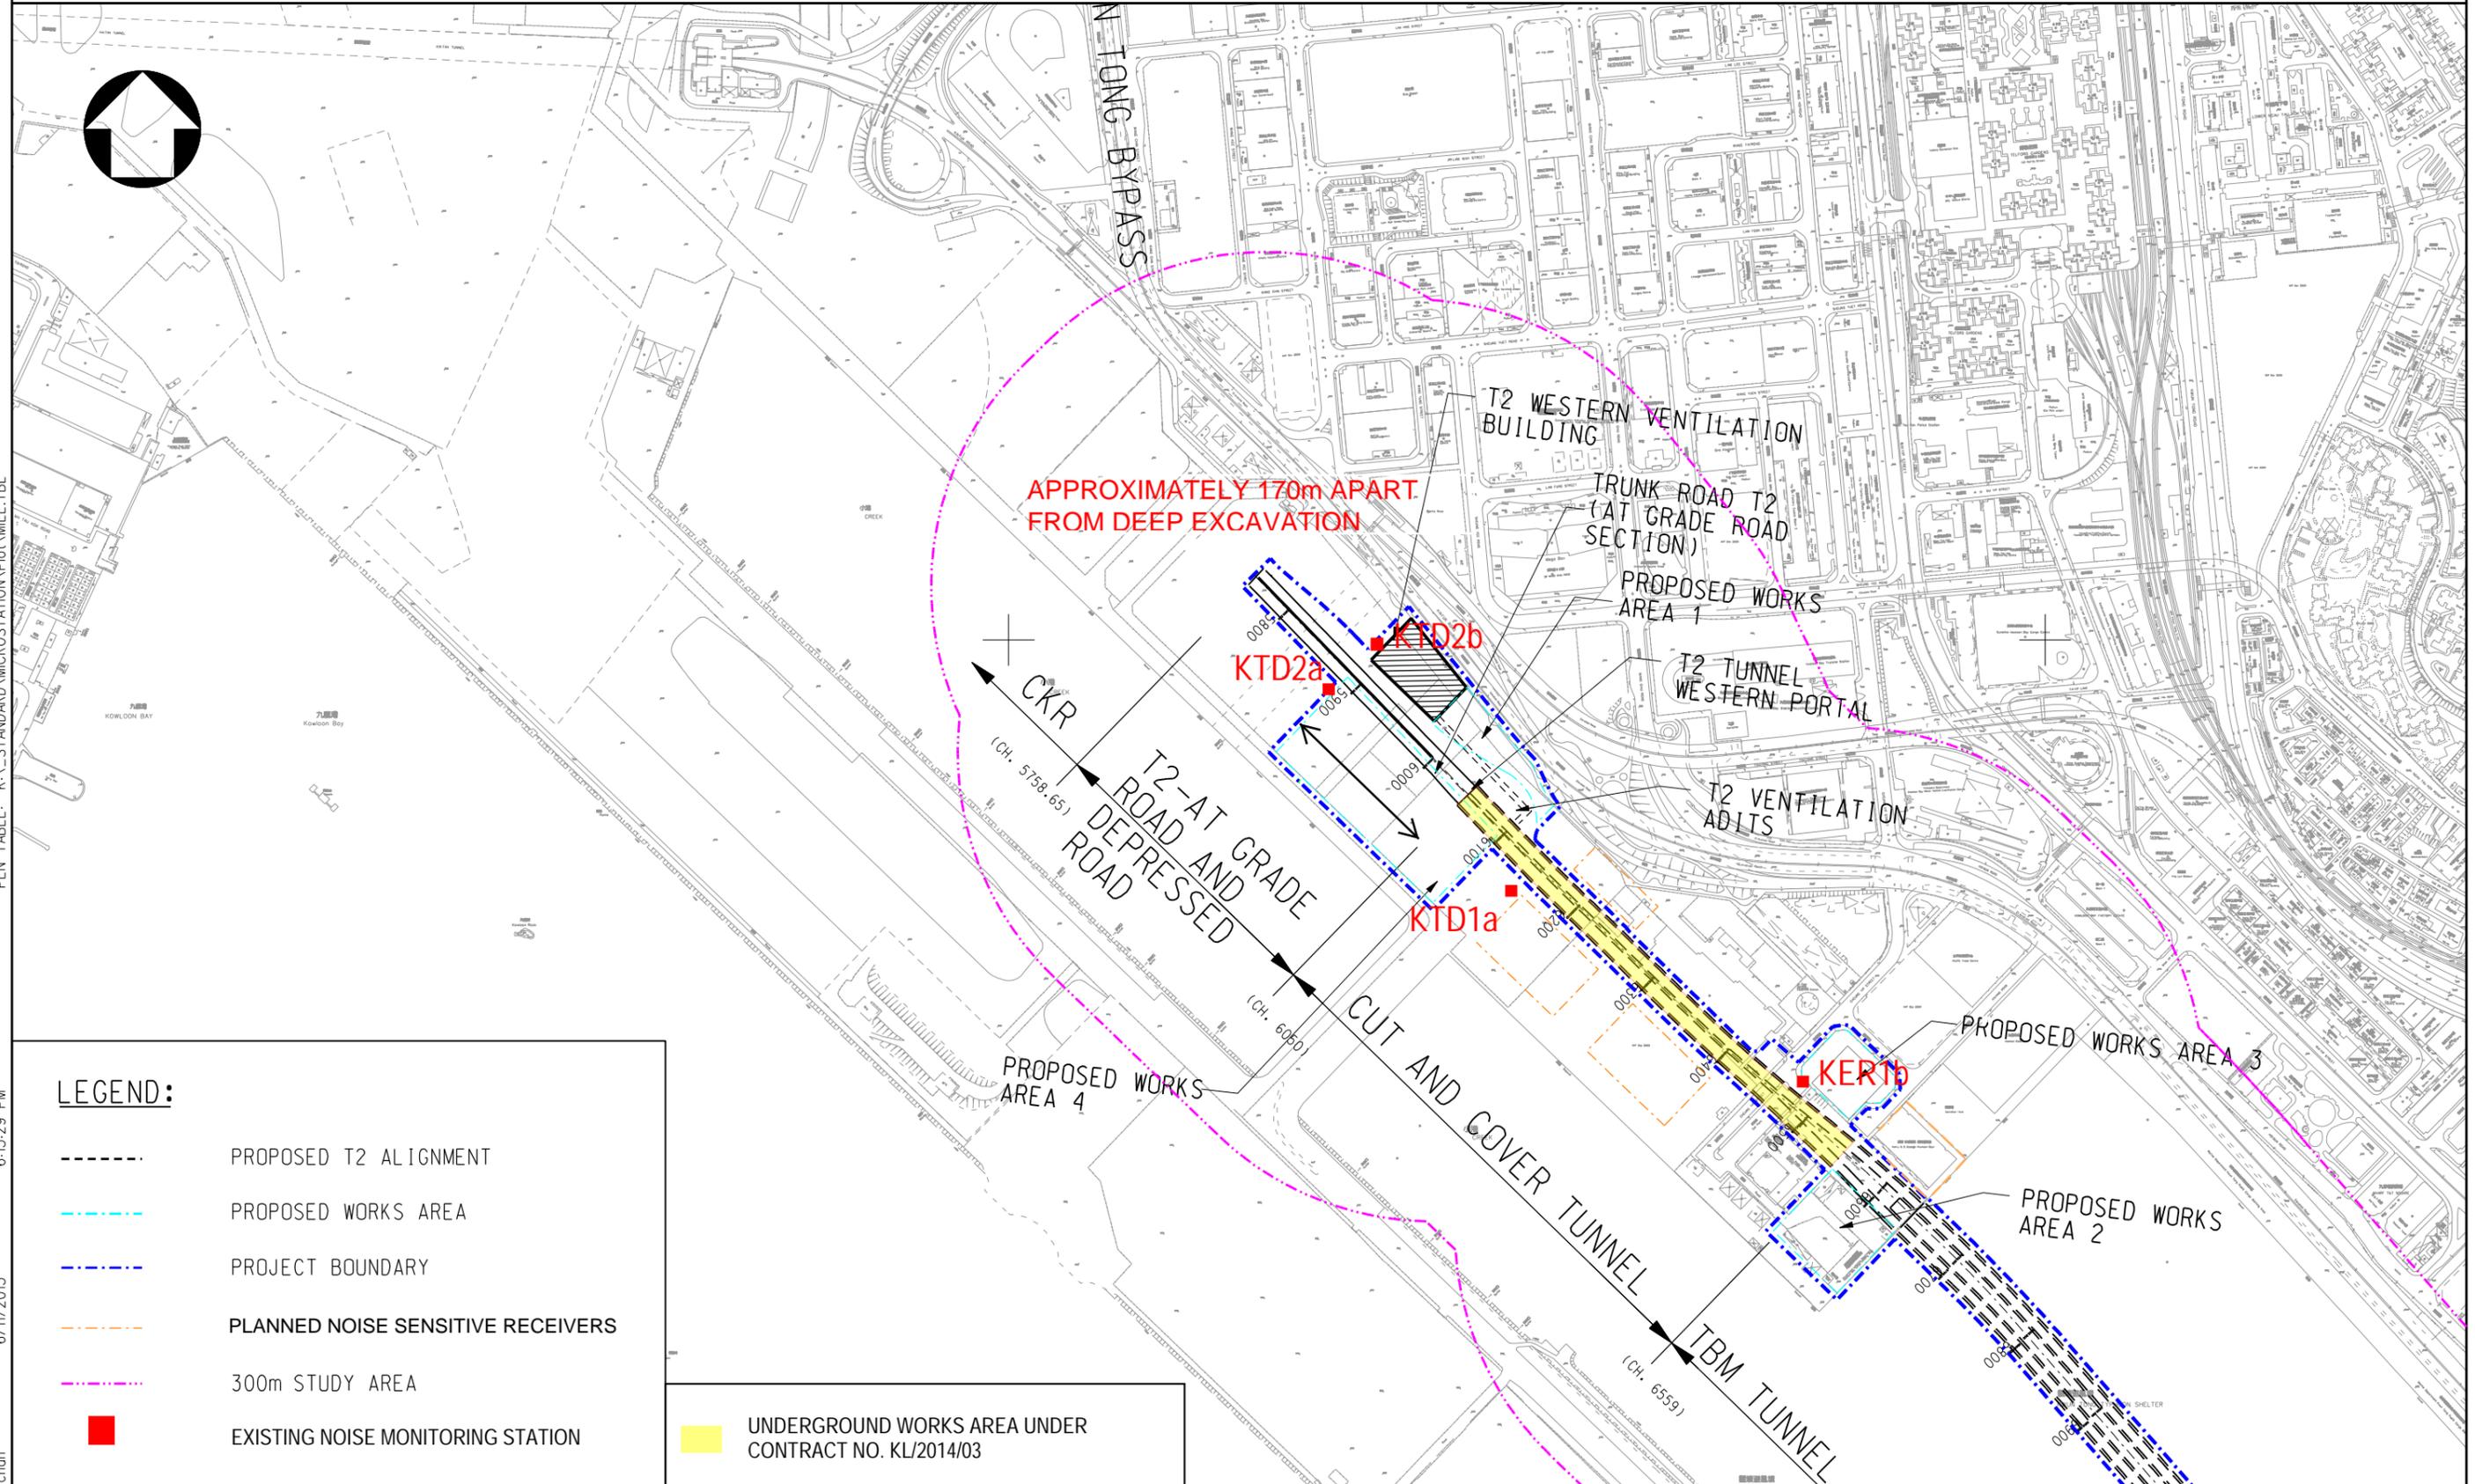
### **Figure 2**

#### **Air and Noise Monitoring Locations**

2.5.2 According to the approved alternative baseline air quality and noise monitoring locations (EPD reference: EP2/K19/A/21 Pt.5), the original monitoring locations (KTD1, KTD2 and KER1) are proposed to be replaced by alternative monitoring locations (KTD1a, KTD2a and KER1a) for air quality monitoring.

2.5.6 The existing location KTD2a for 24-hour TSP monitoring is situated at the site area to be handed over to the Hospital Authority in mid-July 2018 to become the future site of the New Acute Hospital. The proposal of relocation of monitoring location KTD2a for TSP monitoring was submitted to EPD on 20 July 2018 for approval under condition 3.1 of EP-337/2009, EP339/2009/A and EP-451/2013 and Section 11.3.1.2 of the EM&A Manual, AEIAR-174/2013, and was approved by EPD on 25 July 2018. Monitoring location KTD2a was relocated to the approved location KTD2b, effective from 9 August 2018.
