## MONTHLY EM&A REPORT

October 2018

**Contract Name** : Environmental Monitoring Works for  
Contract KL/2014/03 – Kai Tak Development  
– Stage 3 Infrastructure Works for Developments  
at the Southern Part of the Former Runway

**Report No.** : 0405/15/ED/1119A

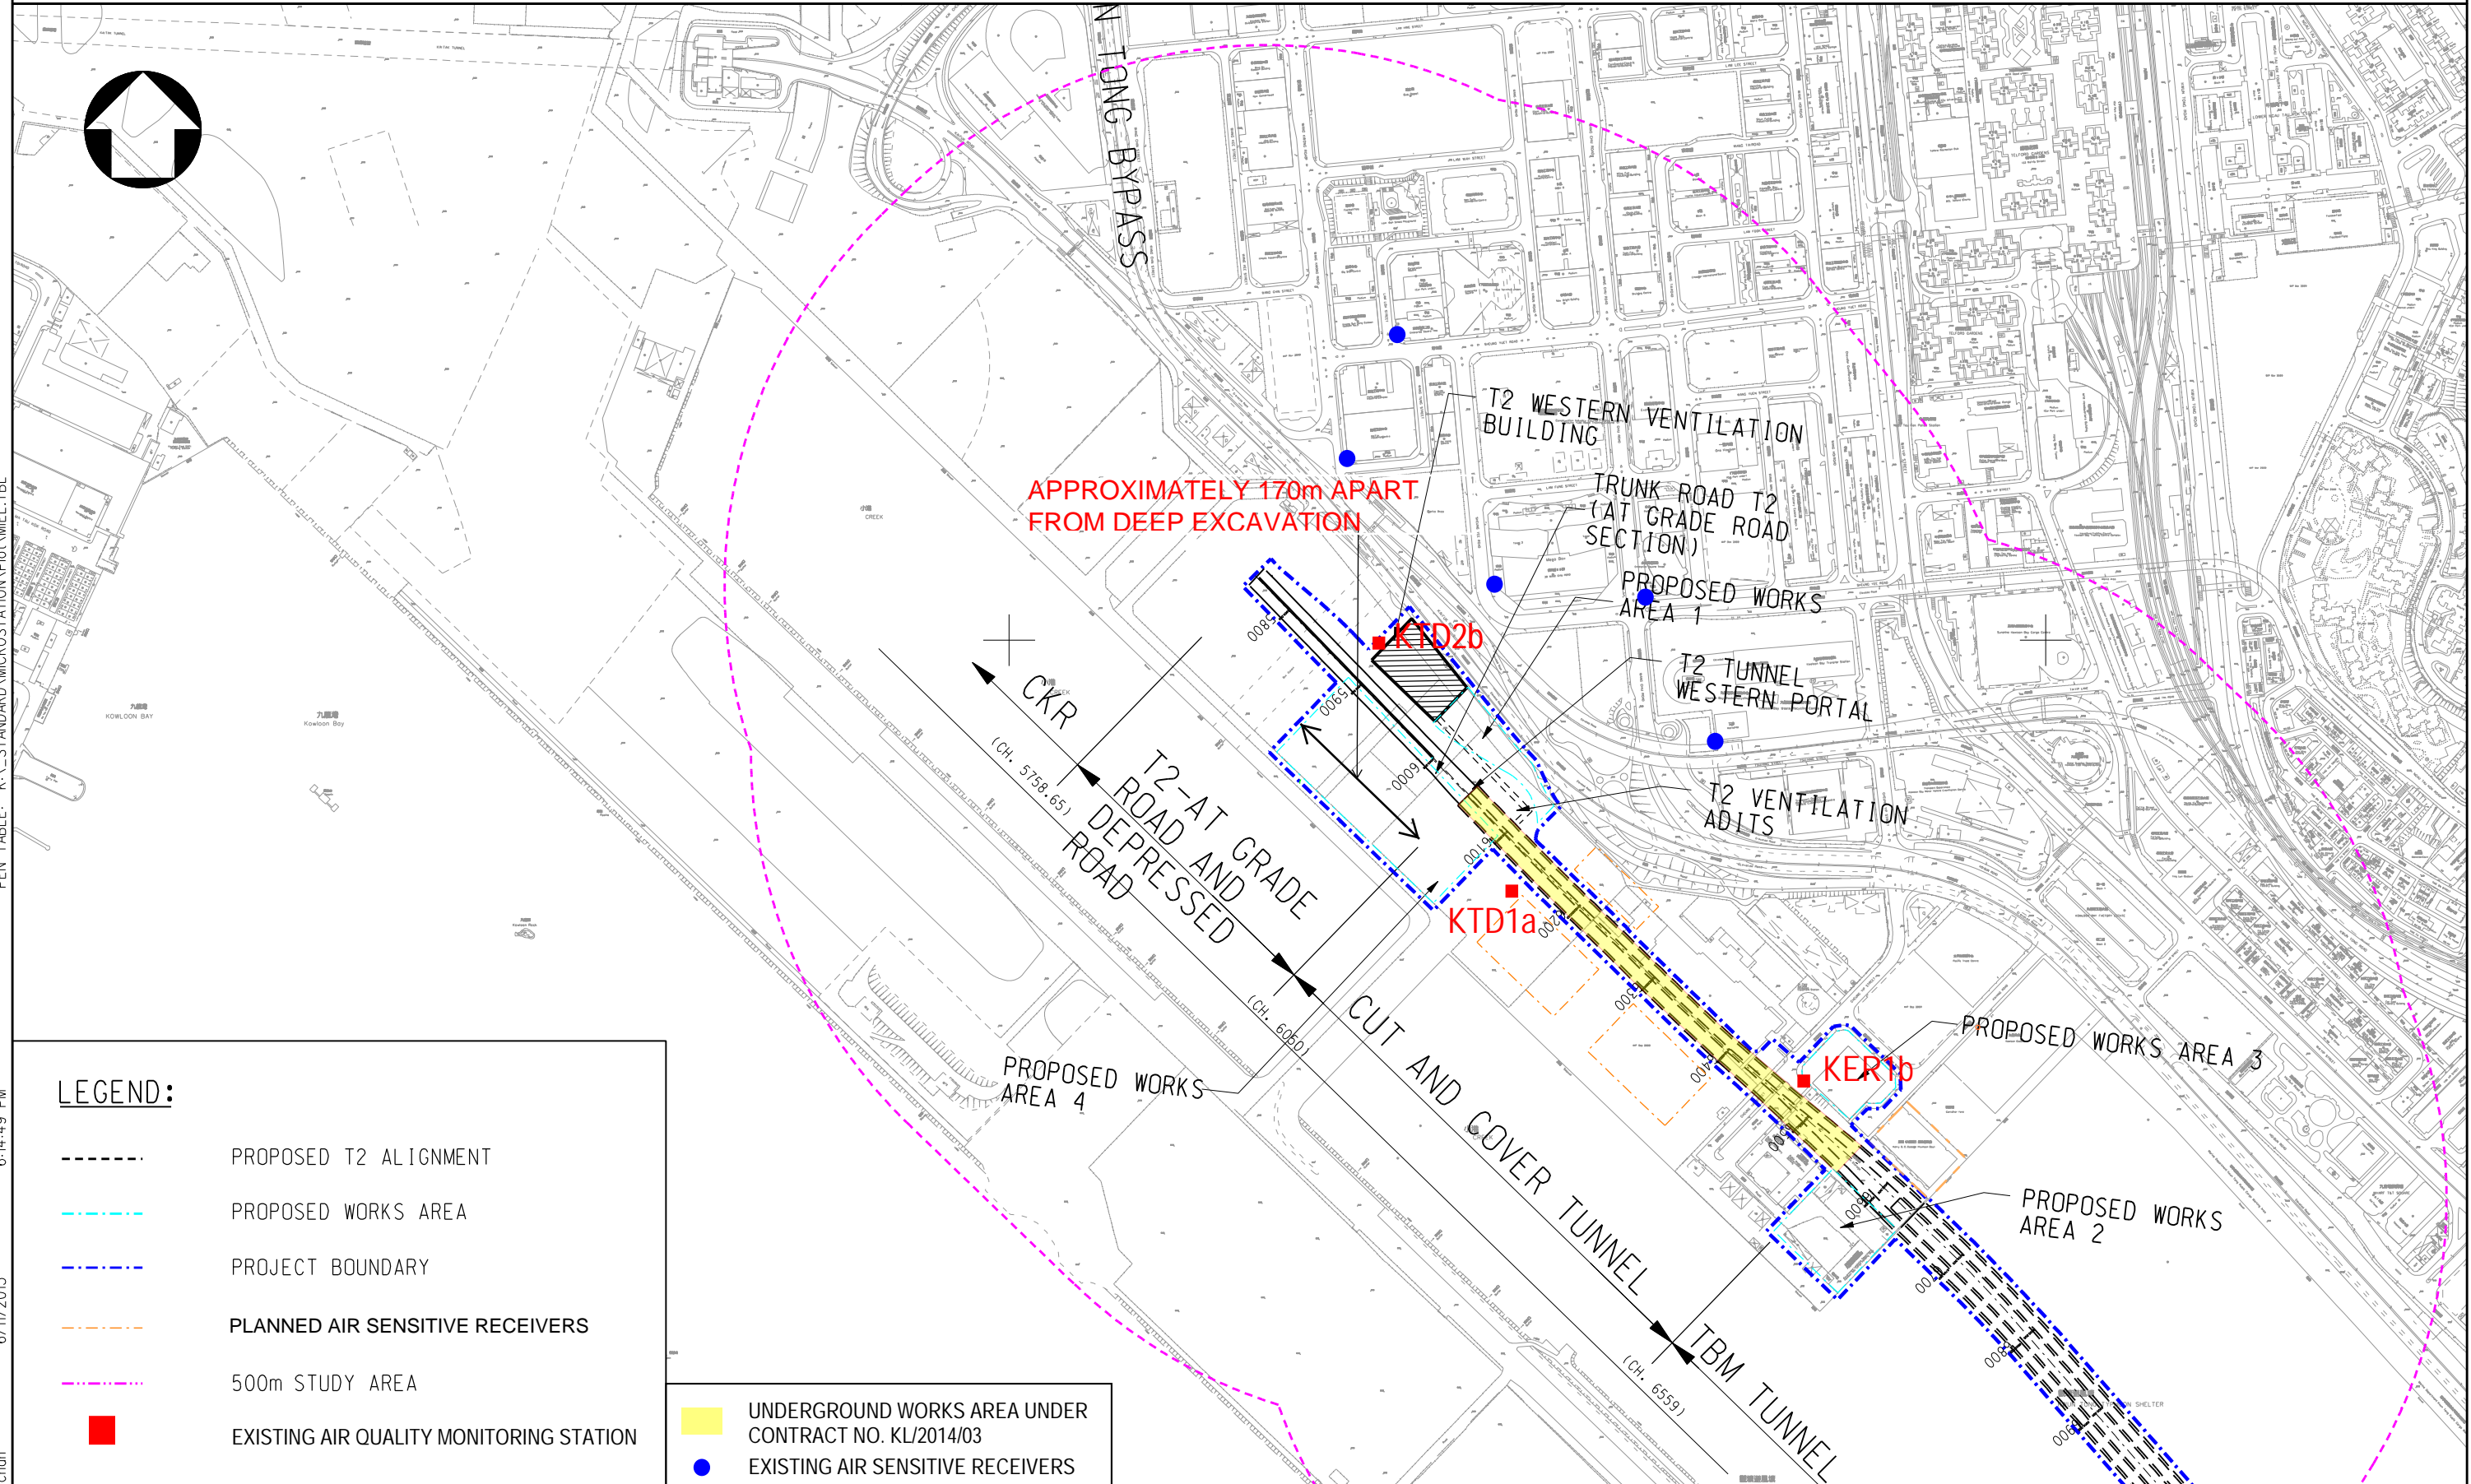
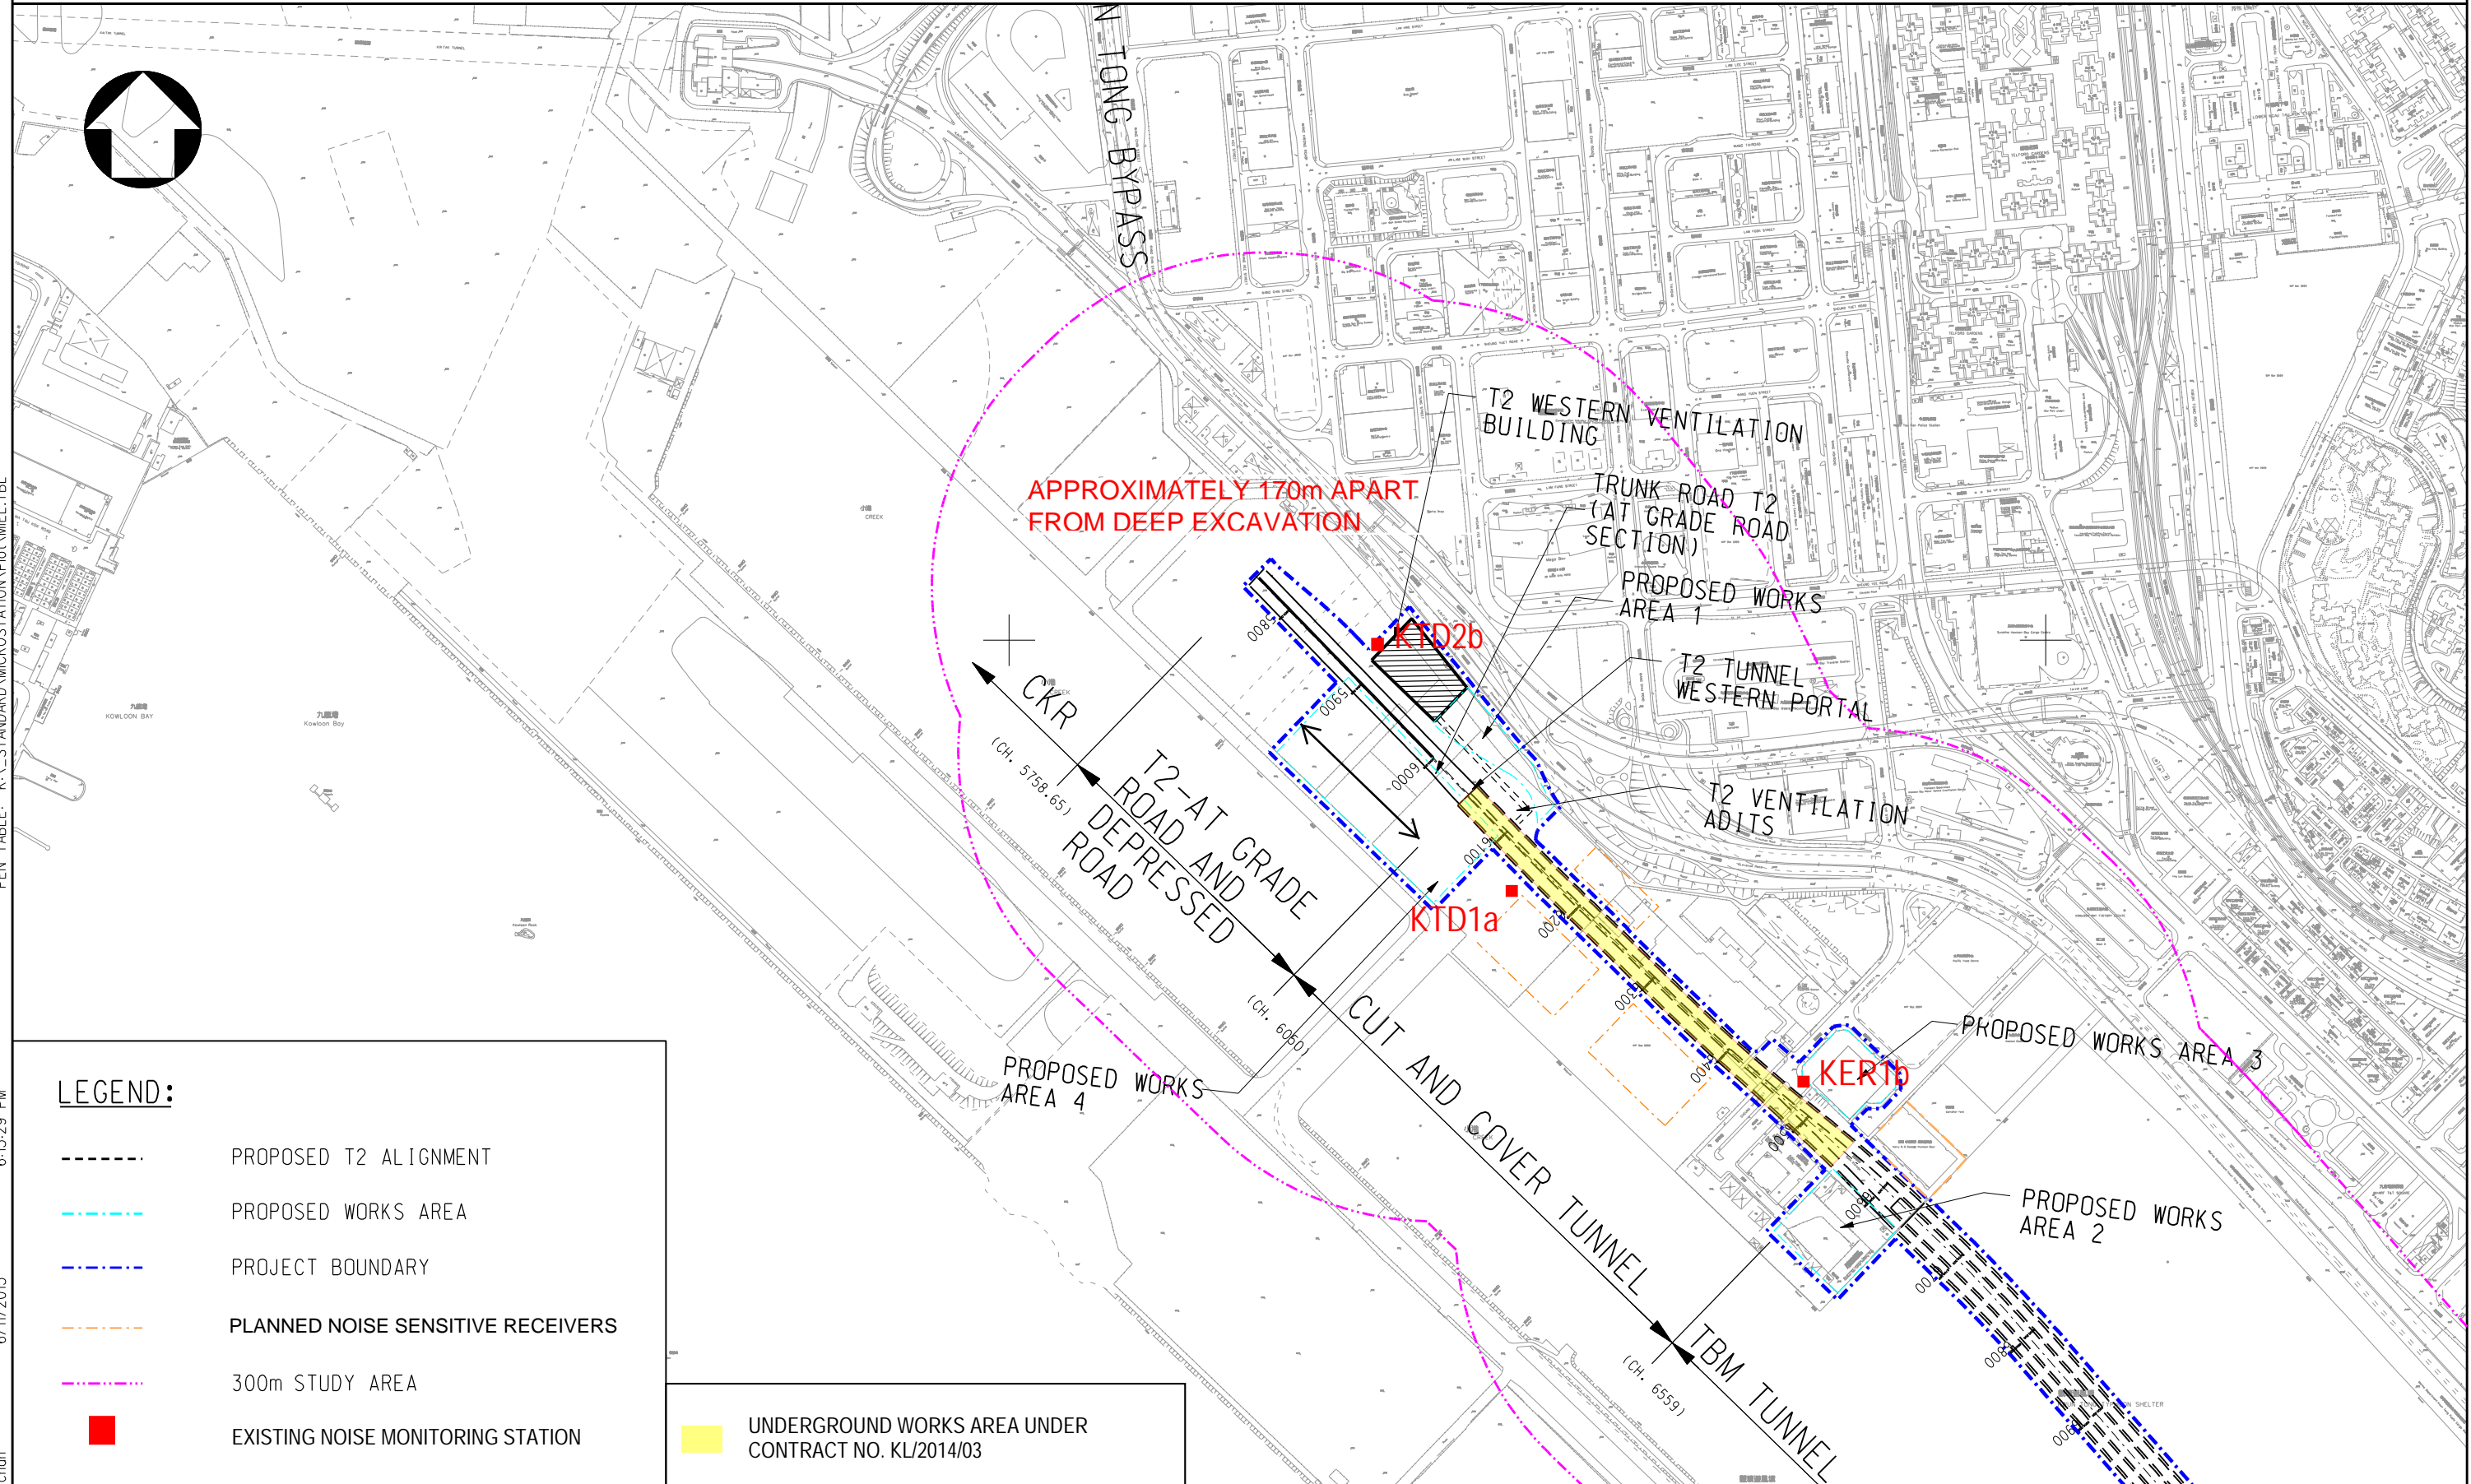
### **Figure 2**

#### **Air and Noise Monitoring Locations**

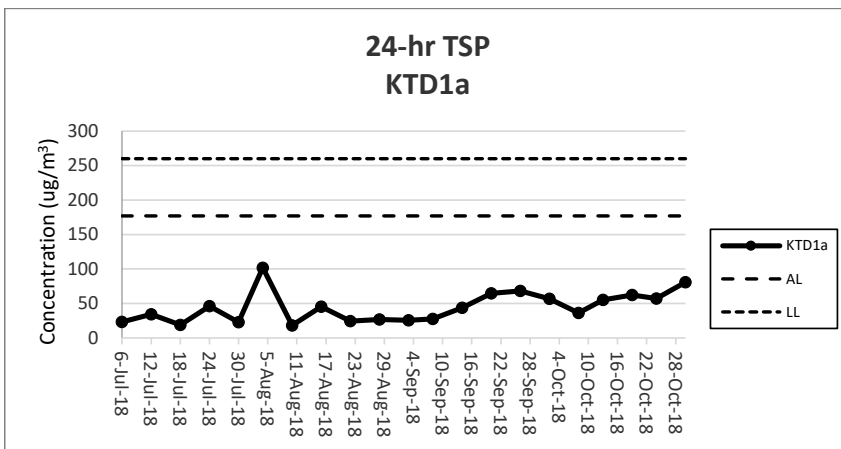
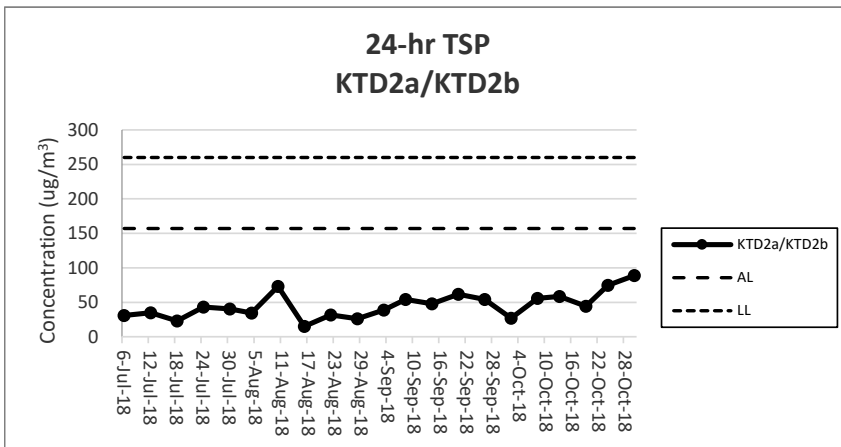
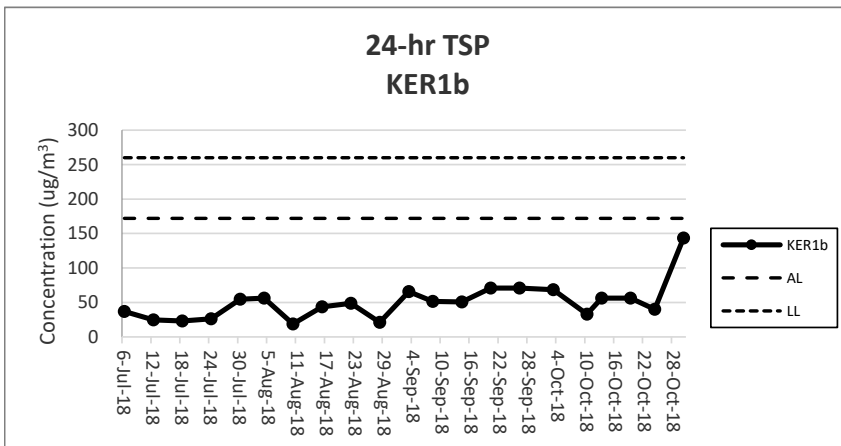
Power supply of high volume sampler at KER1b was suspended due to the damage of the cable, TSP monitoring was resumed at 10 October 2018.

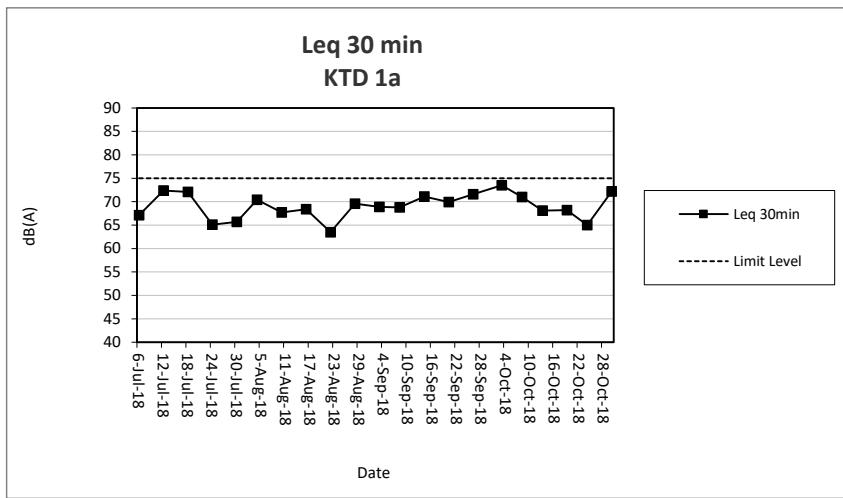
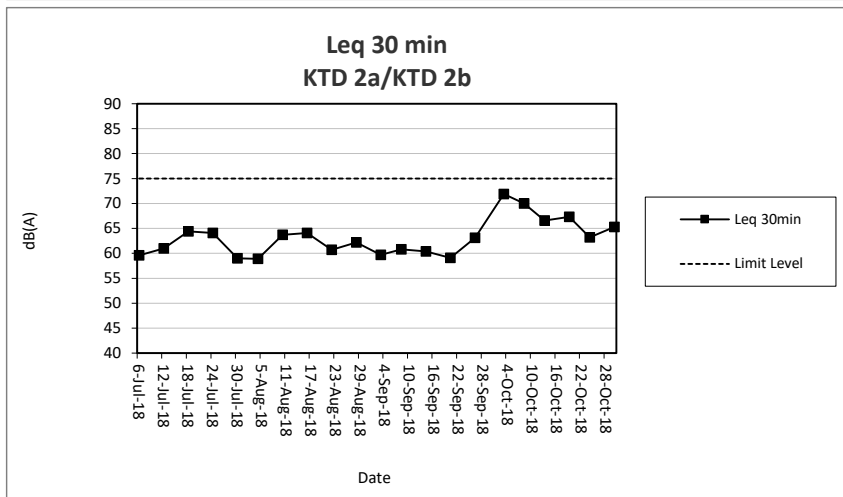
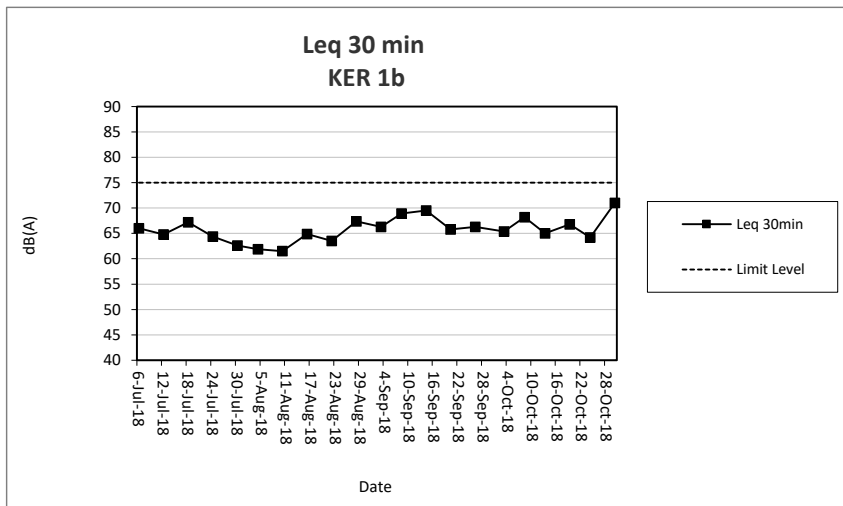
KTD2b & KER1b: Free-field measurement (+3dB(A) correction has been applied)

No raining or wind with speed over 5 m/s was observed during noise monitoring according to the onsite observation.
