MONTHLY EM&A REPORT

February 2018

Contract No. : KLN/2015/07

Contract Name : Environmental Monitoring Works for
Contract KL/2014/03 – Kai Tak Development
– Stage 3 Infrastructure Works for Developments
at the Southern Part of the Former Runway

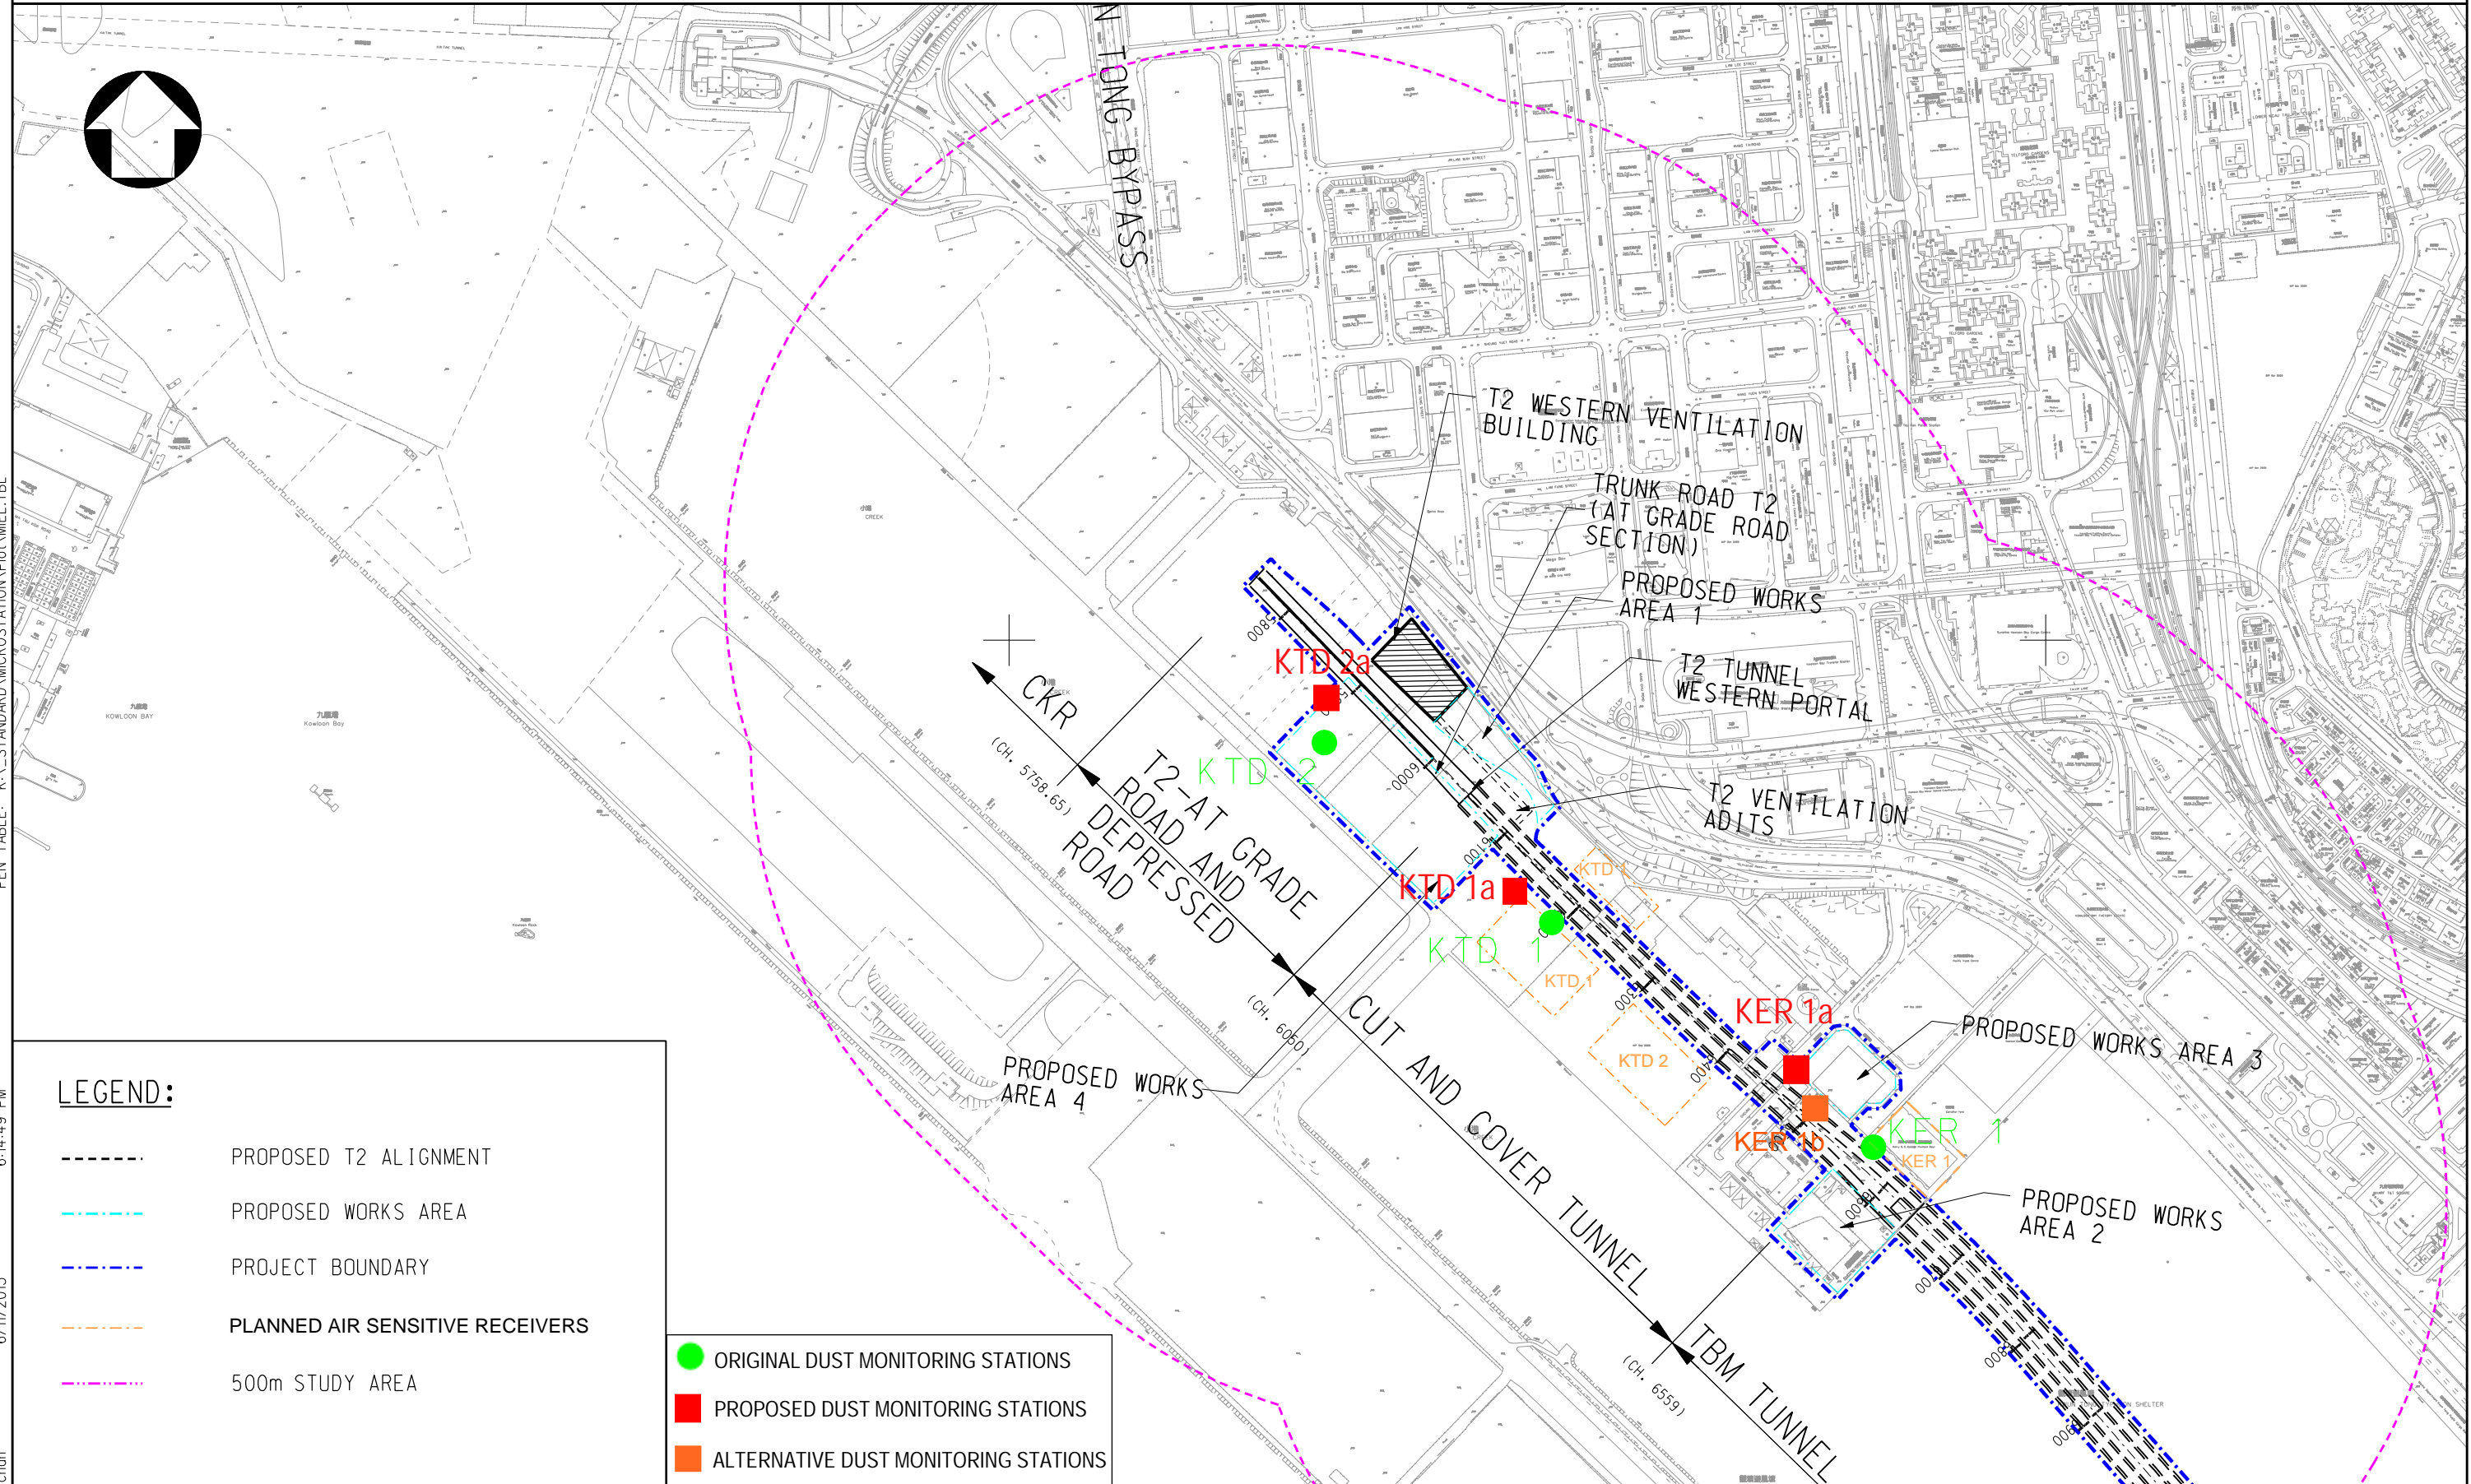
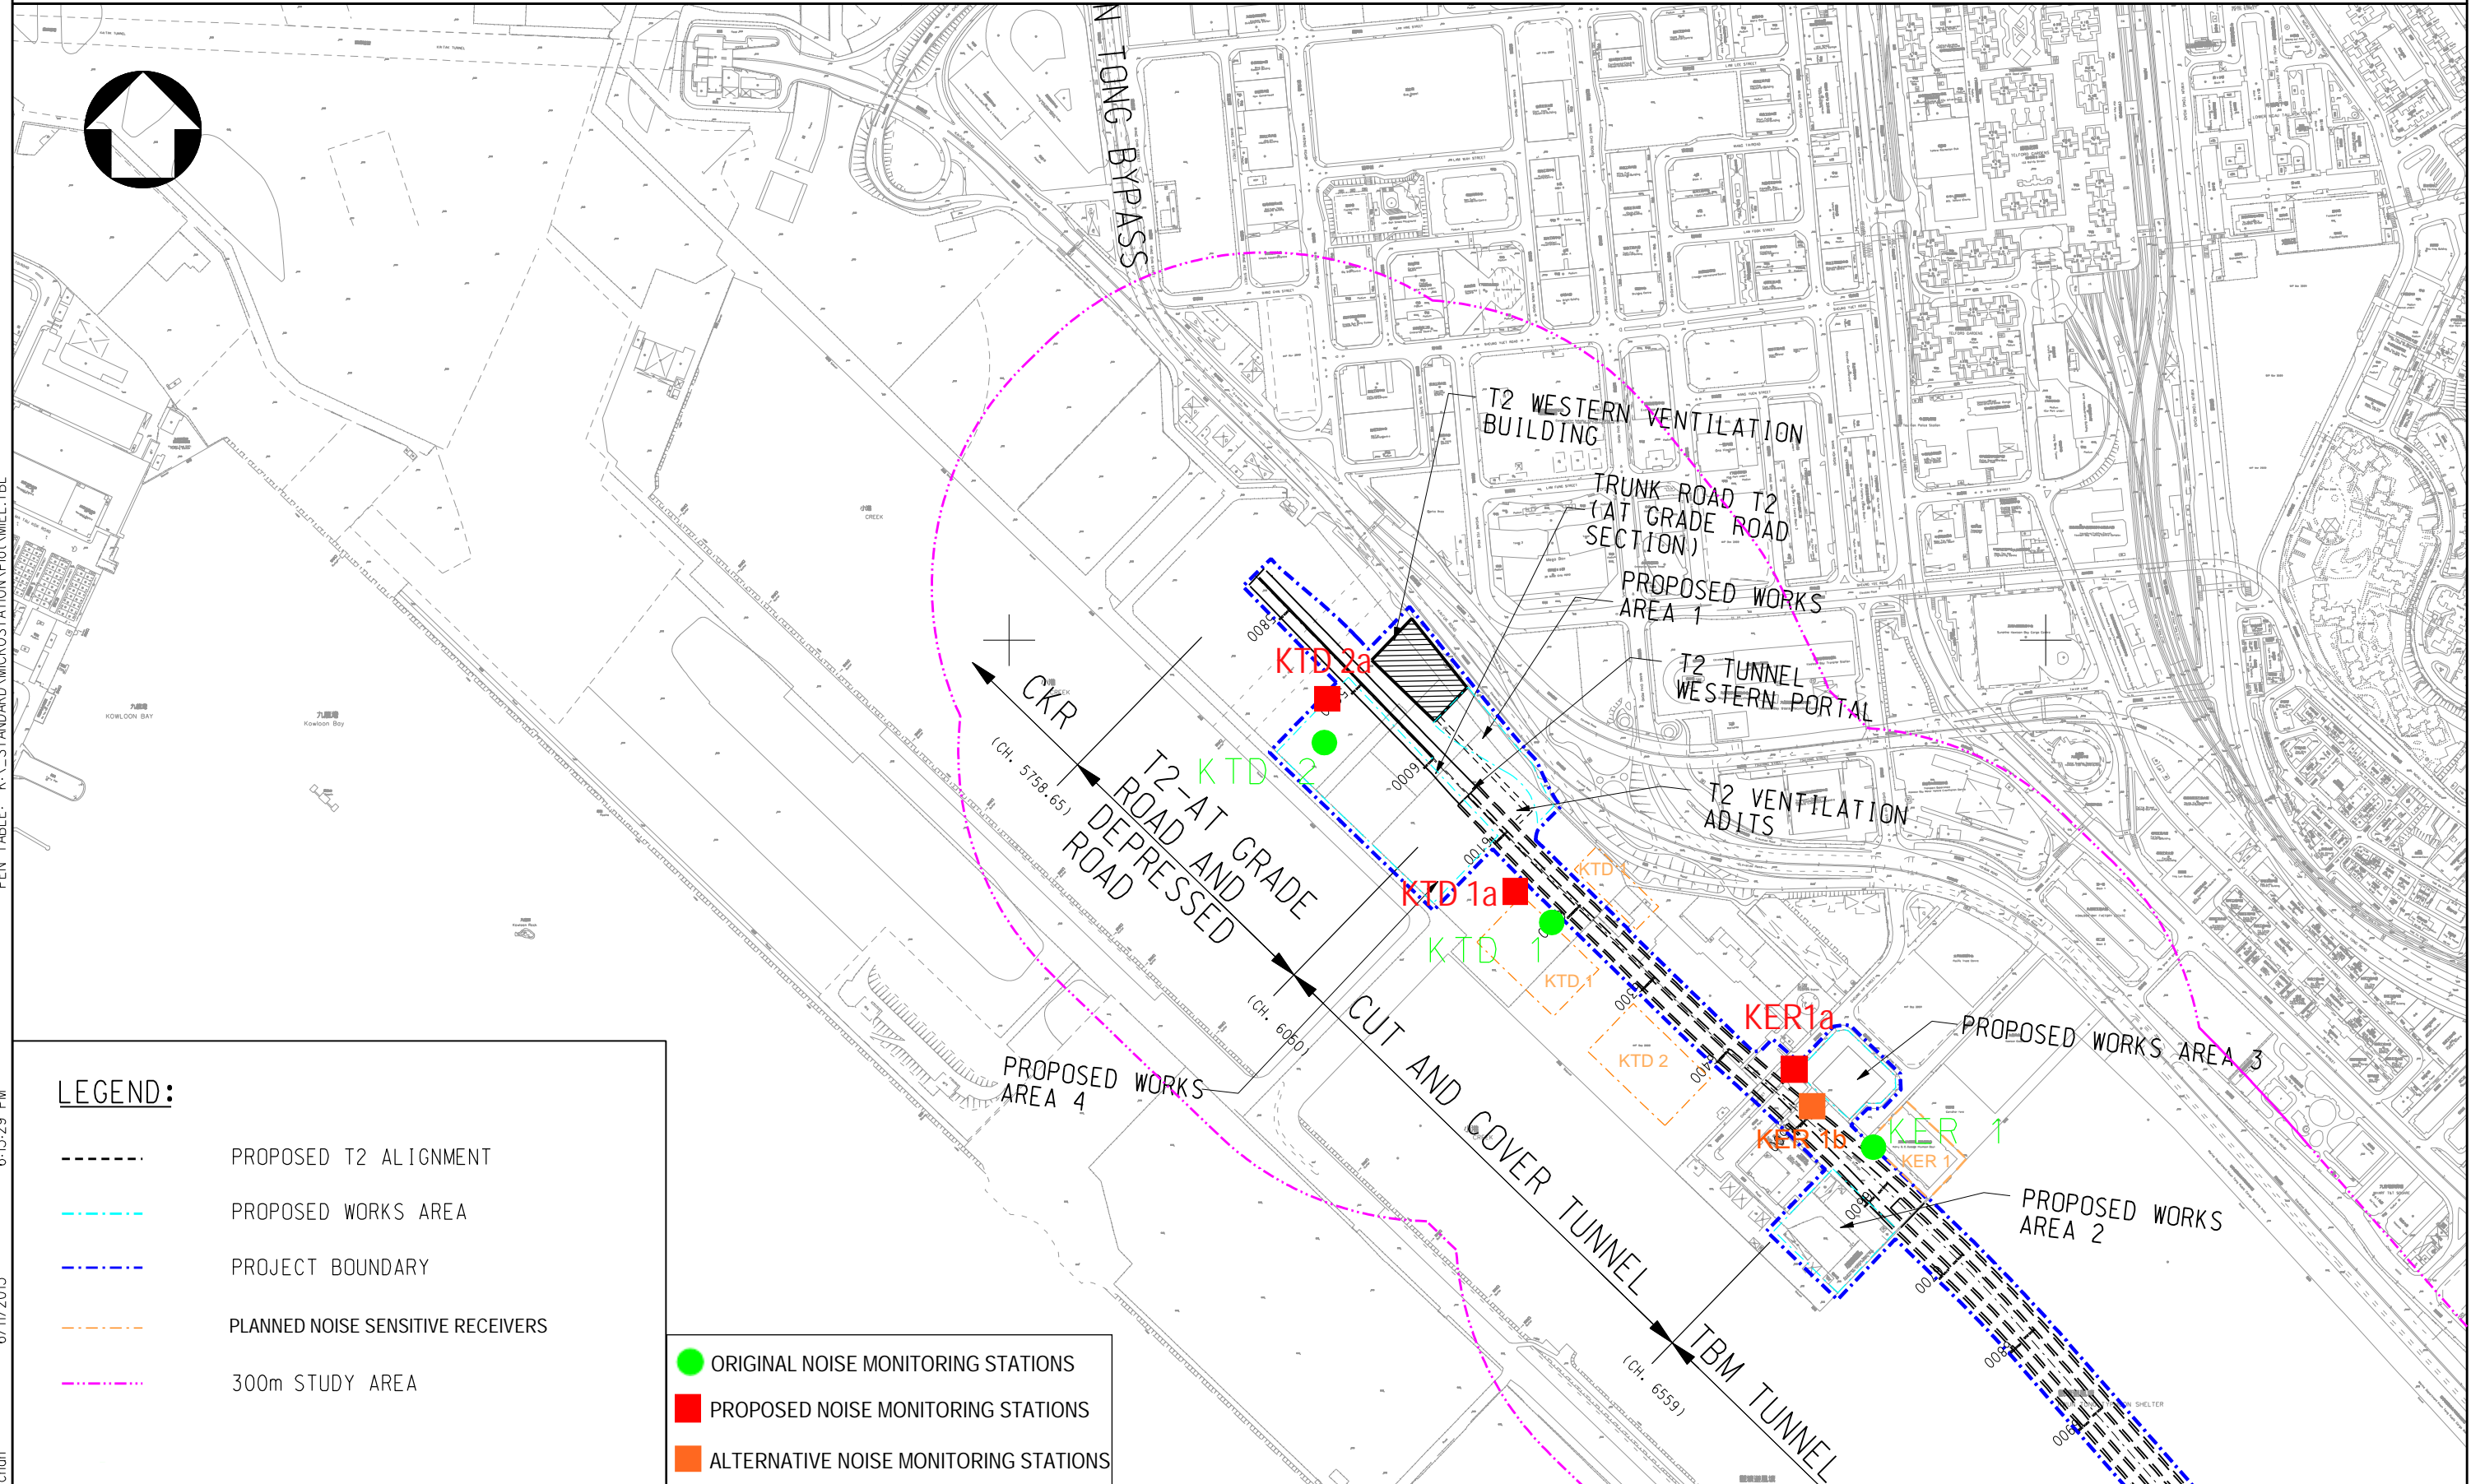
Figure 2

Air and Noise Monitoring Locations

Drawing title	Original Size	A3	Scale	Date
		IDENTIFIED DUST MONITORING STATIONS AT SOUTH APRON OF FORMER KAI TAK AIRPORT			
		© Copyright reserved		File name	30/01/2012
Rev.	Description	Date	Drawing No.	FIGURE 2.1a(revised)	
				Rev. --

2.5.2 According to the approved alternative baseline air quality and noise monitoring locations (EPD reference: EP2/K19/A/21 Pt.5), the original monitoring locations (KTD1, KTD2 and KER1) are proposed to be replaced by alternative monitoring locations (KTD1a, KTD2a and KER1b) for air quality monitoring, they are summarized in **Table 2.2** and shown in **Figure 2**.

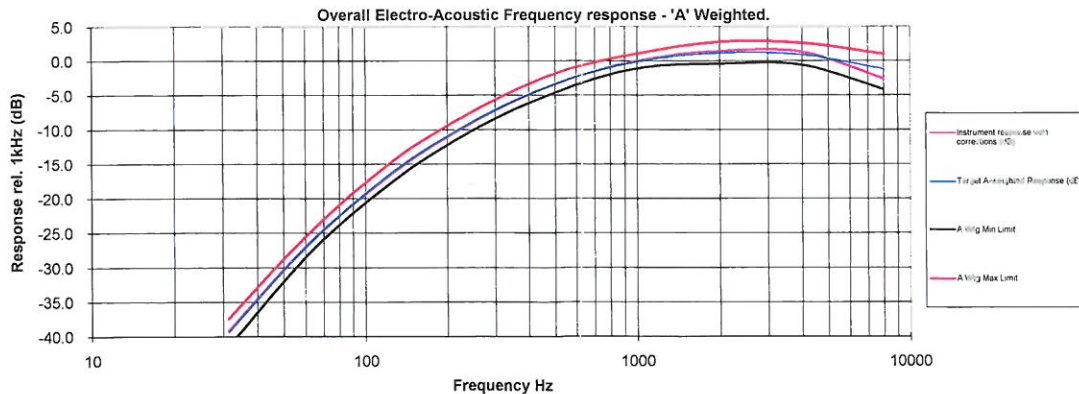
Combined Electro-Acoustic Frequency Response - A Weighted (IEC 61672-3:2006)

The following A-Weighted frequency response graph shows this instruments overall frequency response based upon the application of multi-frequency pressure field calibrations. The microphones Pressure to Free field correction coefficients are applied to pressure response. Reference level taken at 1kHz.
