QUARTERLY EM&A REPORT

March 2018 - May 2018

Contract No. : KLN/2015/07

Contract KL/2014/03 – Kai Tak Development – Stage 3 Infrastructure Works for Developments at the Southern Part of the Former Runway

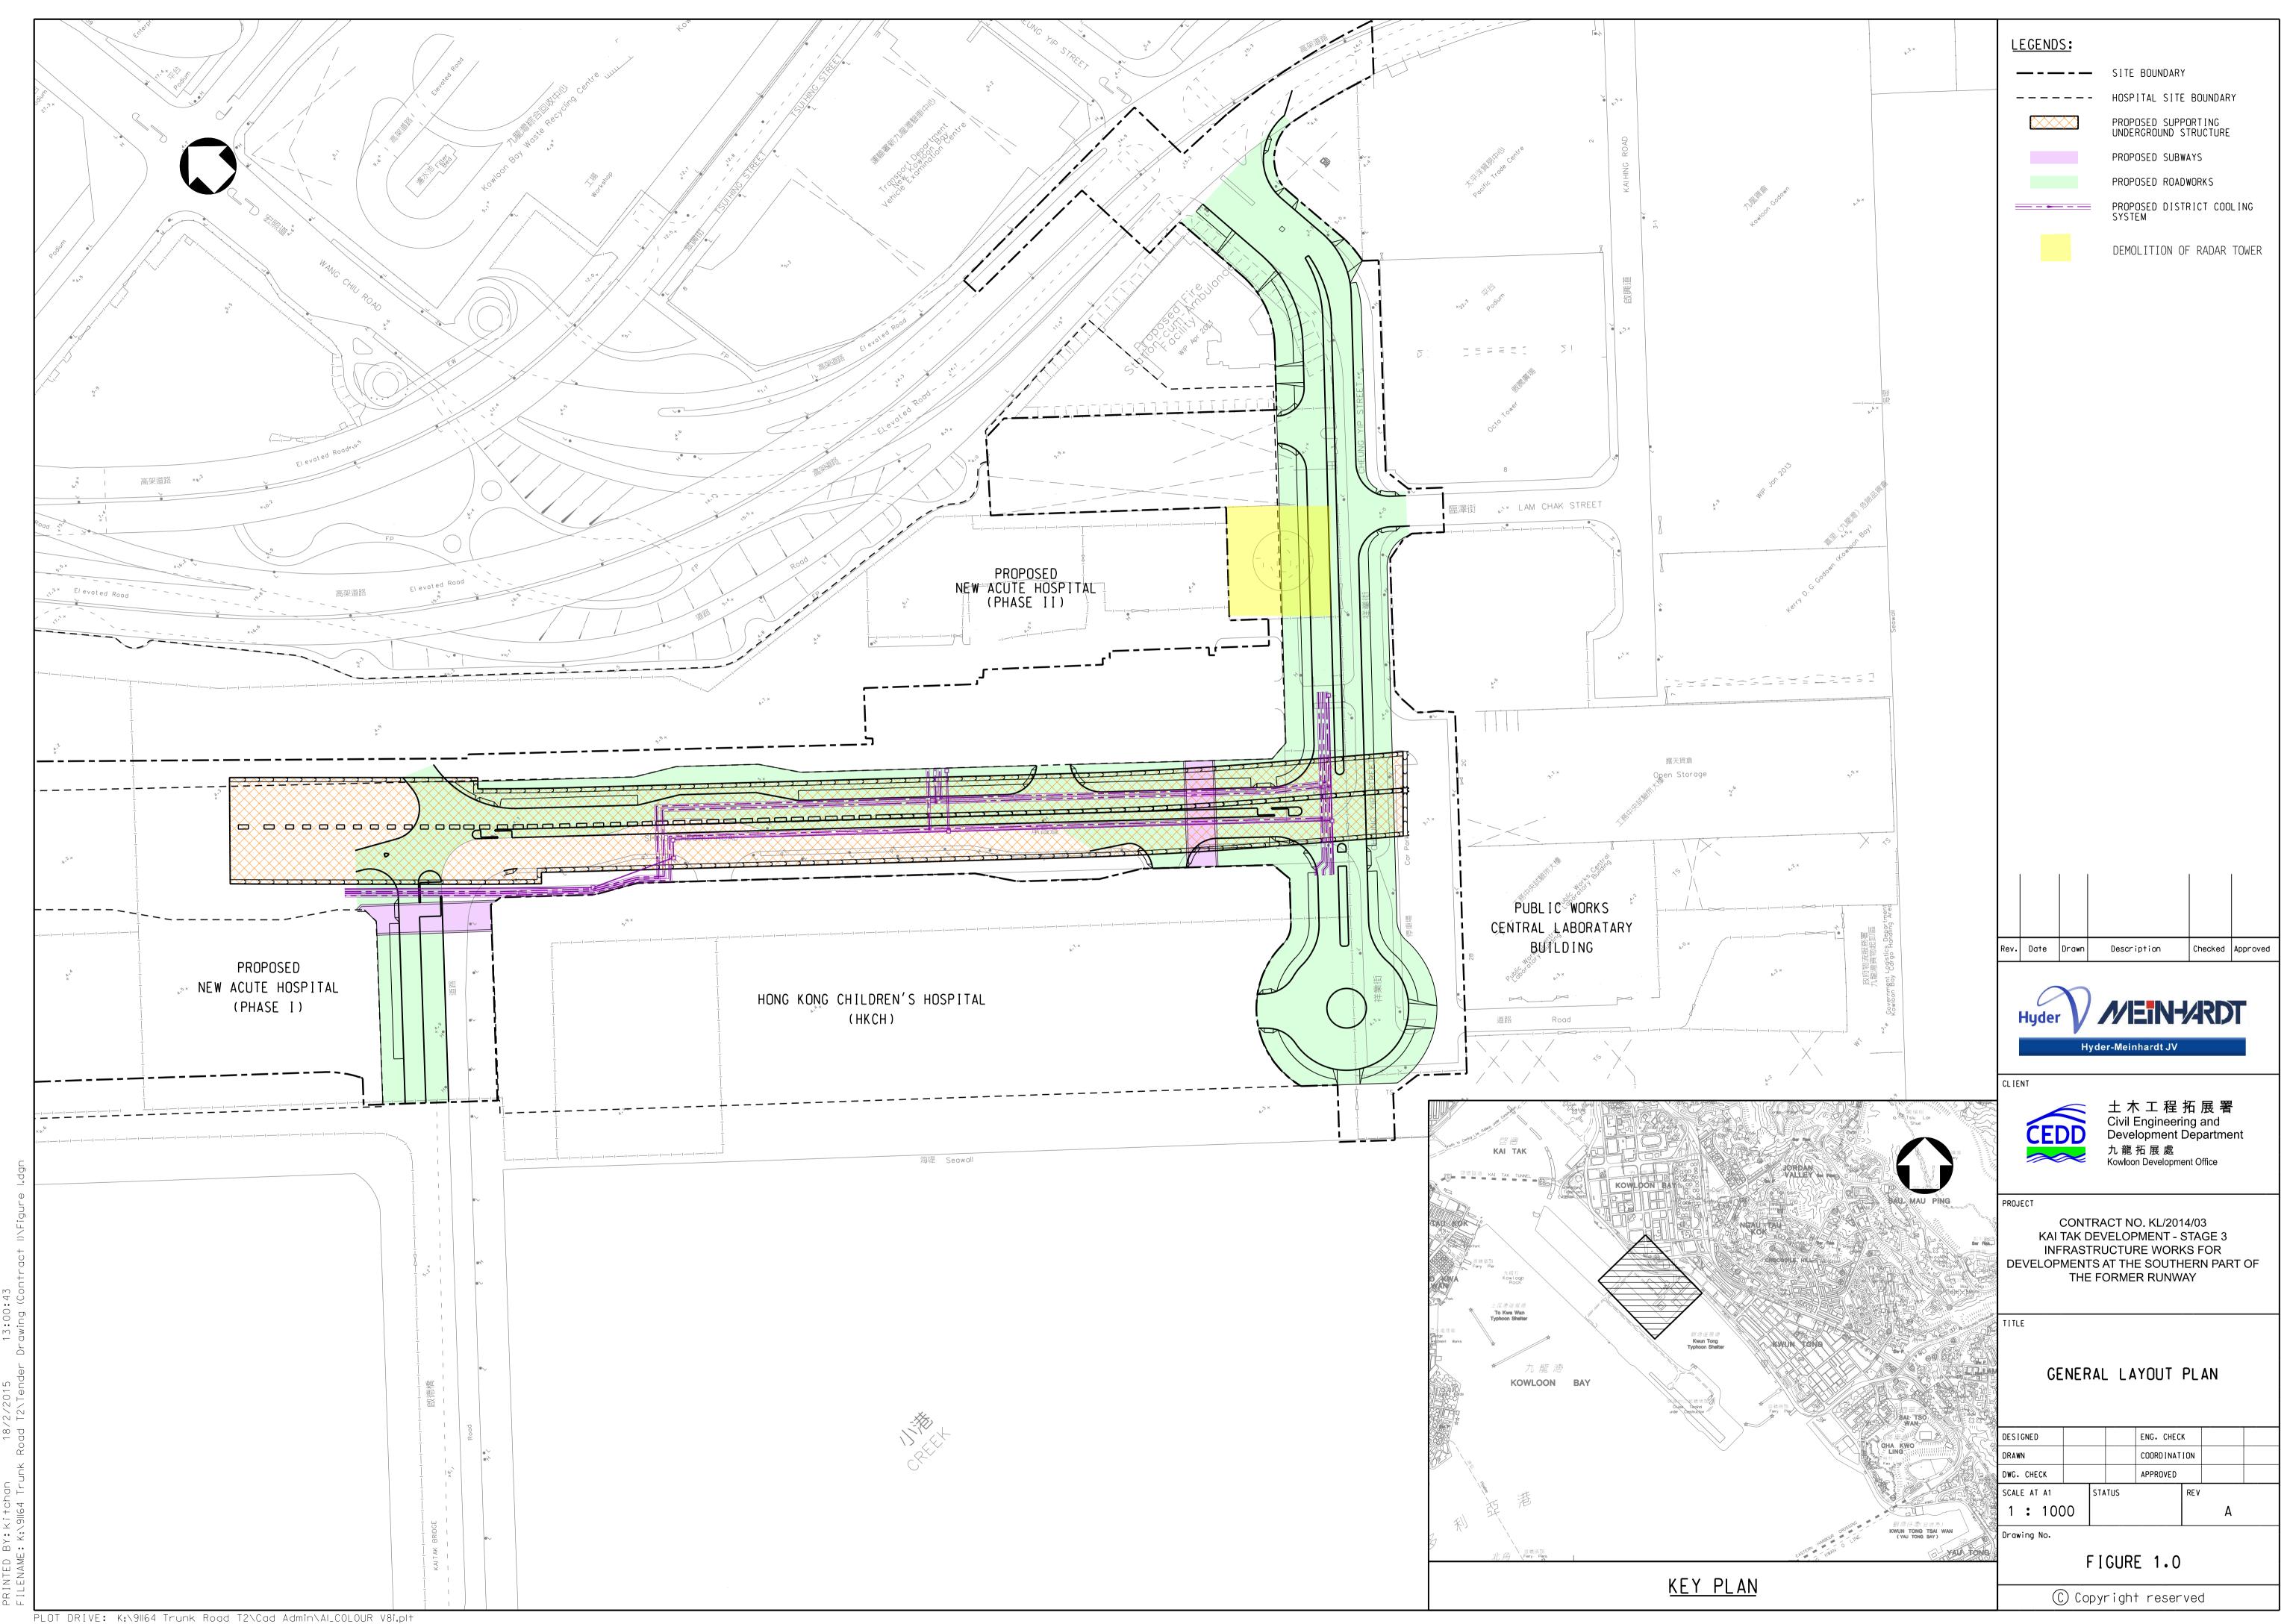
Figure 1

Project General Layout

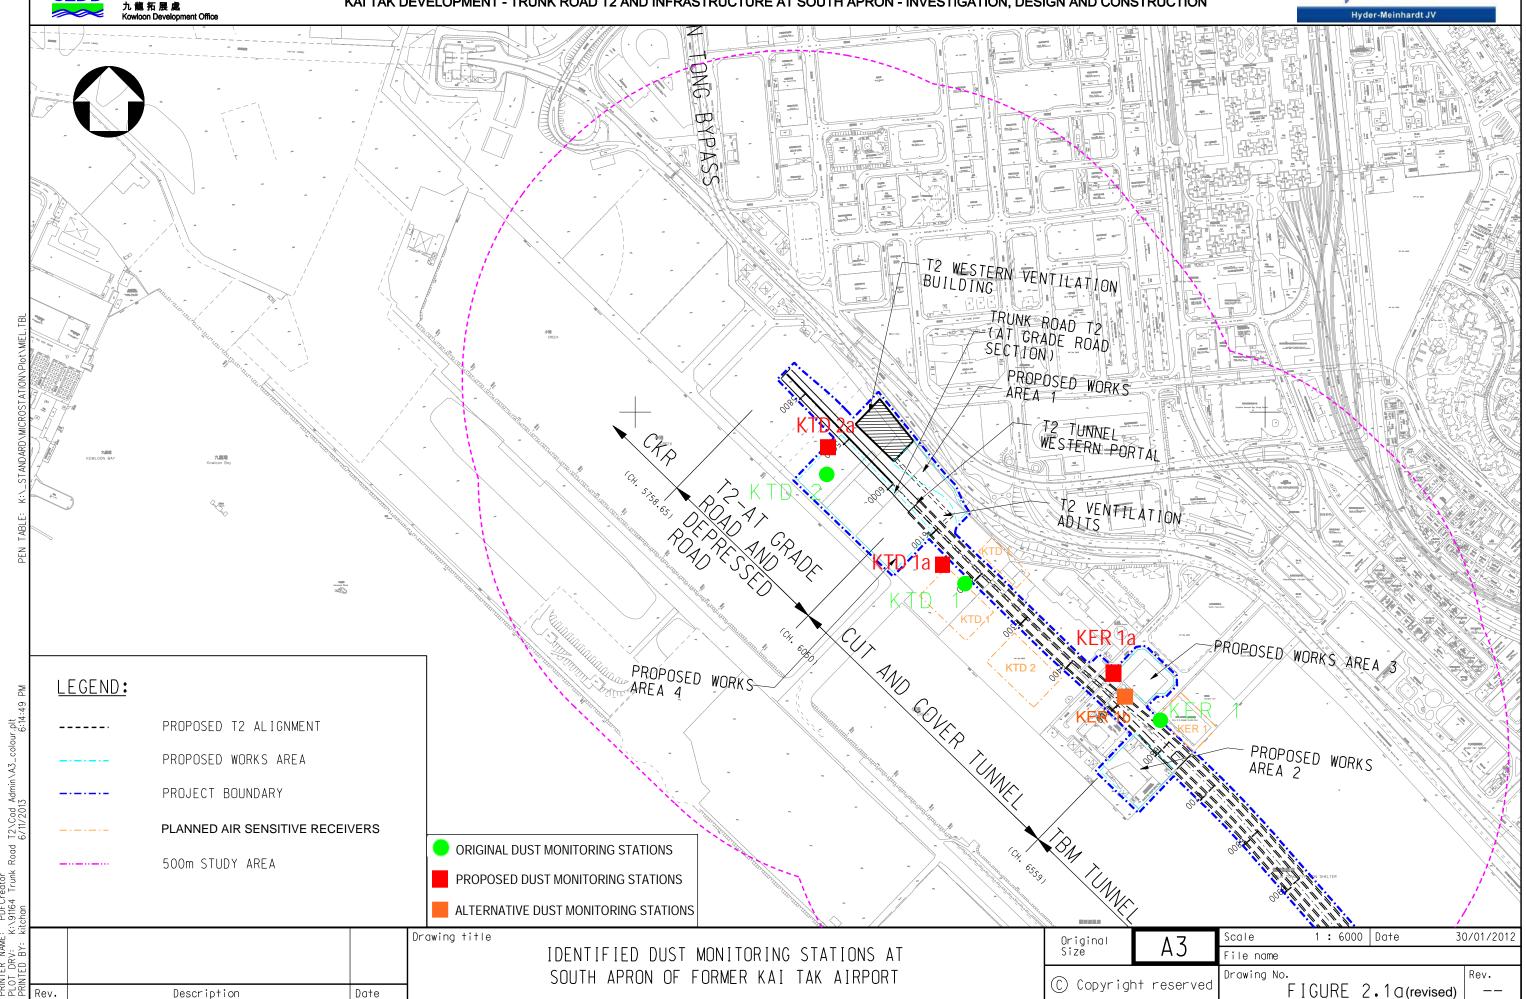
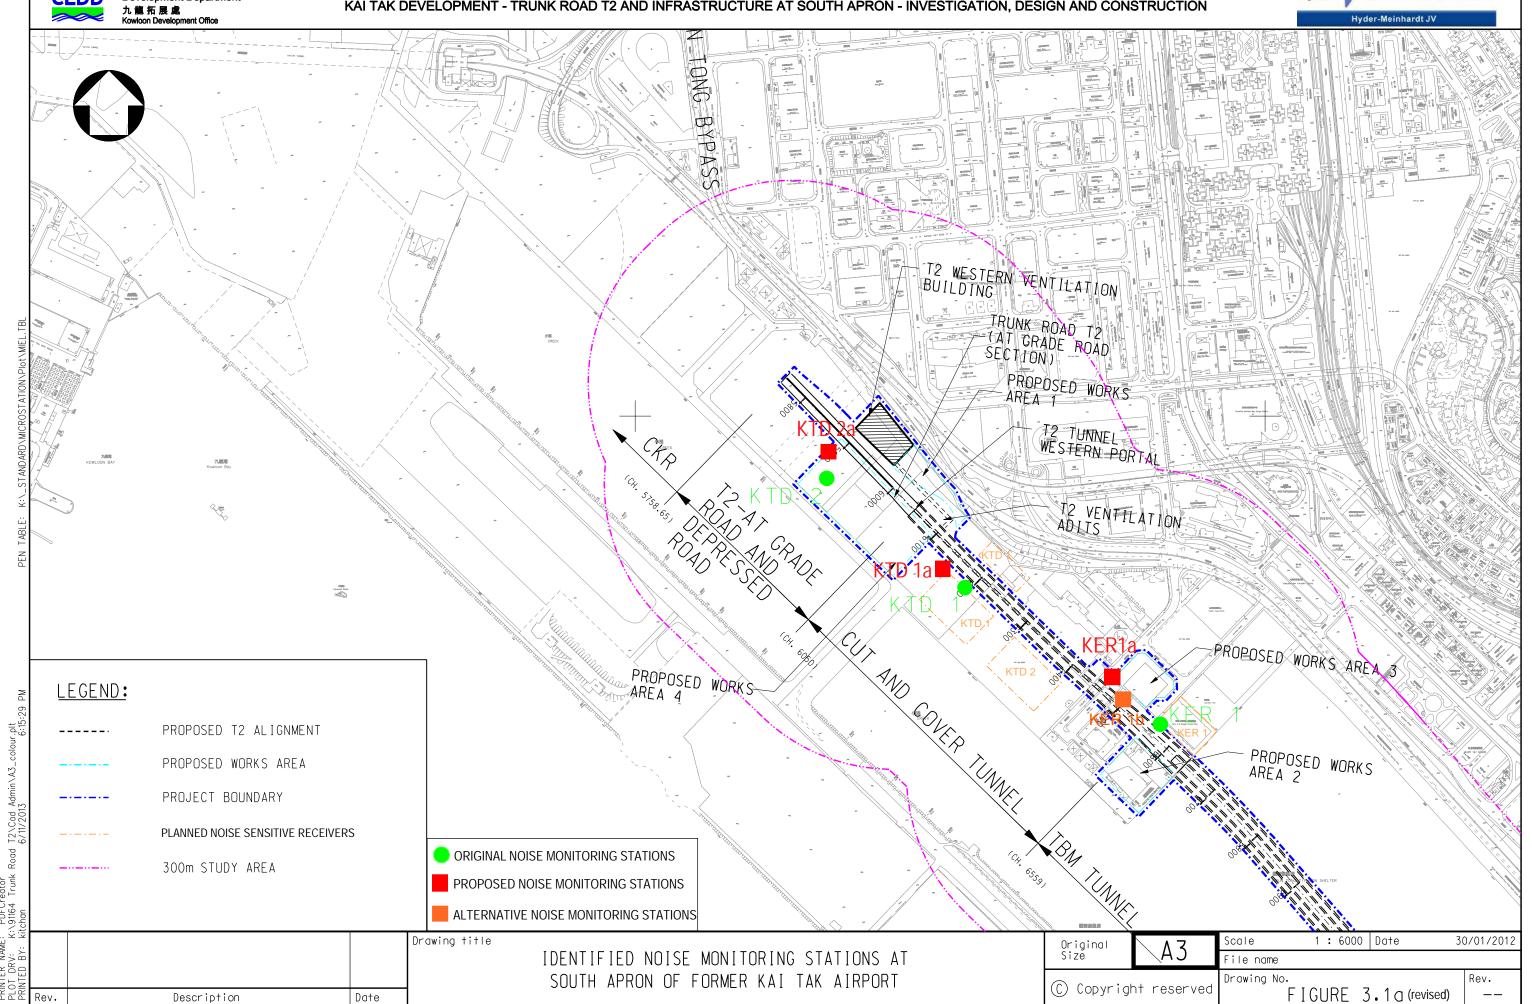
Figure 2 Air and Noise Monitoring Locations

- 2.2.1 According to the EM&A Manual, three monitoring locations for air quality monitoring and noise monitoring, namely KTD1, KTD2 and KER1, are covered by this Contract within the South Apron Area of Former Kai Tak Airport. The other two air quality monitoring locations and two noise monitoring locations which are identified in Cha Kwo Ling area, are farther than 500m and 300m away from the site boundary respectively and thus not covered by this Contract. The monitoring works in Cha Kwo Ling area are covered by other Contract(s) respectively.
- According to the approved alternative baseline air quality and noise monitoring locations (EPD reference: EP2/K19/A/21 Pt.5), the original monitoring locations (KTD1, KTD2 and KER1) are proposed to be replaced by alternative monitoring locations (KTD1a, KTD2a and KER1b), they are summarized in Table 2.1 and shown in Figure 2.

Monitoring Station Location	
KTD1a	Centre of Excellence in Paediatrics (Children's Hospital)
KTD2a	G/IC Zone next to Kwun Tong Bypass (Future Hospital at Site 3C1)
KER1b	Site Boundary at Cheung Yip Street

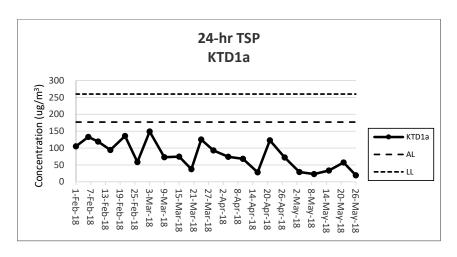
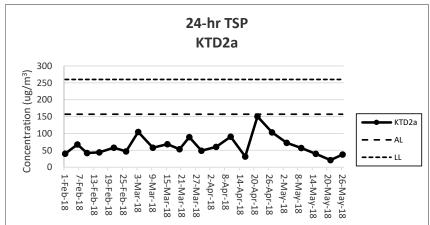
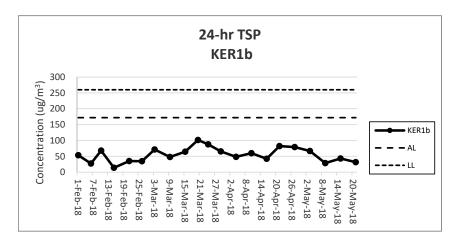
Appendix D

Graphical Presentation of Monitoring Data

- 1) The major activities being carried out on site during the reporting period can be referred to Section 1.3.1.
- 2) The weather conditions during monitoring in the reporting period was range from cloudy and fine.
- 3) Any other factors which might affect the monitoing results can be referred to Section 2.3.4.

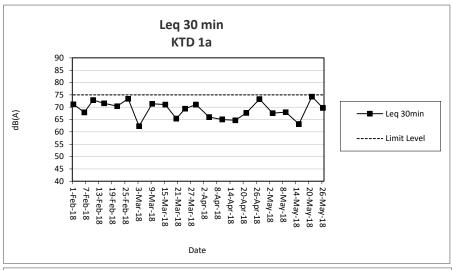
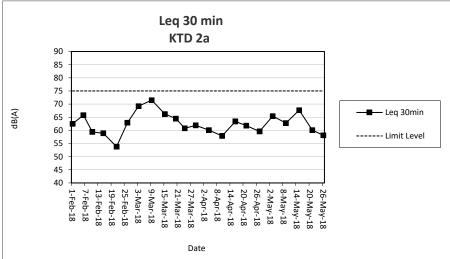
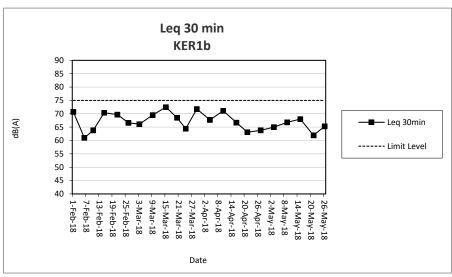
- 1) The major activities being carried out on site during the reporting period can be referred to Section 1.3.1.
- 2) The weather conditions during monitoring in the reporting period was ranged from cloudy and fine. No raining or wind with speed over 5 m/s was observed during monitoring in the reporting period.
- 3) Any other factors which might affect the monitoing results can be referred to Section 2.3.4.
