Contract No. ED/2018/04 Trunk Road T2 and Infrastructure Works for Developments at the Former South Apron Graphical Presentation of 1-hour TSP Monitoring Results	Scale N.T.S	Project No. MA20003	
	Date	Appendix C

Contract No. ED/2018/04 Trunk Road T2 and Infrastructure Works for Developments at the Former South Apron Graphical Presentation of 24-hour TSP Monitoring Results	Scale N.T.S	Project No. MA20003	CINOTECH
	Date	Appendix C

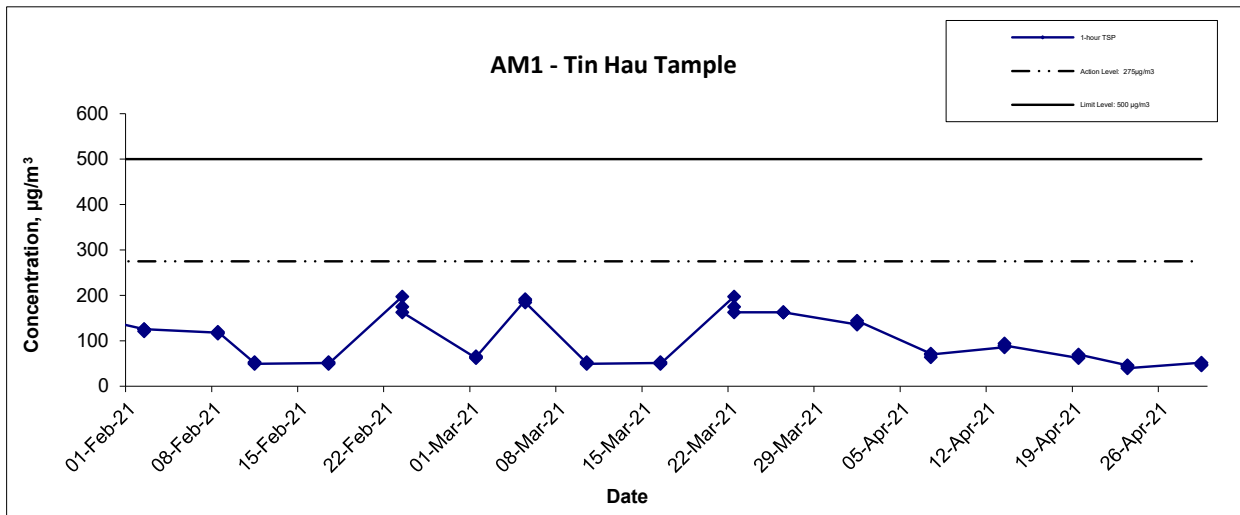
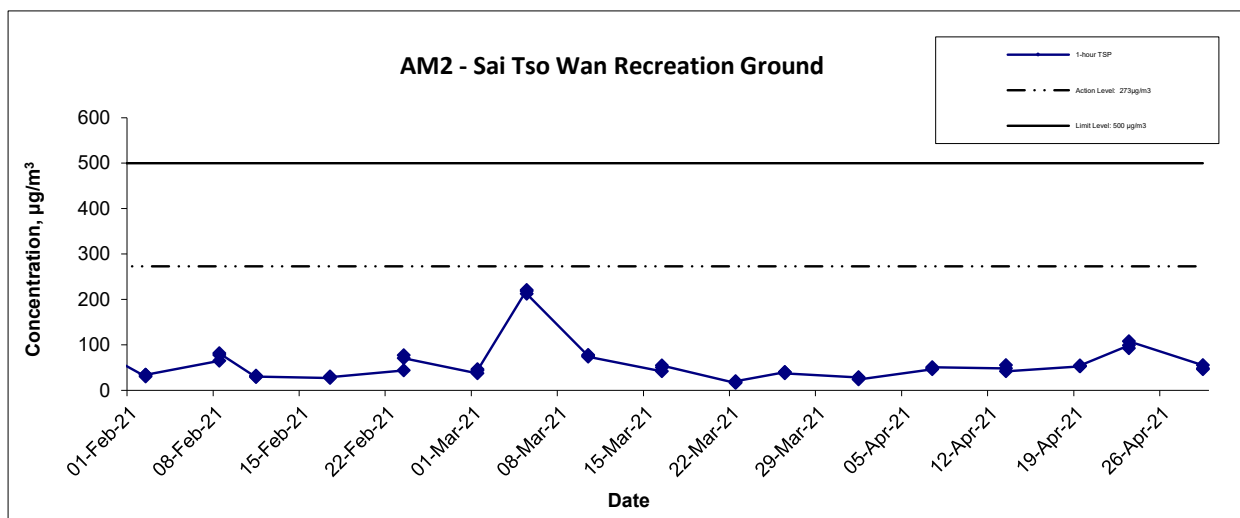
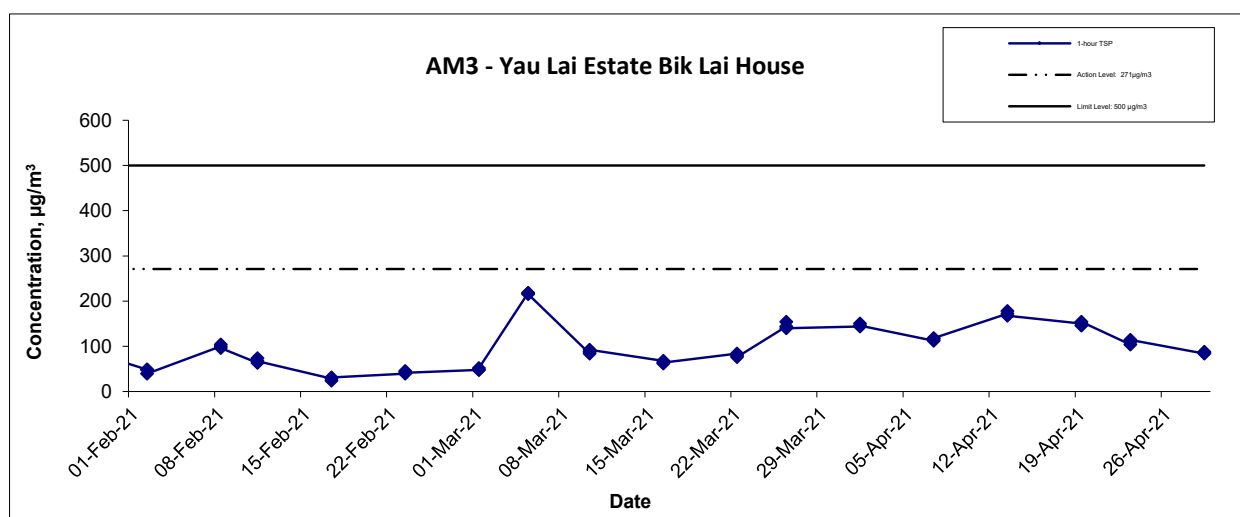
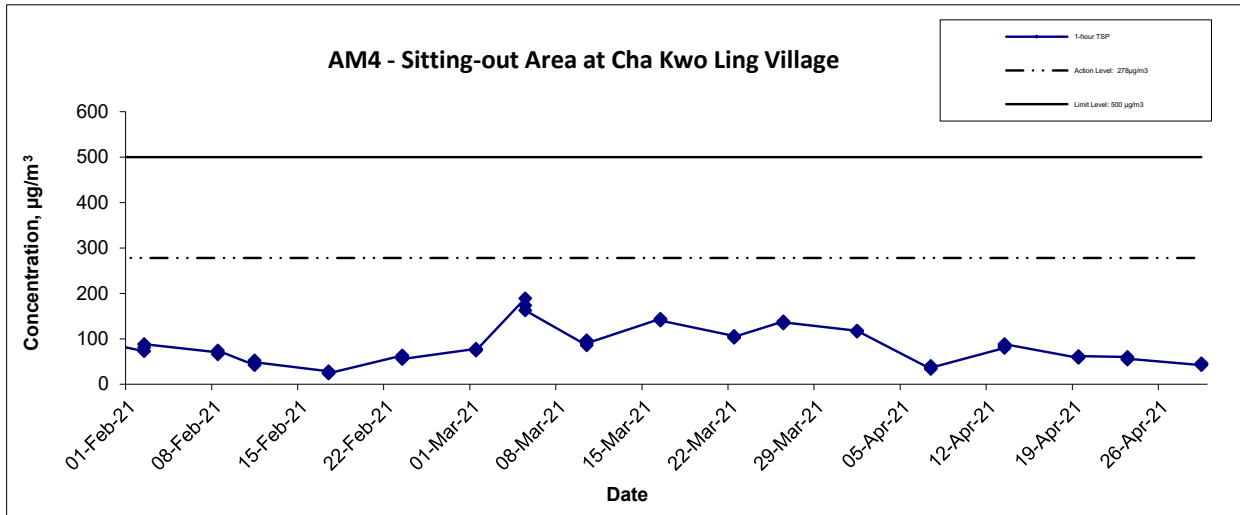
1-hr TSP Concentration Levels

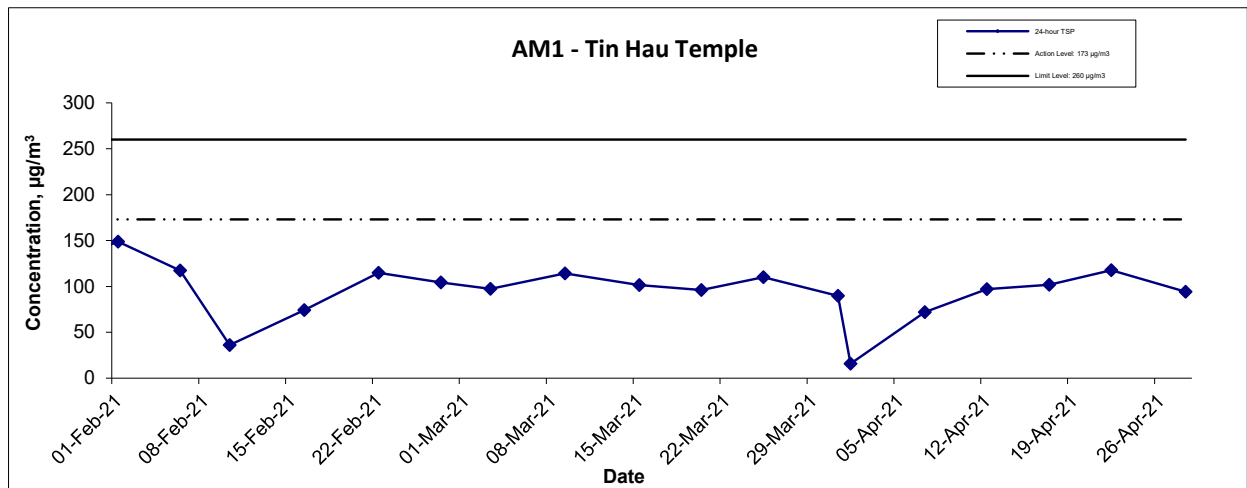
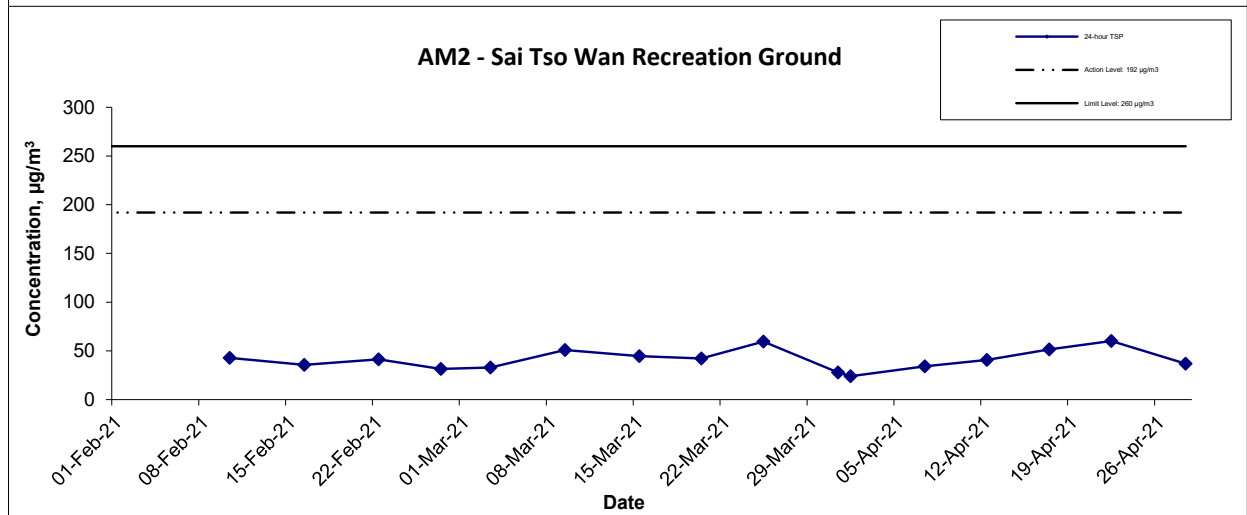
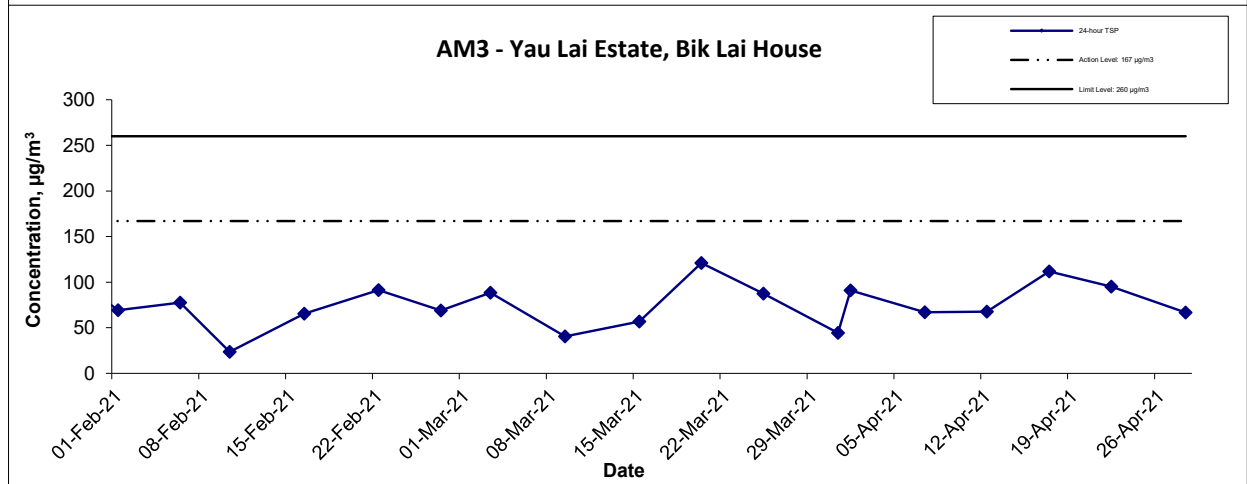
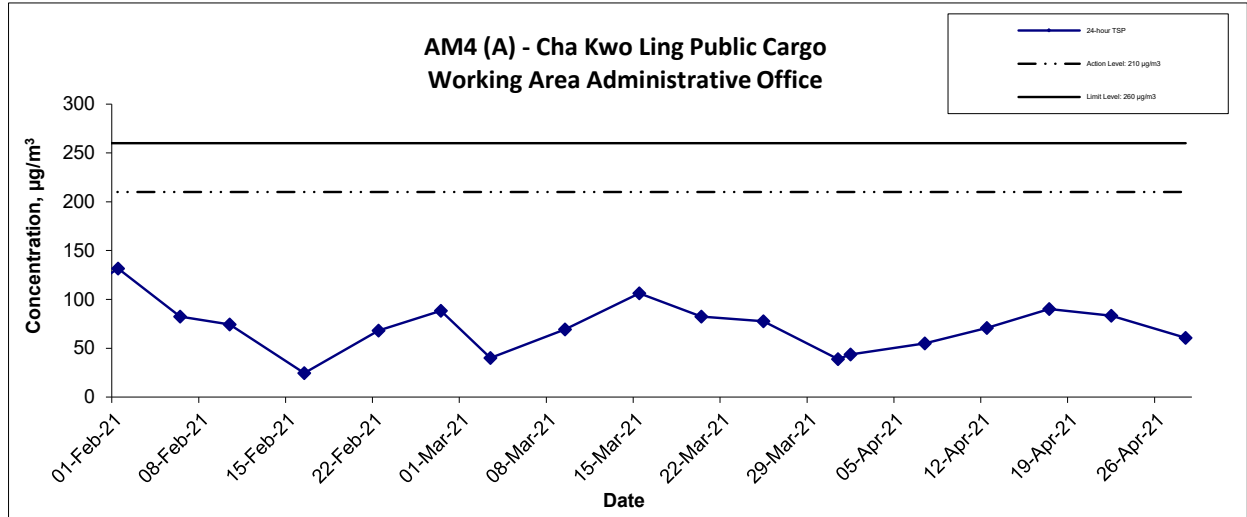
24-hr TSP Concentration Levels

- 1) The major activitie(s) being carried out on site during the reporting period is/are presented in Section 1.10
- 2) The weather conditions during the reporting month are presented in Section 3.1.
- 3) Other factors which might affect the monitoring results are presented in Section 3.16.
- 4) The HVS at AM2 was broken-down during the first week of February 2021.
