MONTHLY EM&A REPORT

July 2017

Client	:	Civil Engineering and Development Department, HKSAR
Contract No.	:	KLN/2015/07
Contract Name	:	Environmental Monitoring Works for Contract KL/2014/03 – Kai Tak Development – Stage 3 Infrastructure Works for Developments at the Southern Part of the Former Runway
Report No.	:	0405/15/ED/0864A
EP-337/2009		New Distributor Roads Serving the Planned Kai Tak Development Area
EP-339/2009/A		Decommissioning of the Remaining Parts (Ex-GFS Building, Radar Station and Hong Kong Aviation Club) of the former Kai Tak Airport
EP-451/2013		Trunk Road T2

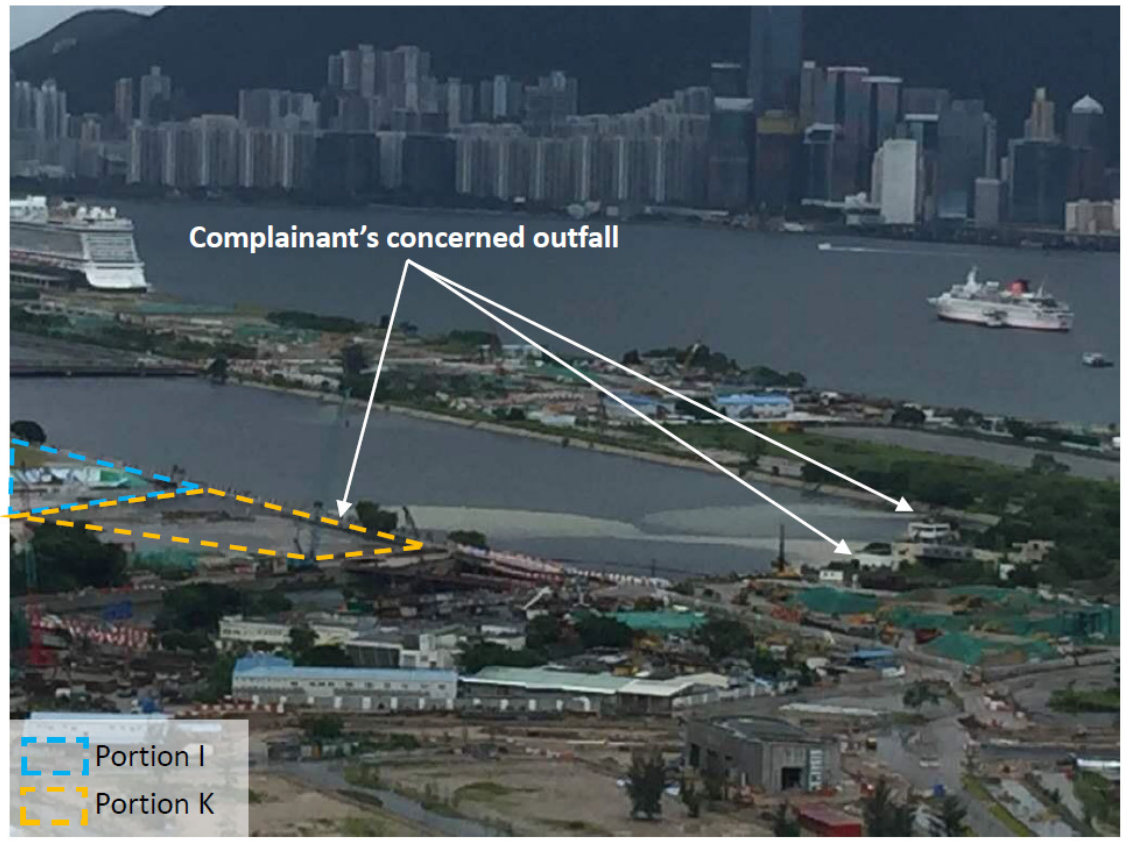
Complainant's concerned outfall (photo date: 16 July 2017)

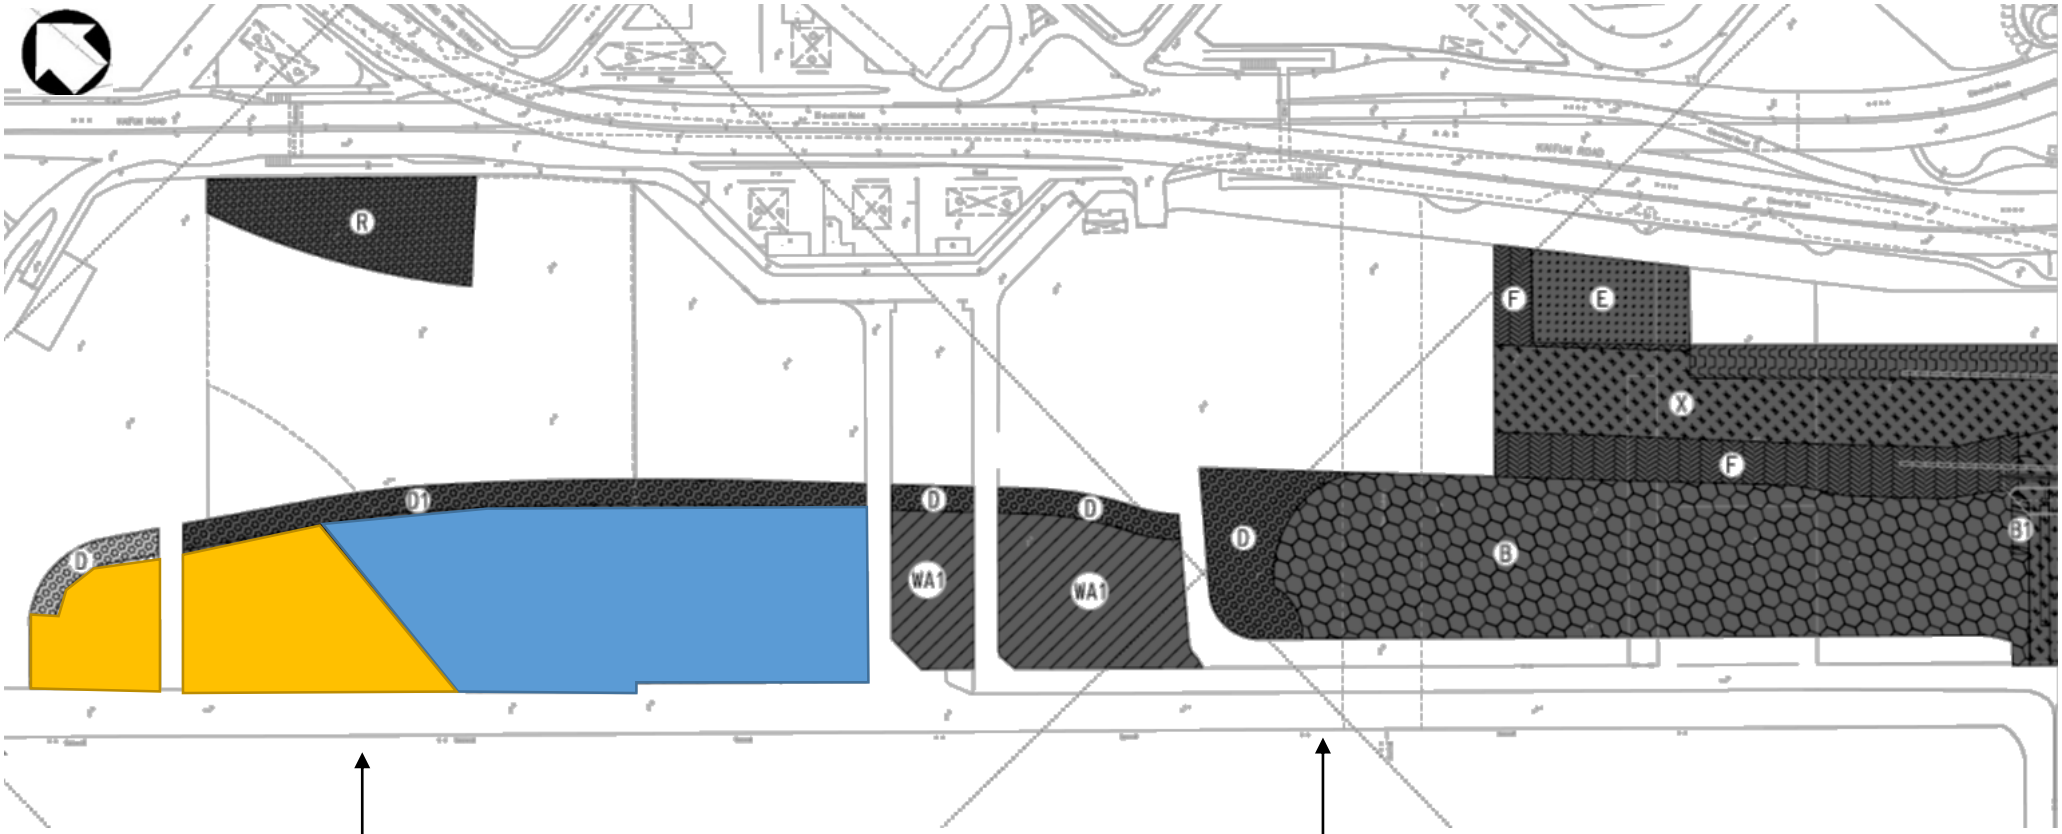
Dye traced at the 7-cell box culvert outfall

The complainant's concerned outfall

Location of the complainant's concerned outfall

Location of dye traced
