Appendix M – Summary of Exceedance

Reporting Month: March 2023

- Notification of Exceedances

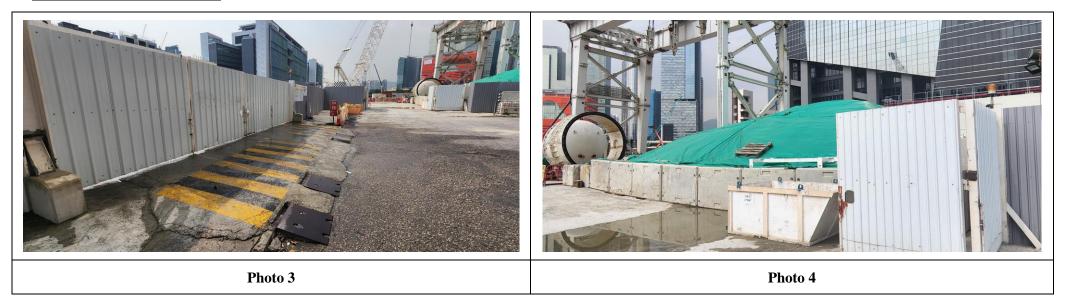
- 1. Kerry staff was smoking near the High Volume Sampler (HVS), which may cause the dust nuisance and affect the result (Photo 1).
- 2. The vehicle which entering the Kerry DG Warehouse was observed.
- 3. No environmental deficiencies were observed at KER1 during monitoring and audit, the contractor has implemented adequate dust mitigation measure, i.e. watering and install spraying system at the site entrance, covering the stockpile of dusty material. (Photo 2-4)

Based on the finding(s) and observation(s) above, we deduce the Action Level exceedance of 24-hour TSP recorded at station KER1 on 1 March 2023 is due to smoking near the HVS, therefore, the exceedance is considered as **non-project related**.

- 1. Watering of the construction areas 12 times per day to reduce dust emissions.
- 2. Side enclosure and covering of any aggregate or dusty material storage piles to reduce emissions.
- 3. Open stockpiles shall be avoided or covered.
- 4. Tarpaulin covering of all dusty vehicle loads transported to, from and between site locations.
- 5. Establishment and use of vehicle wheel and body washing facilities at the exit points of the site.
- 6. Imposition of speed controls for vehicles on unpaved site roads, 8 km per hour is the recommended limit.
- 7. Use of regular watering to reduce dust emissions from exposed site surfaces and unpaved roads, particularly during dry weather.
