MONTHLY EM&A REPORT

November 2020

Contract No. : KLN/2015/07

Contract Name : Environmental Monitoring Works for
Contract KL/2014/03 – Kai Tak Development
– Stage 3 Infrastructure Works for Developments
at the Southern Part of the Former Runway

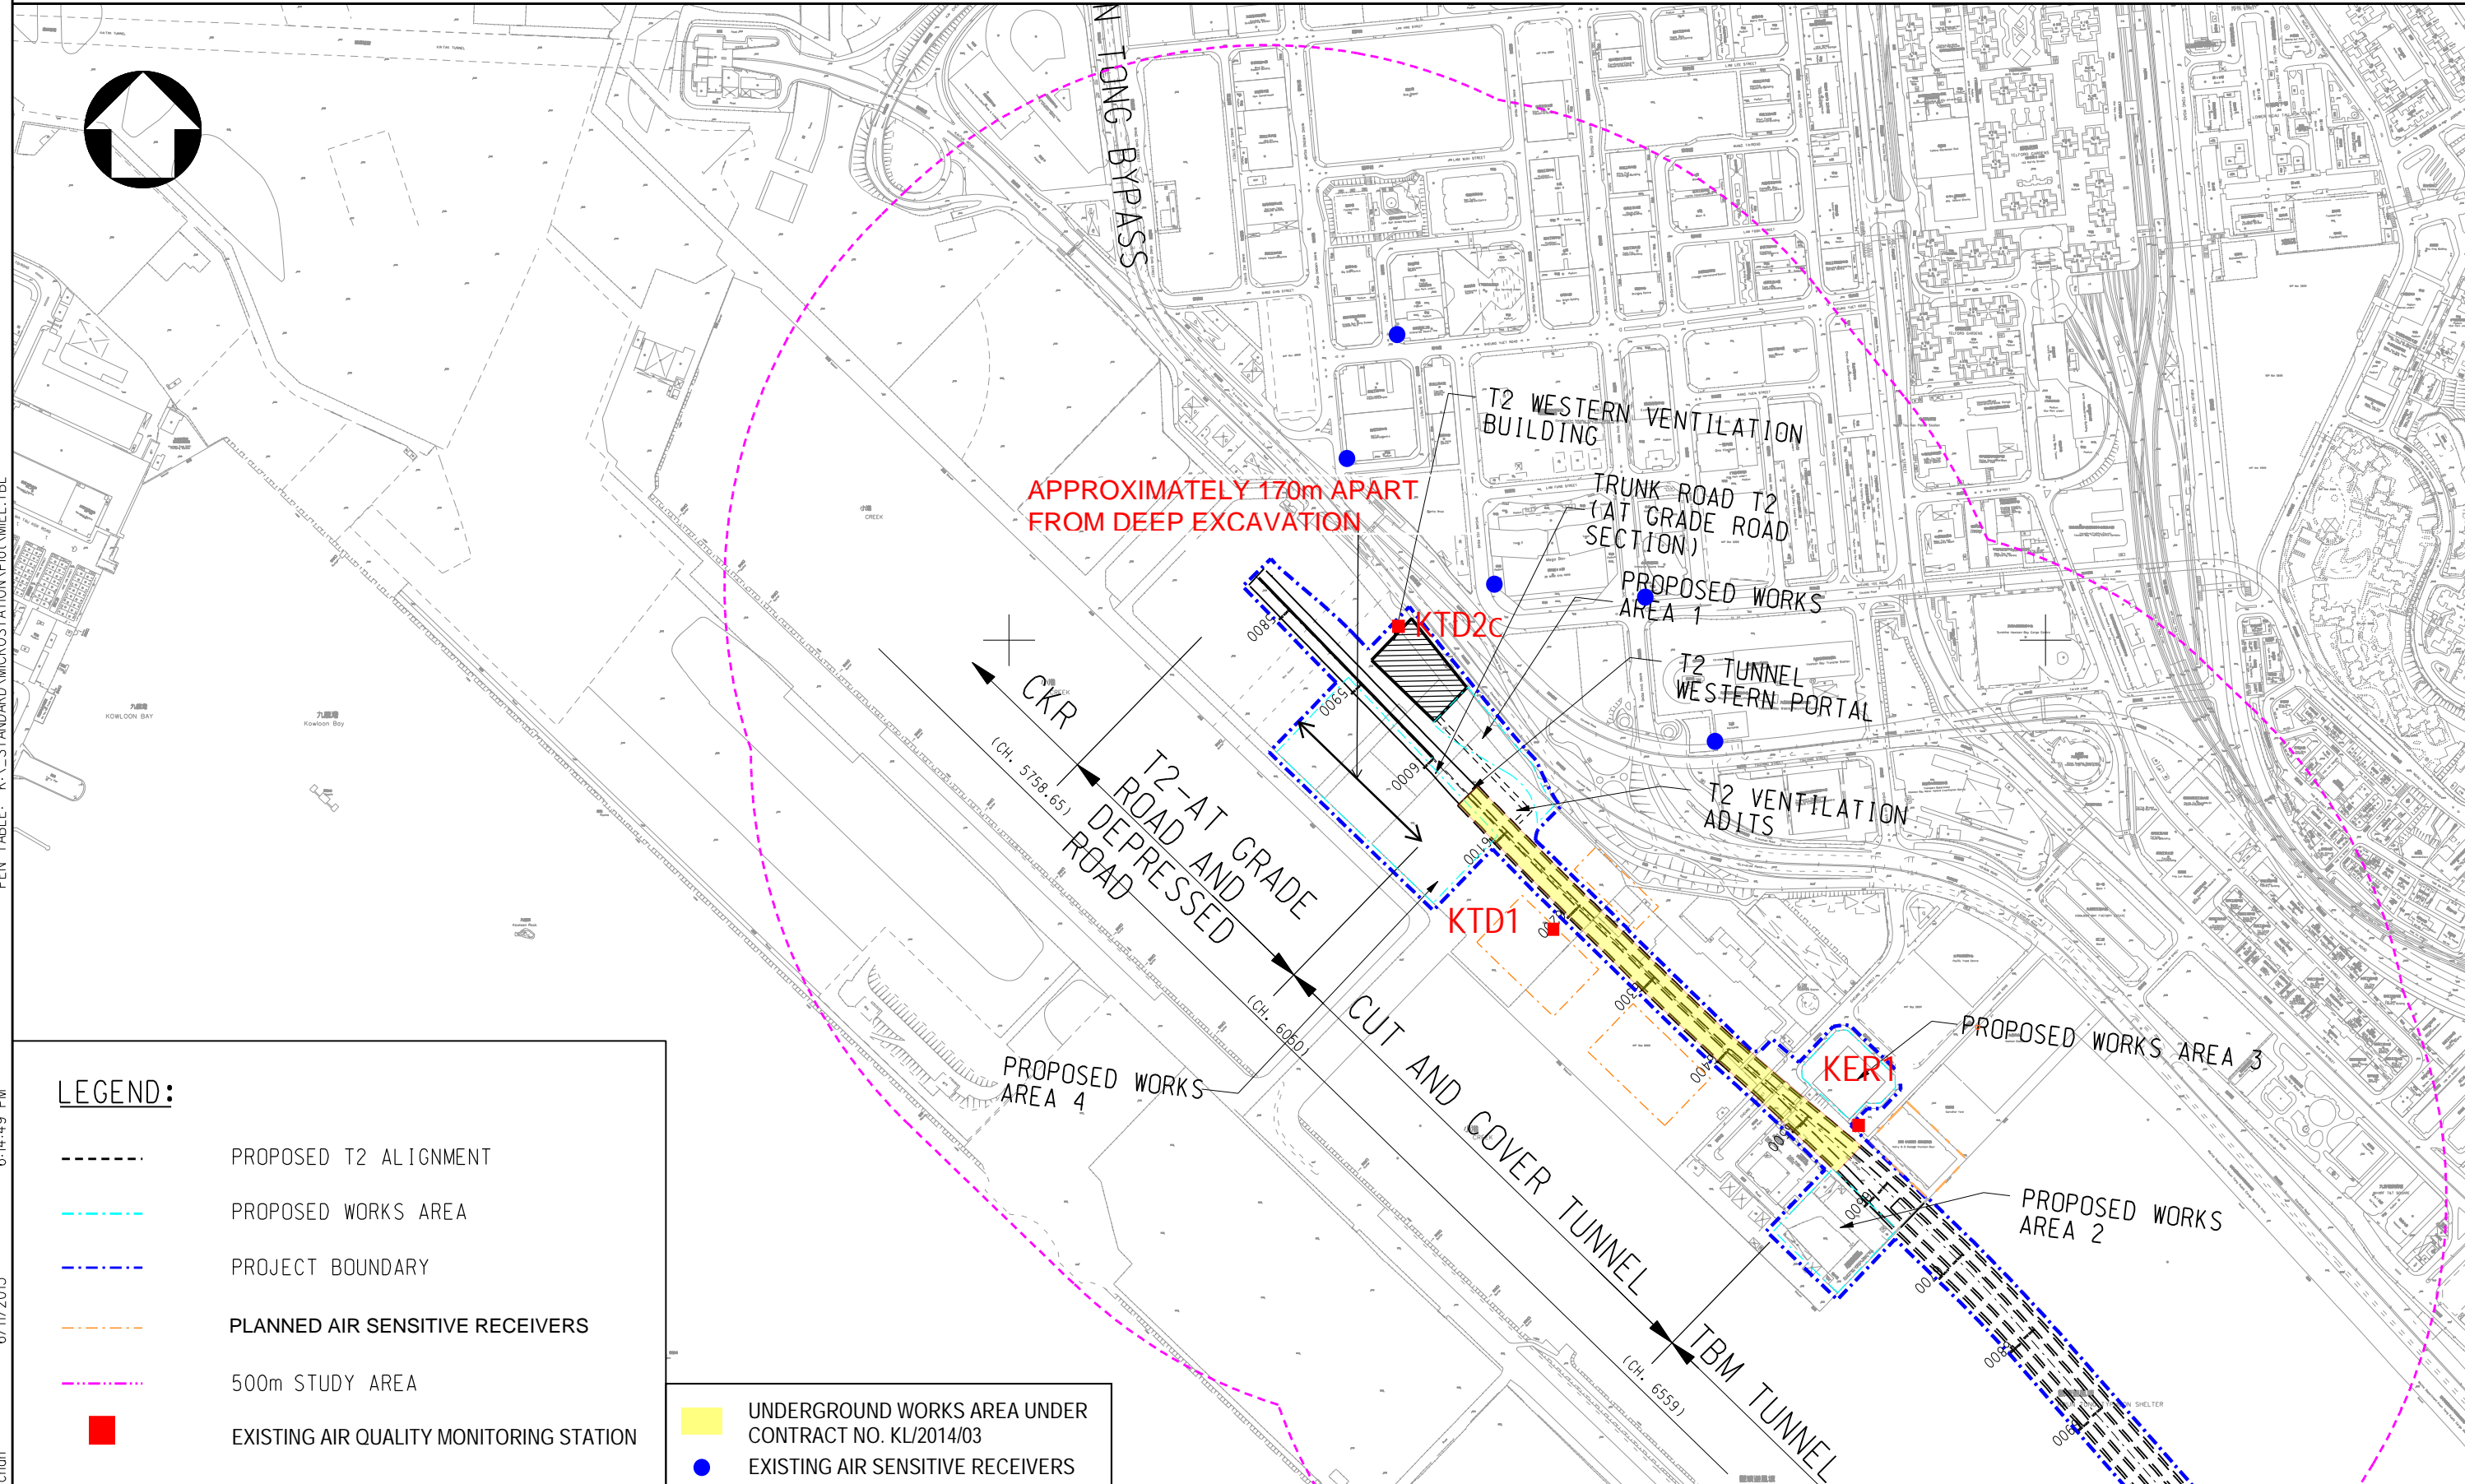
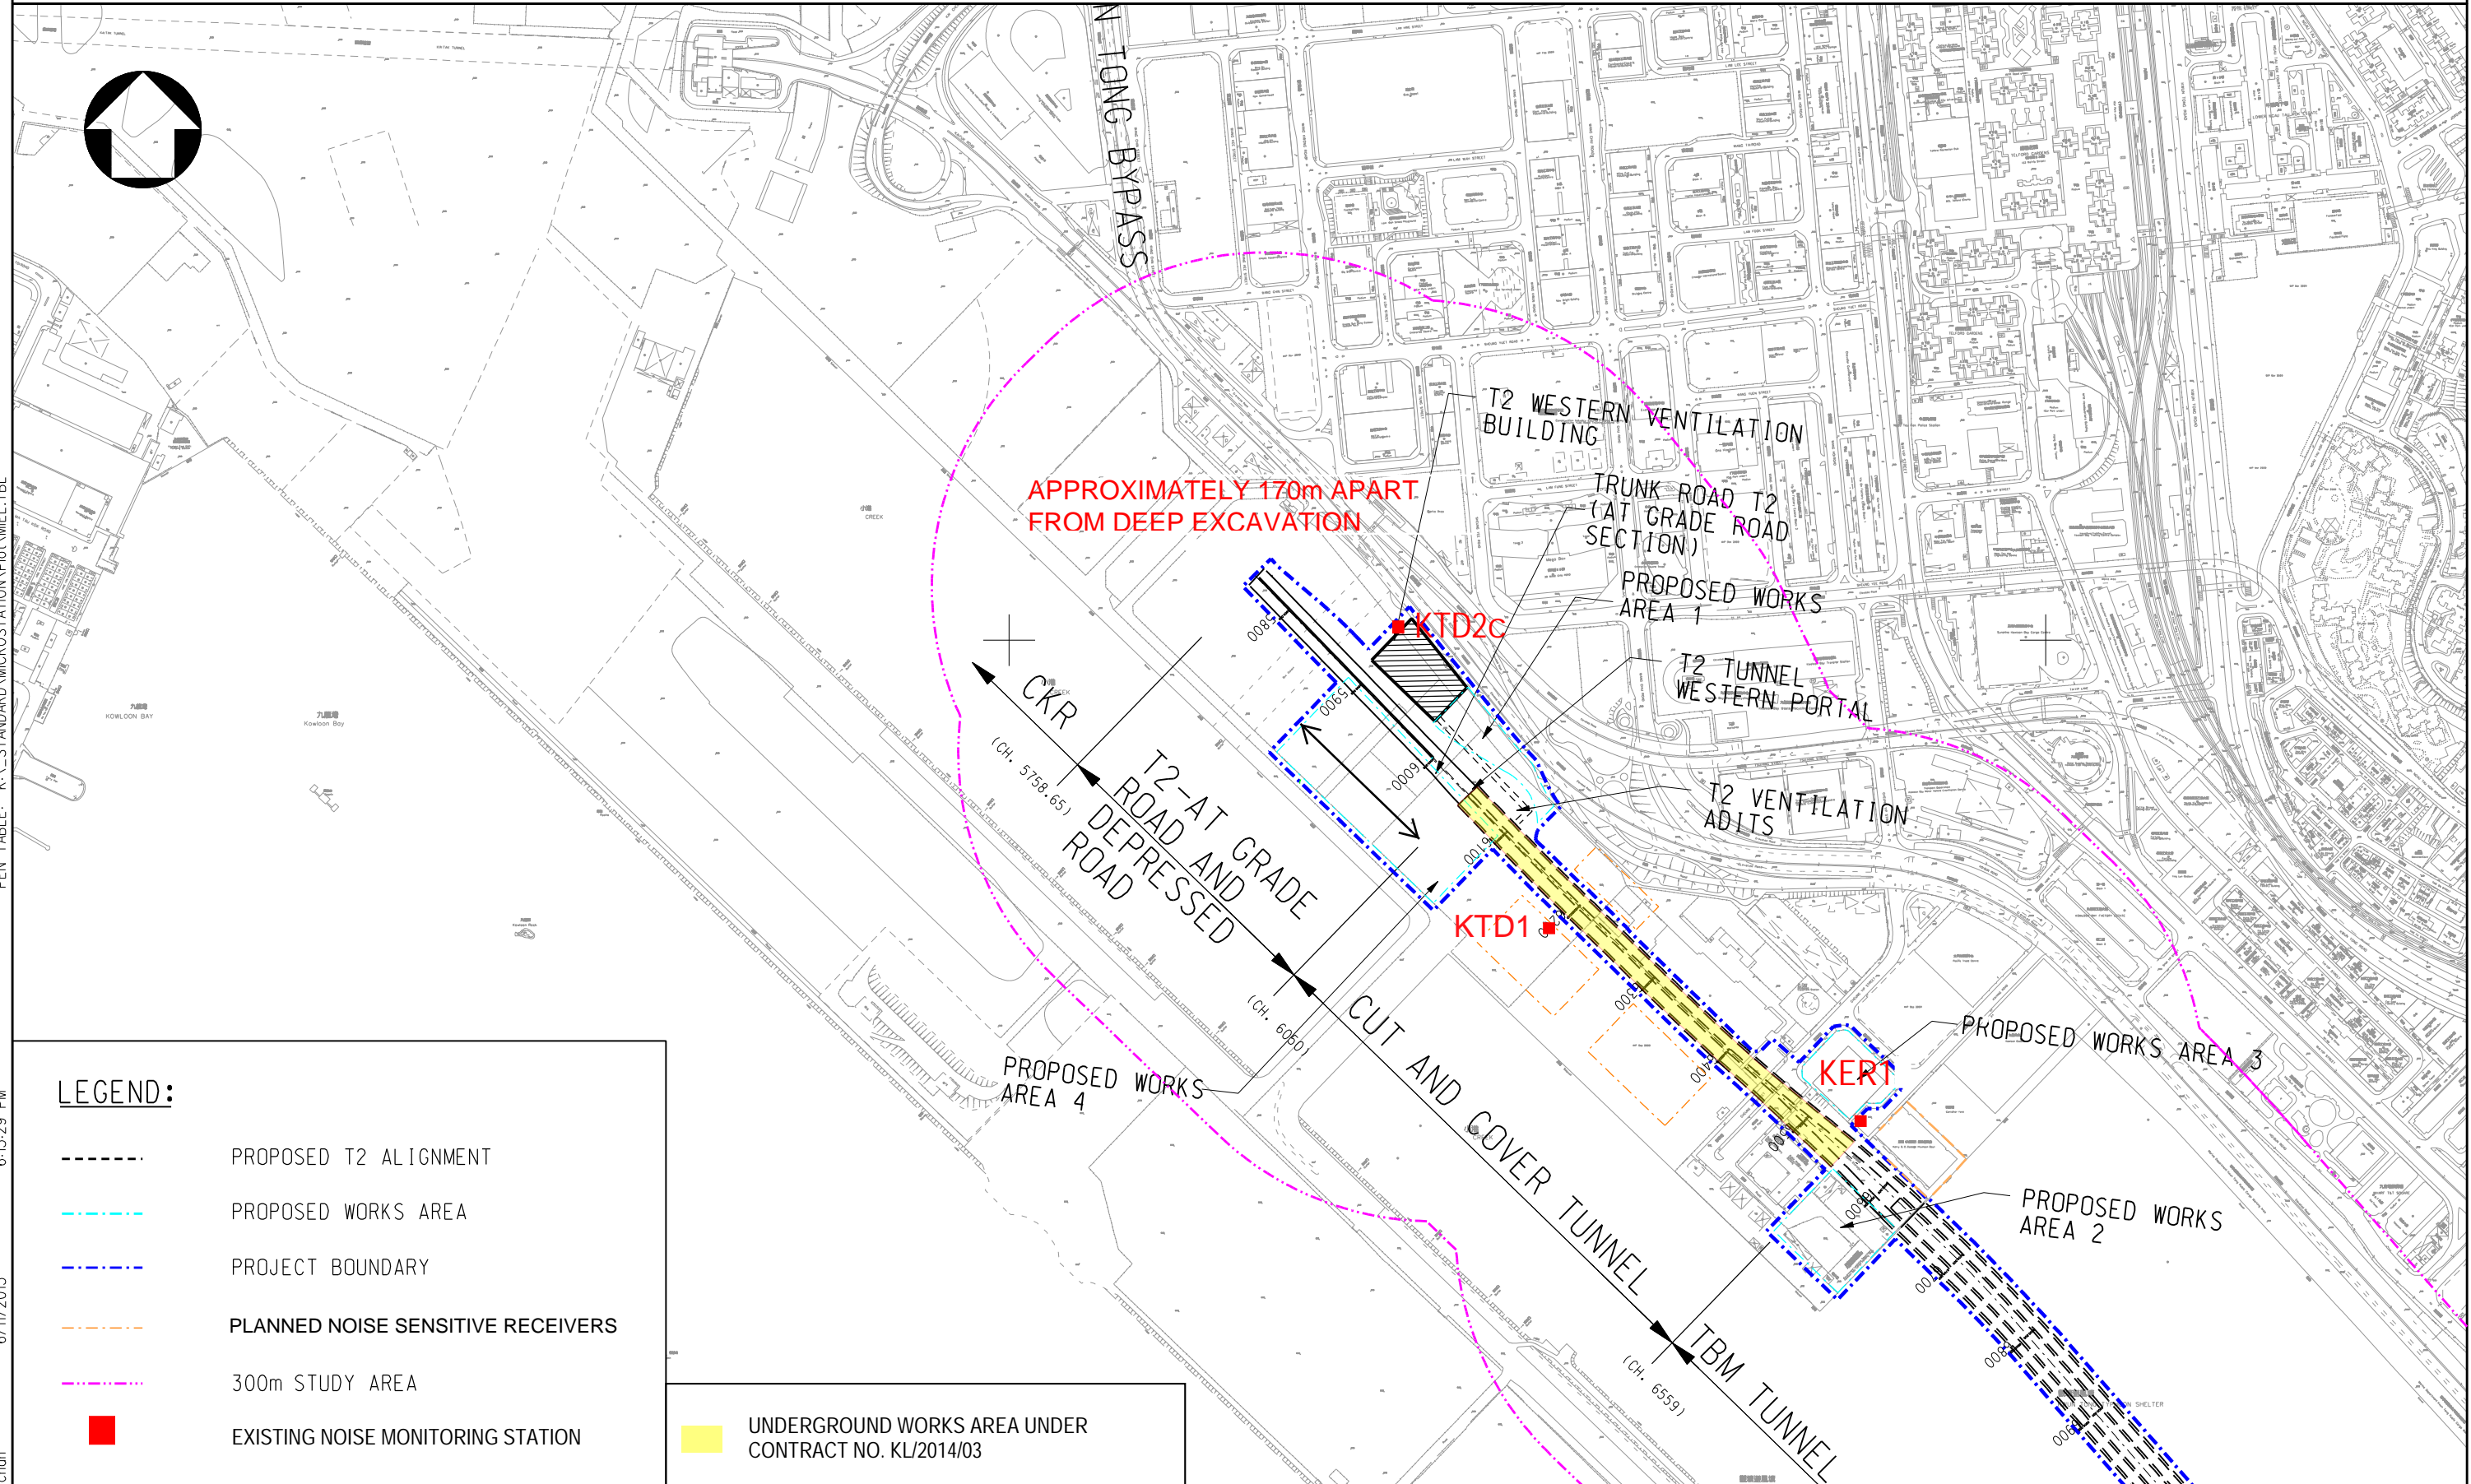
Figure 2

2.2.7 The most updated locations are summarized in **Table 2.2** and shown in **Figure 2**.

Air and Noise Monitoring Locations
