MONTHLY EM&A REPORT

December 2020

Contract No. : KLN/2015/07

Contract Name : Environmental Monitoring Works for
Contract KL/2014/03 – Kai Tak Development
– Stage 3 Infrastructure Works for Developments
at the Southern Part of the Former Runway

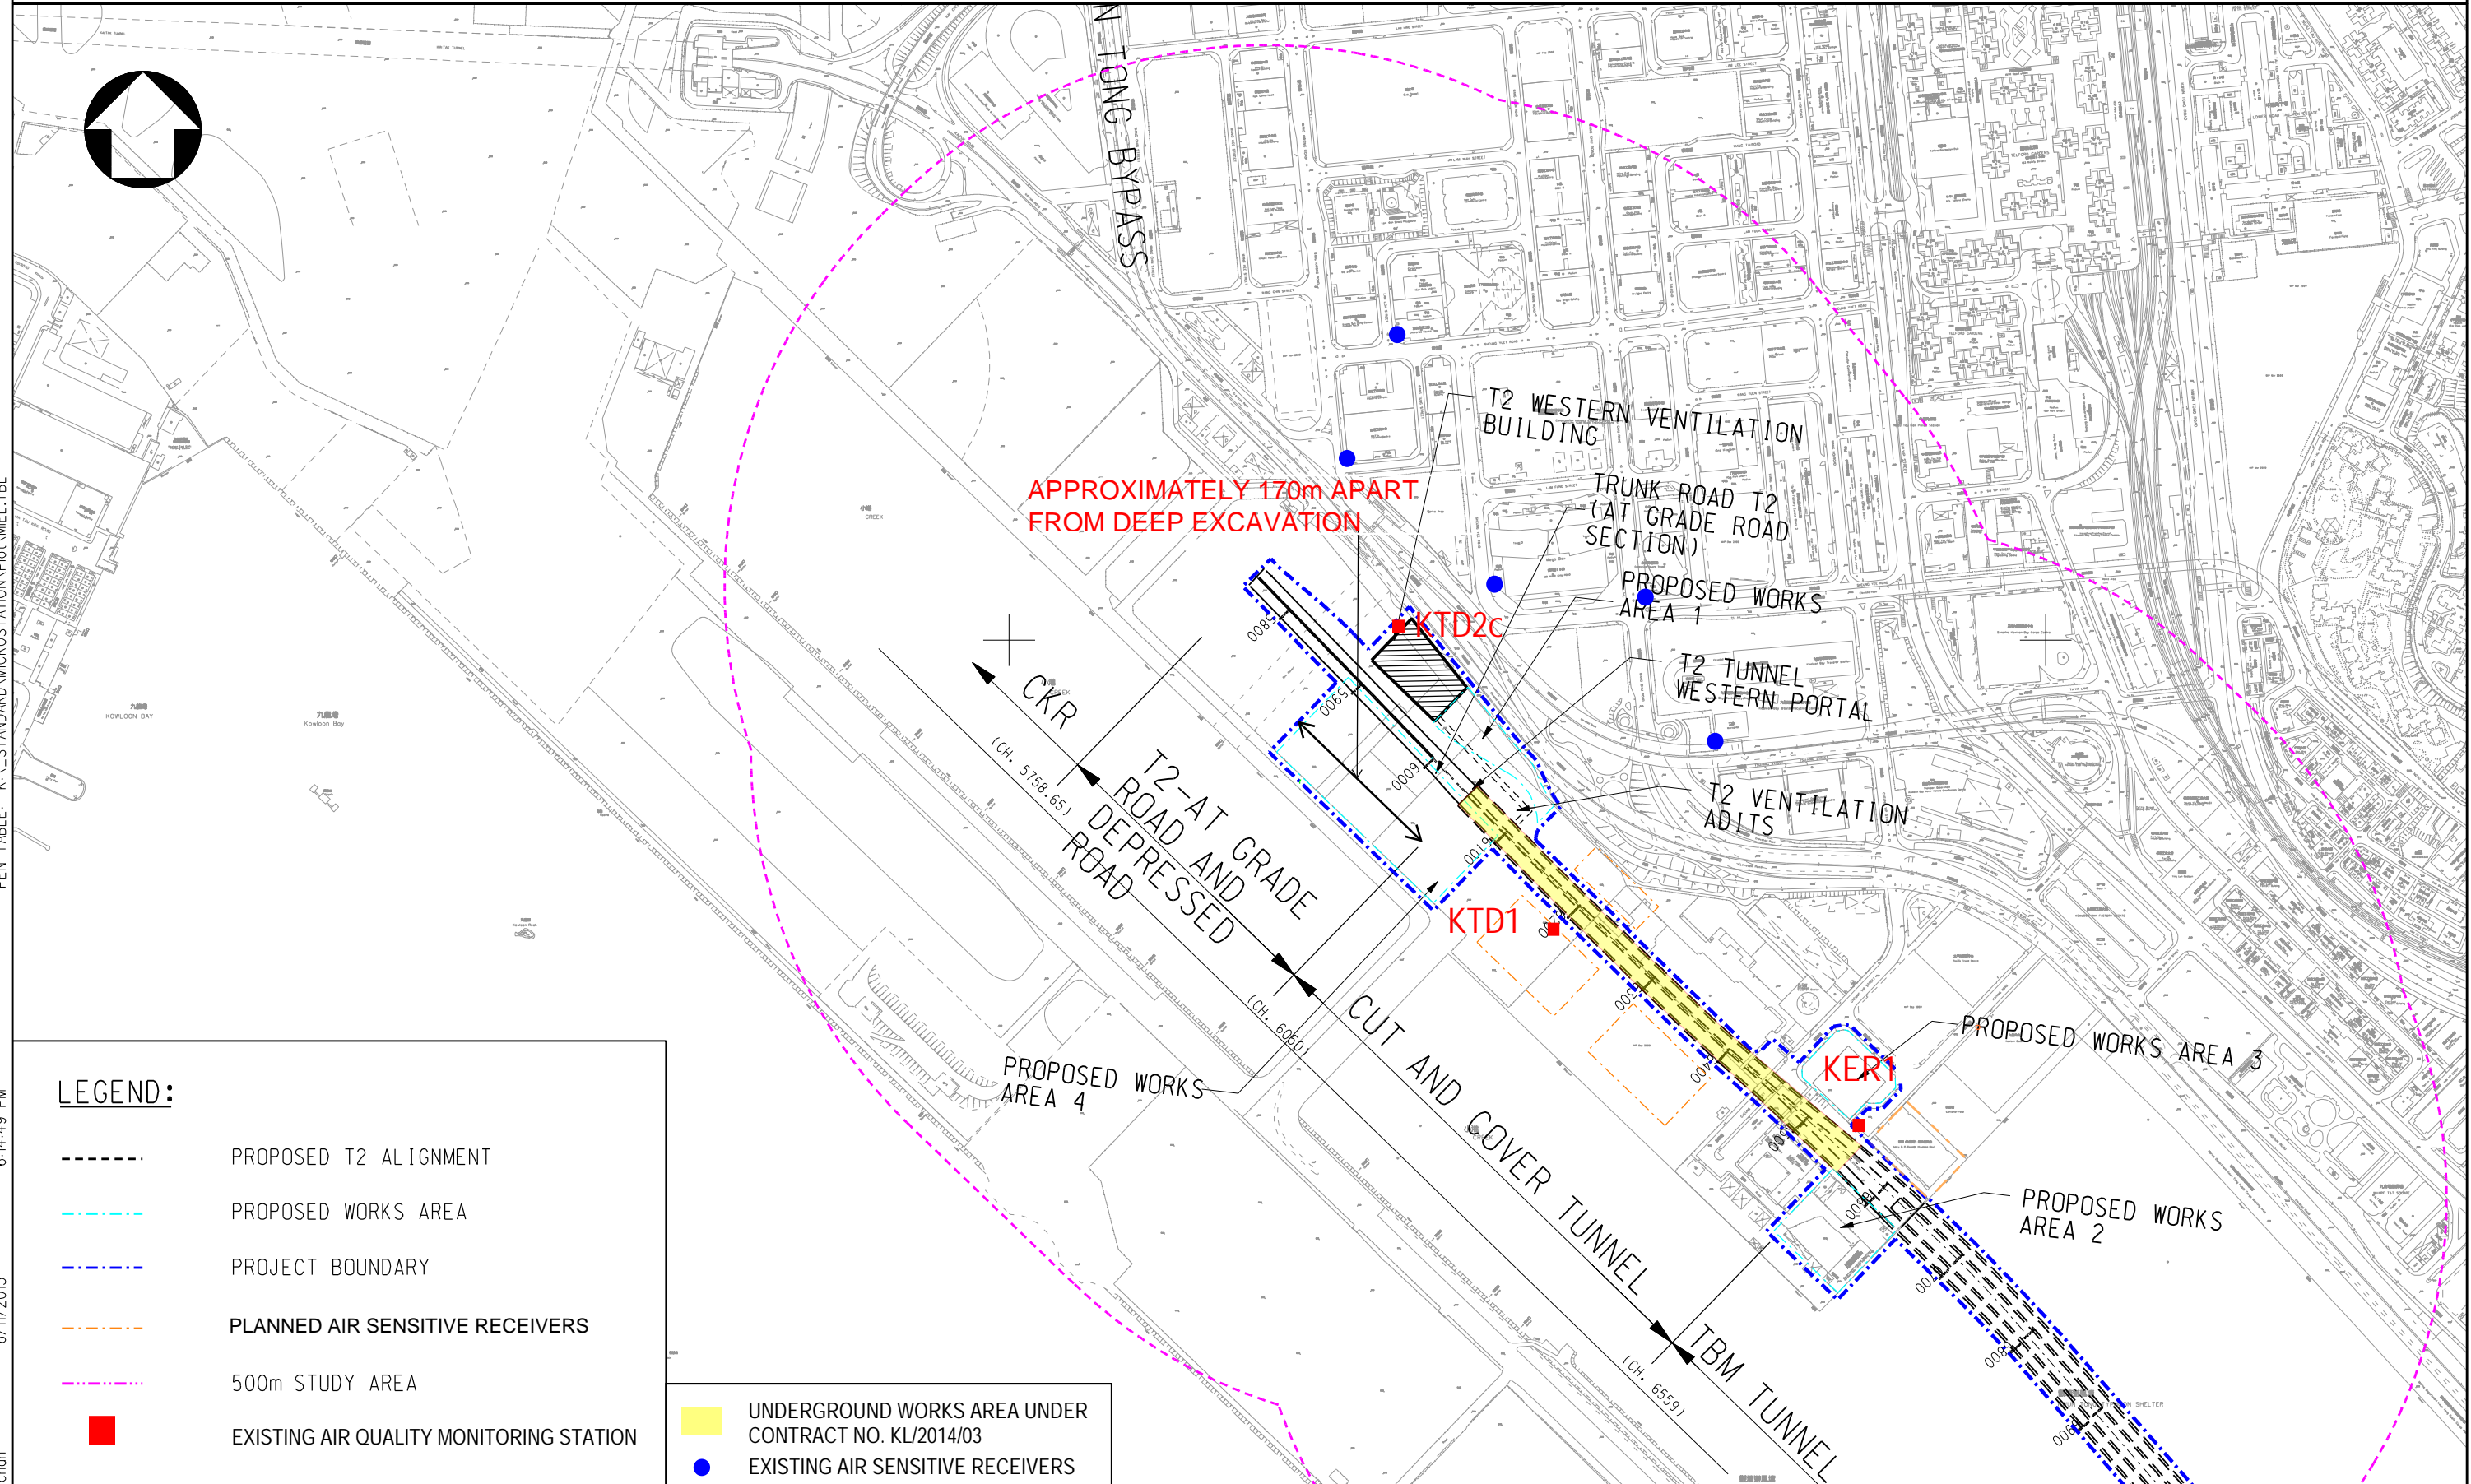
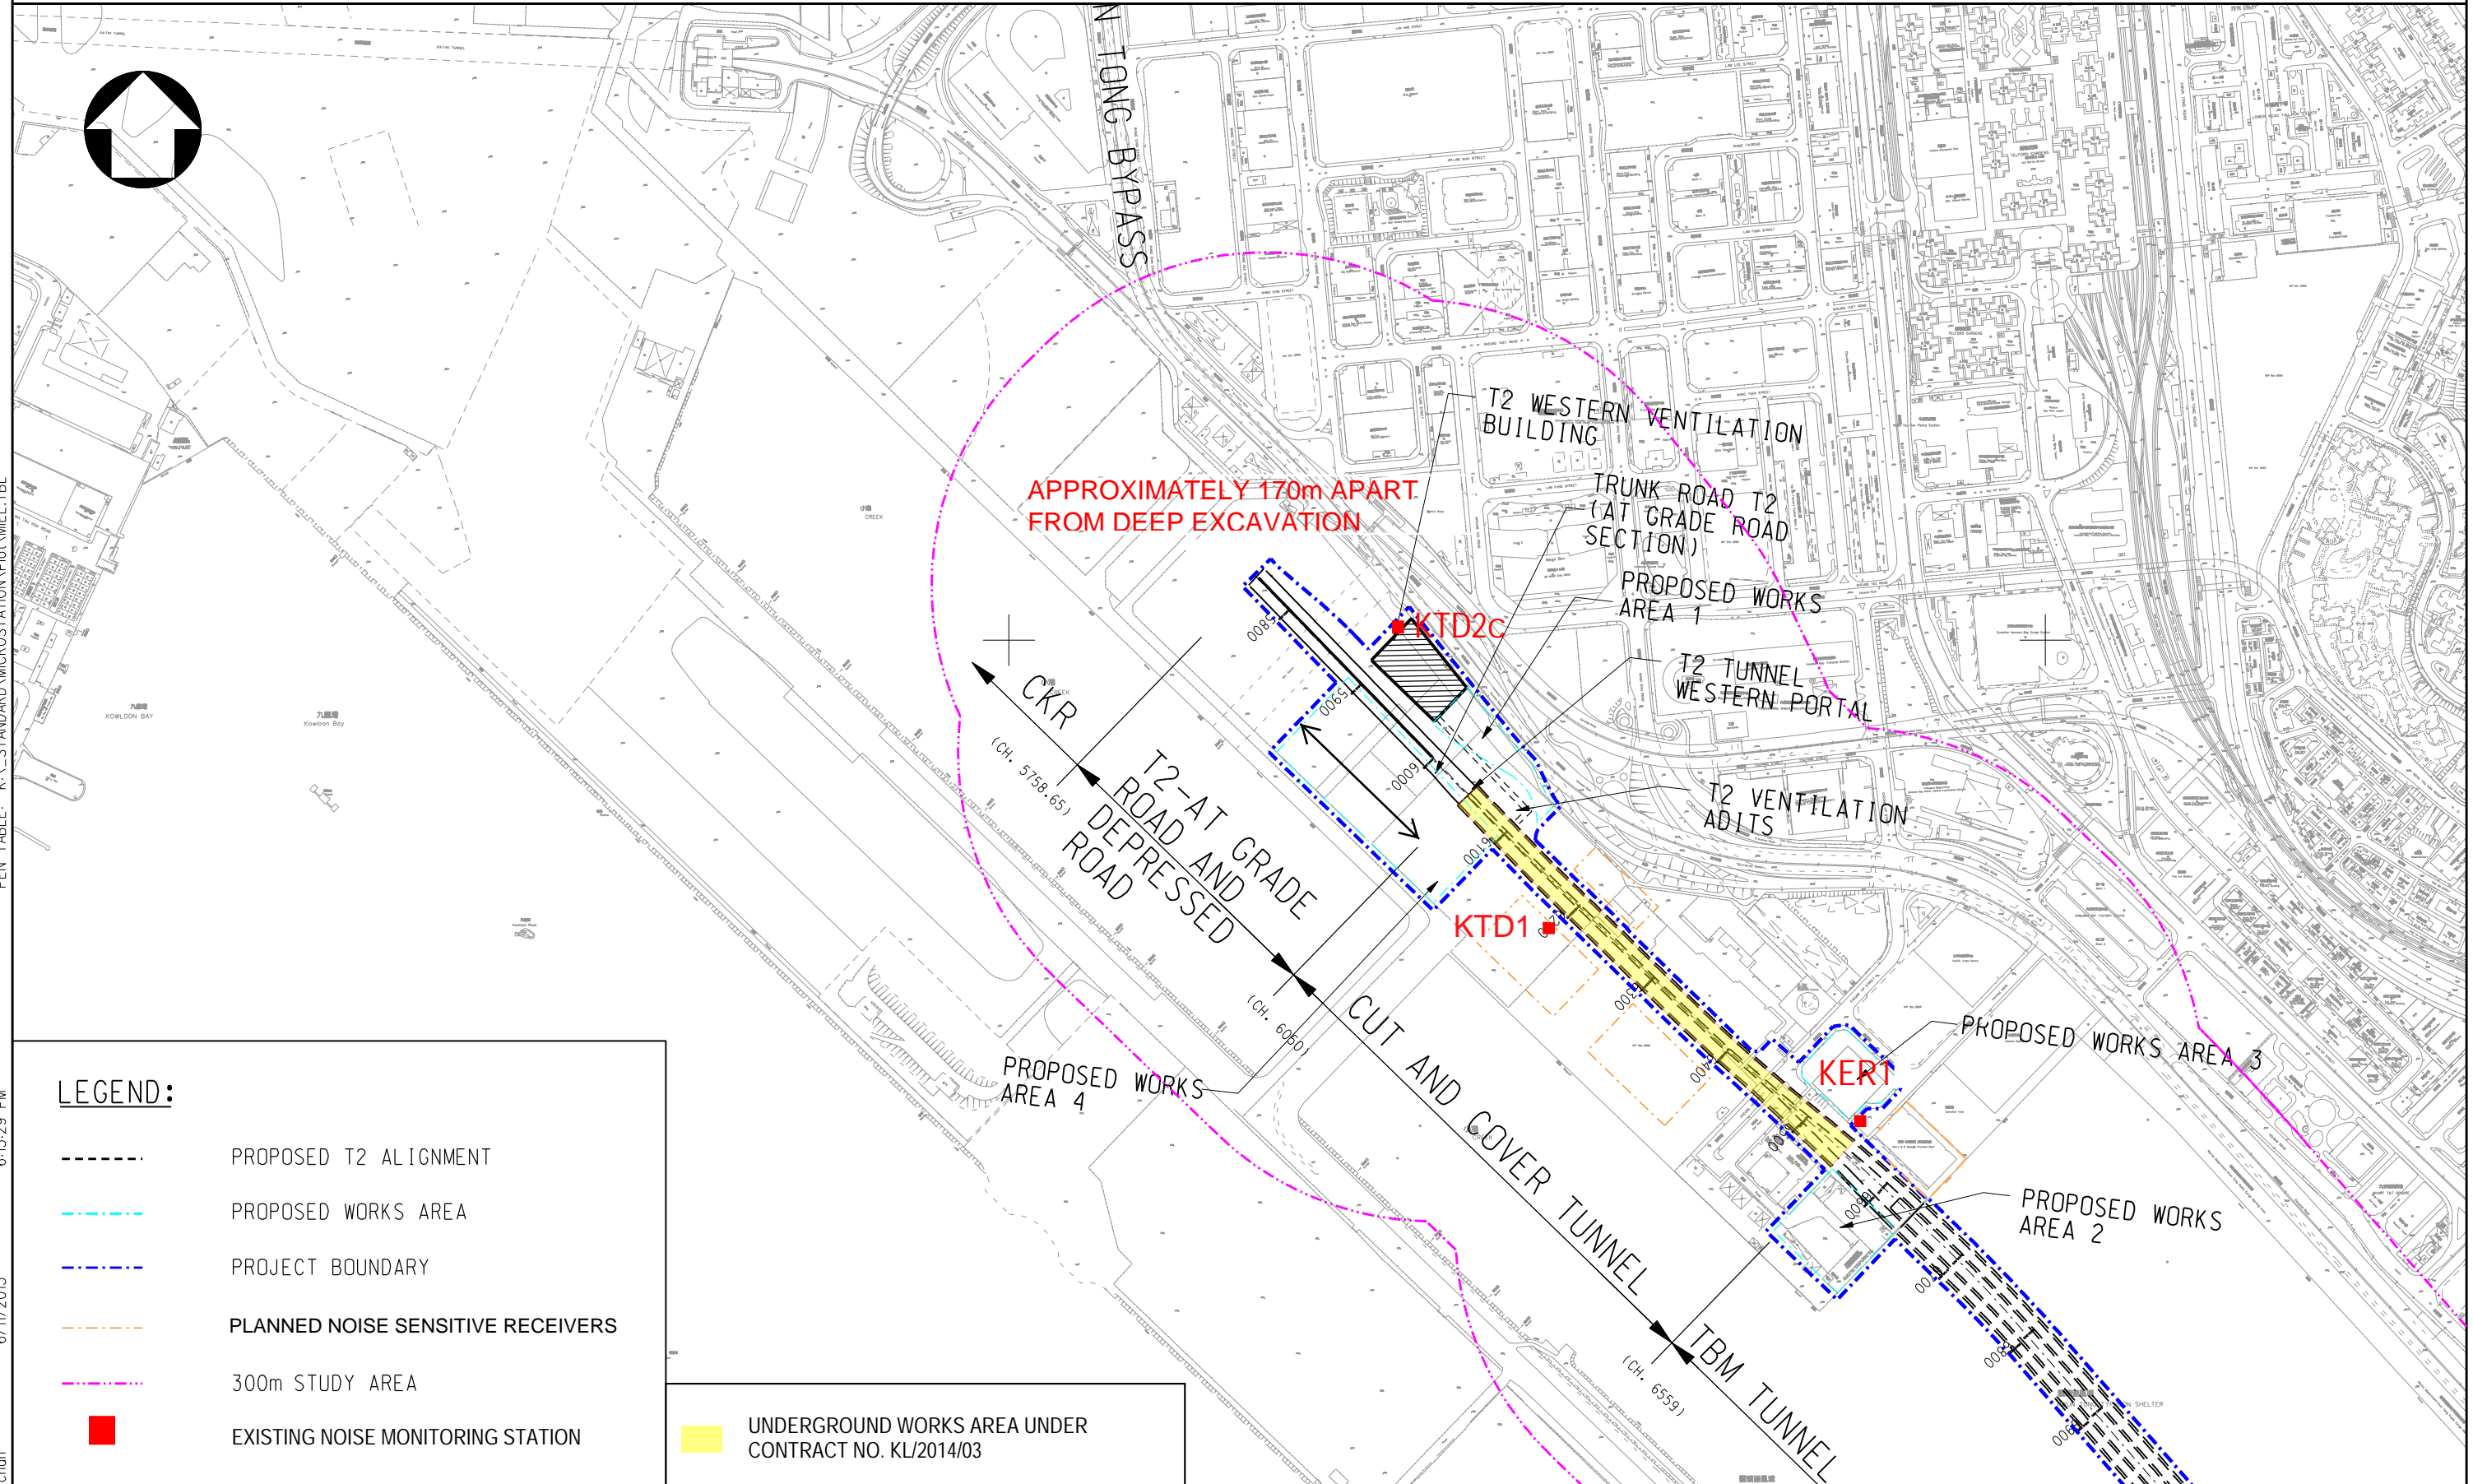
Figure 2

2.2.7 The most updated locations are summarized in **Table 2.1** and shown in **Figure 2**.

- 3.2.7 The most updated locations are summarized in **Table 3.1** and shown in **Figure 2**.

Air and Noise Monitoring Locations
