**Environmental Permit No.: EP-451/2013**  
**Environmental Team for Trunk Road T2**

**Appendix M – Summary of Exceedance**

**Reporting Month:** April 2023

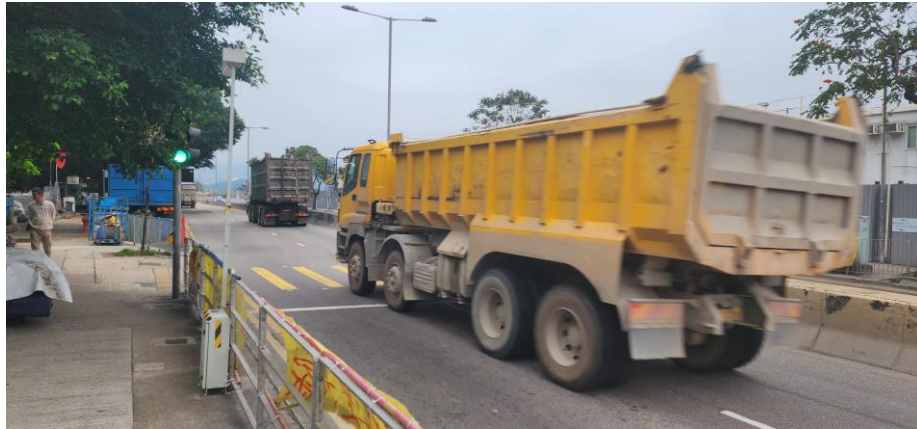
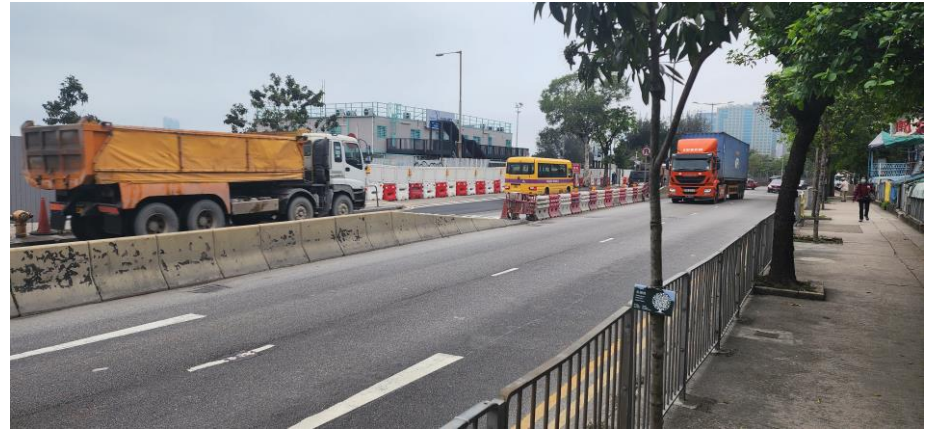
(a) Statement of exceedance(s) 24-hour TSP monitoring measured at CKL2 on 11 April 2023 exceeded the action level.
(b) Cause of exceedance(s) According to the observation of our field staff and the information provided by ER and Contractor, the Investigation result for exceedance identified at CKL2 is/are as follow:  <ol style="list-style-type: none"> <li>1. Fluctuation of road traffic along the Cha Kwo Ling Road, especially the completion of TKOLTT, a numerous of dump trucks from other construction site transport their C&amp;D material through Cha Kwo Ling Road to TKO Area 137 via TKOLTT (Photo 1 &amp; 2).</li> <li>2. Steel work was performed at Portion Q (near CKL2), no dusty activities (i.e Excavation, loading or unloading of C&amp;D material) were performed at this section.</li> </ol>

Based on the finding(s) and observation(s) above, we deduce the Action Level exceedance of 24-hour TSP recorded at station CKL2 on 11 April 2023 is due to fluctuation of road traffic, therefore, the exceedance is considered as **non-project related**.

1. Watering of the construction areas 12 times per day to reduce dust emissions.
2. Side enclosure and covering of any aggregate or dusty material storage piles to reduce emissions.
3. Open stockpiles shall be avoided or covered.
4. Tarpaulin covering of all dusty vehicle loads transported to, from and between site locations.
5. Establishment and use of vehicle wheel and body washing facilities at the exit points of the site.
6. Imposition of speed controls for vehicles on unpaved site roads, 8 km per hour is the recommended limit.
7. Use of regular watering to reduce dust emissions from exposed site surfaces and unpaved roads, particularly during dry weather.

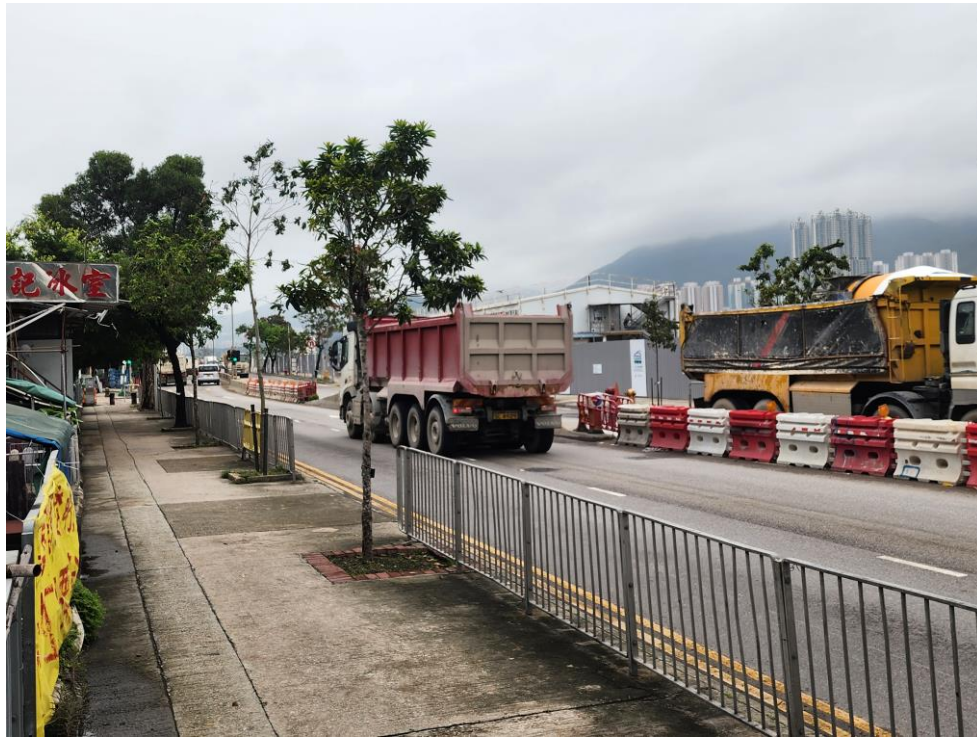
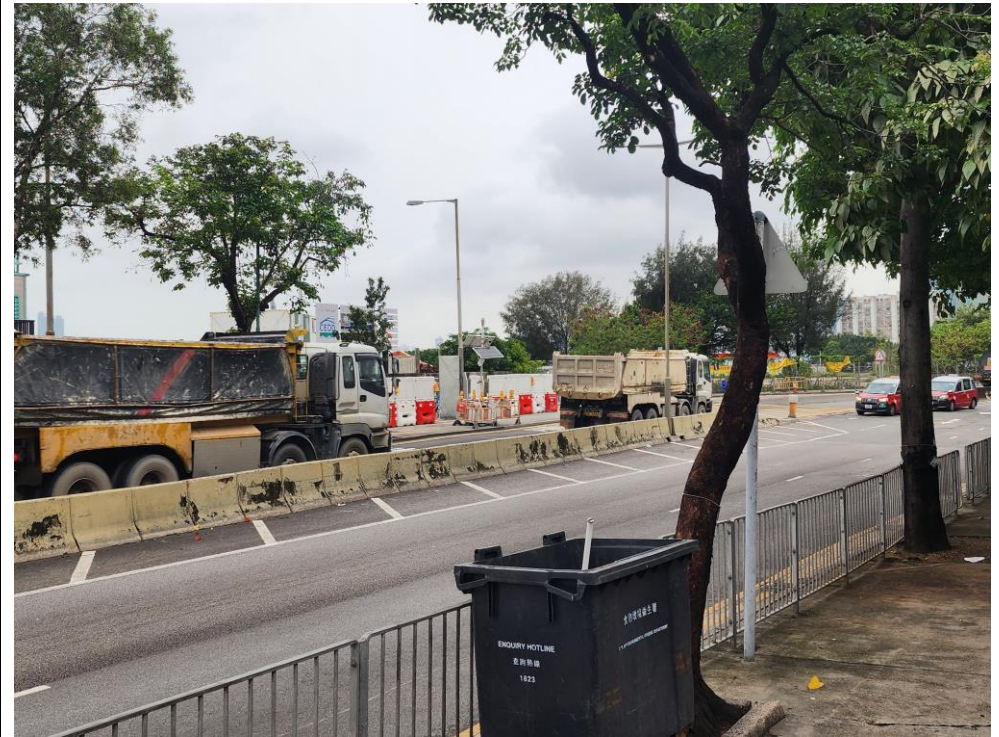
(a) Statement of exceedance(s) 24-hour TSP monitoring measured at CKL2 on 14 April 2023 exceeded the limit level.
(b) Cause of exceedance(s) According to the observation of our field staff and the information provided by ER and Contractor, the Investigation result for exceedance identified at CKL2 is/are as follow:  1. Fluctuation of road traffic along the Cha Kwo Ling Road, especially the completion of TKOLTT, a numerous of dump trucks from other construction site transport their C&D material through Cha Kwo Ling Road to TKO Area 137 via TKOLTT (Photo 1 & 2). 2. Steel work was performed at Portion Q (near CKL2), no dusty activities (i.e Excavation, loading or unloading of C&D material) were performed at this section.

Based on the finding(s) and observation(s) above, we deduce the Limit Level exceedance of 24-hour TSP recorded at station CKL2 on 14 April 2023 is due to fluctuation of road traffic, therefore, the exceedance is considered as **non-project related**.

1. Watering of the construction areas 12 times per day to reduce dust emissions.
2. Side enclosure and covering of any aggregate or dusty material storage piles to reduce emissions.
3. Open stockpiles shall be avoided or covered.
4. Tarpaulin covering of all dusty vehicle loads transported to, from and between site locations.
5. Establishment and use of vehicle wheel and body washing facilities at the exit points of the site.
6. Imposition of speed controls for vehicles on unpaved site roads, 8 km per hour is the recommended limit.
7. Use of regular watering to reduce dust emissions from exposed site surfaces and unpaved roads, particularly during dry weather.

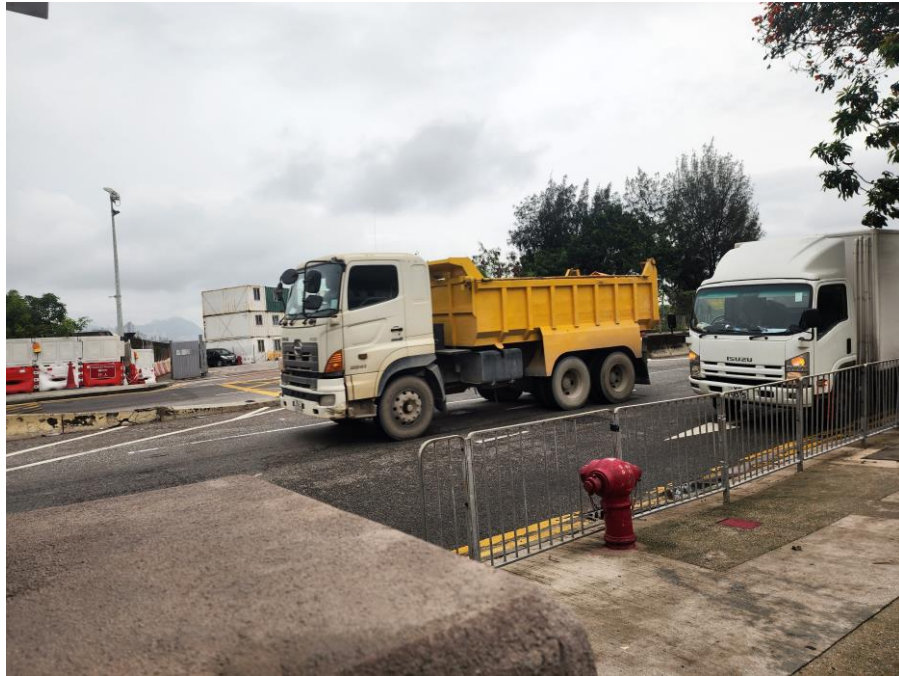
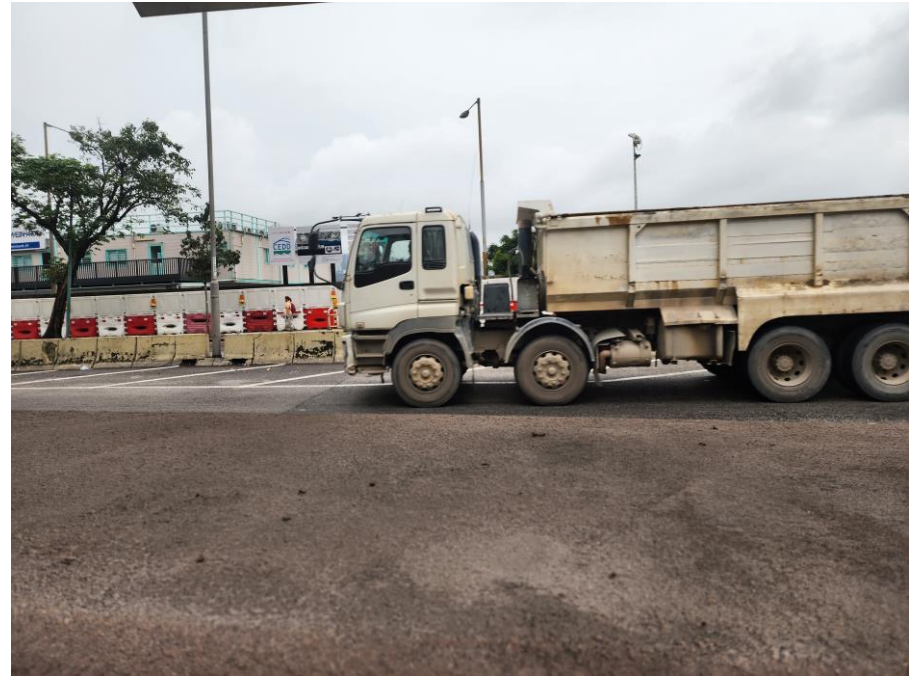
(a) Statement of exceedance(s) 24-hour TSP monitoring measured at CKL2 on 26 April 2023 exceeded the action level.
(b) Cause of exceedance(s) According to the observation of our field staff and the information provided by ER and Contractor, the Investigation result for exceedance identified at CKL2 is/are as follow:  1. Fluctuation of road traffic along the Cha Kwo Ling Road, especially the completion of TKOLTT, a numerous of dump trucks from other construction site transport their C&D material through Cha Kwo Ling Road to TKO Area 137 via TKOLTT (Photo 1 & 2). 2. Steel work was performed at Portion Q (near CKL2), no dusty activities (i.e Excavation, loading or unloading of C&D material) were performed at this section.

Based on the finding(s) and observation(s) above, we deduce the Limit Level exceedance of 24-hour TSP recorded at station CKL2 on 26 April 2023 is due to fluctuation of road traffic, therefore, the exceedance is considered as **non-project related**.

1. Watering of the construction areas 12 times per day to reduce dust emissions.
2. Side enclosure and covering of any aggregate or dusty material storage piles to reduce emissions.
3. Open stockpiles shall be avoided or covered.
4. Tarpaulin covering of all dusty vehicle loads transported to, from and between site locations.
5. Establishment and use of vehicle wheel and body washing facilities at the exit points of the site.
6. Imposition of speed controls for vehicles on unpaved site roads, 8 km per hour is the recommended limit.
7. Use of regular watering to reduce dust emissions from exposed site surfaces and unpaved roads, particularly during dry weather.
