Trunk Road T2 Monthly Environmental Monitoring and Audit Report (under EP-458/2013/C)

August 2023 (Version 1.0)

Re: Agreement No. EDO 01/2019 **Independent Environmental Checker for** Contract No. ED/2018/04 - Trunk Road T2 and Infrastructure Works for **Developments at the Former South Apron**

Monthly EM&A Report (August 2023) for EP-458/2013/C

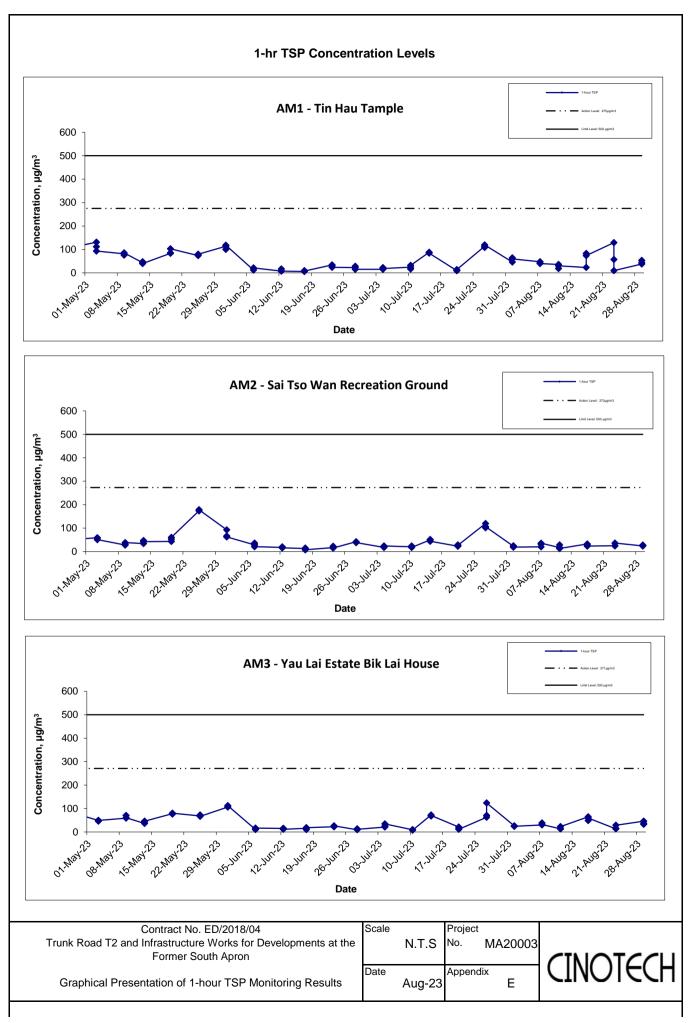
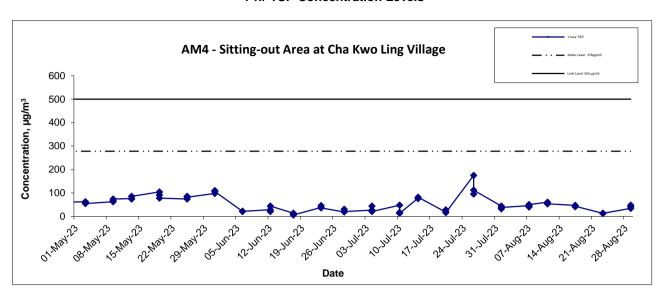
1-hr TSP Concentration Levels

Location AM3 -	Yau Lai Esta	ate Bik Lai House	
Date	Time	Weather	Particulate Concentration (μg/m ³)
1-Aug-23	12:00	Sunny	26.0
1-Aug-23	13:00	Sunny	24.0
1-Aug-23	14:00	Sunny	24.0
7-Aug-23	10:32	Sunny	30.0
7-Aug-23	11:32	Sunny	38.0
7-Aug-23	12:32	Sunny	32.0
11-Aug-23	15:30	Cloudy	13.3
11-Aug-23	16:30	Cloudy	13.3
11-Aug-23	17:30	Cloudy	22.8
17-Aug-23	15:50	Cloudy	64.8
17-Aug-23	16:50	Cloudy	48.6
17-Aug-23	17:50	Cloudy	59.4
23-Aug-23	12:50	Sunny	13.3
23-Aug-23	13:50	Sunny	15.2
23-Aug-23	14:50	Sunny	28.5
29-Aug-23	13:09	Sunny	45.6
29-Aug-23	14:09	Sunny	32.3
29-Aug-23	15:09	Sunny	36.1
		Average	31.5
		Maximum	64.8
		Minimum	13.3

Location AM4 -	Sitting-out A	Area at Cha Kwo I	Ling Village
Date	Time	Weather	Particulate Concentration (μg/m ³)
1-Aug-23	9:00	Sunny	44.0
1-Aug-23	10:00	Sunny	32.0
1-Aug-23	11:00	Sunny	38.0
7-Aug-23	13:45	Sunny	46.0
7-Aug-23	14:45	Sunny	40.0
7-Aug-23	15:45	Sunny	50.0
11-Aug-23	9:30	Cloudy	60.8
11-Aug-23	10:30	Cloudy	55.1
11-Aug-23	11:30	Cloudy	53.2
17-Aug-23	9:30	Cloudy	46.8
17-Aug-23	10:30	Cloudy	41.4
17-Aug-23	11:30	Cloudy	43.2
23-Aug-23	15:55	Sunny	13.3
23-Aug-23	16:55	Sunny	13.3
23-Aug-23	17:55	Sunny	13.3
29-Aug-23	15:07	Sunny	34.2
29-Aug-23	16:07	Sunny	47.5
29-Aug-23	17:07	Sunny	41.8
		Average	39.7
		Maximum	60.8
		Minimum	13.3

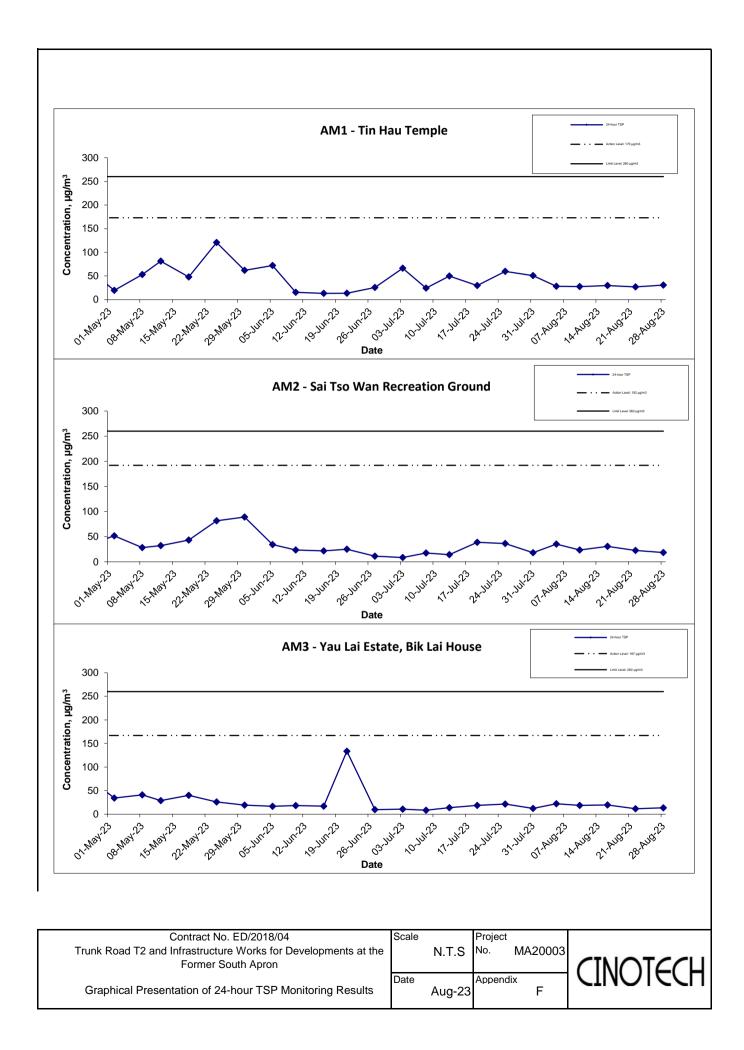
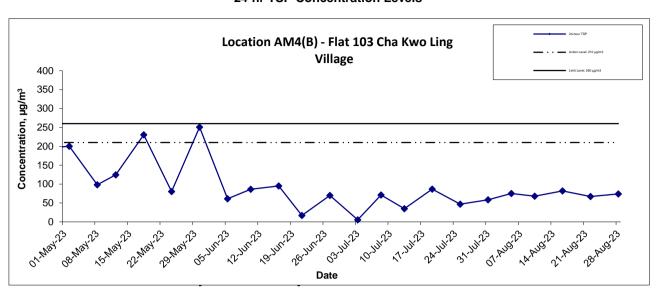
24-hr TSP Concentration Levels

Location AM4(B) - Flat 103 Cha Kwo Ling Village

Start Date	Weather	Filter W	eight (g)	Particulate	Elaps	e Time	Sampling	Flow Rat	te (m³/min.)	Av. flow	Total vol.	Conc.
Start Date	Condition	Initial	Final	Weight (g)	Initial	Final	Time(hrs.)	Initial	Final	(m³/min)	(m ³)	(µg/m³)
5-Aug-23	Sunny	3.2918	3.4234	0.1316	18909.1	18933.1	24.0	1.21	1.21	1.21	1746.1	75.4
10-Aug-23	Cloudy	3.3242	3.4436	0.1194	18933.1	18957.1	24.0	1.22	1.22	1.22	1750.9	68.2
16-Aug-23	Fine	3.3224	3.4658	0.1434	18957.1	18981.1	24.0	1.21	1.21	1.21	1748.0	82.0
22-Aug-23	Fine	3.3263	3.4441	0.1178	18981.1	19005.1	24.0	1.21	1.21	1.21	1748.0	67.4
28-Aug-23	Sunny	3.3455	3.4750	0.1295	19005.1	19029.1	24.0	1.21	1.21	1.21	1747.9	74.1
											Min	67.4
											Max	82.0
											Average	73.4

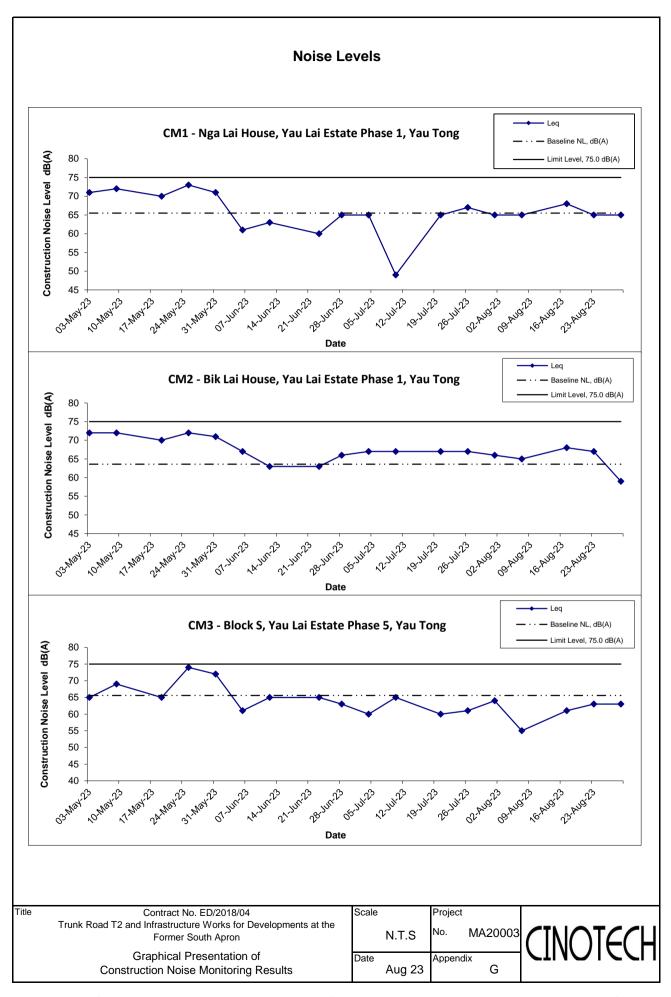
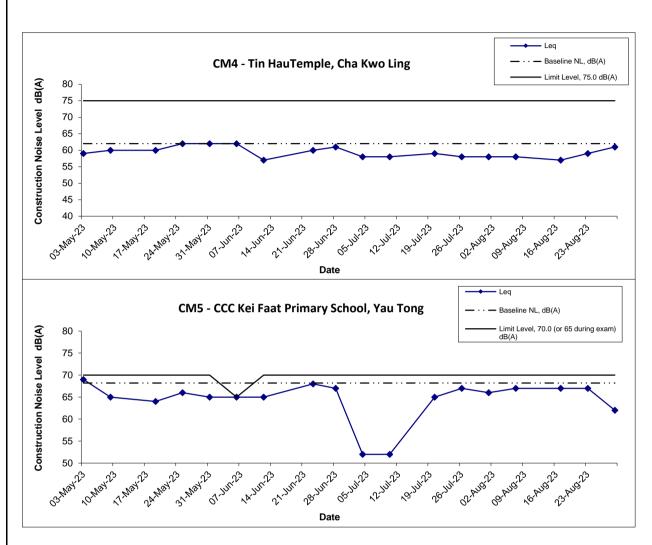
Noise Levels

Location CM4 -	ocation CM4 - Tin Hau Temple, Cha Kwo Ling									
				Unit: dB (A) (30-min)						
Date	Time	Weather	Measured Noise Level			Baseline Level	Construction Noise Level			
Date	11110	camor	L _{eq}	L ₁₀	L 90	L _{eq}	L _{eq}			
1 Aug 2023	10:33	Fine	58.2	59.6	52.7	62.0	58 Measured ≦ Baseline			
7 Aug 2023	14:15	Sunny	57.8	60.5	52.3	62.0	58 Measured ≤ Baseline			
17 Aug 2023	1:02	Cloudy	57.1	59.9	51.6	62.0	57 Measured ≤ Baseline			
23 Aug 2023	13:10	Fine	63.8	66.7	56.0	62.0	59			
29 Aug 2023	12:03	Sunny	60.5	62.8	55.7	62.0	61 Measured ≤ Baseline

Location CM5 -	ocation CM5 - CCC Kei Faat Primary School, Yau Tong									
				Unit: dB (A) (30-min)						
Date	Date Time		Meas	sured Noise	_evel	Baseline Level	Construction Noise Level			
Date	11110	Weather	L _{eq}	L ₁₀	L 90	L _{eq}	L _{eq}			
1 Aug 2023	11:30	Sunny	65.8	68.0	61.6	68.2	66 Measured ≤ Baseline			
7 Aug 2023	13:45	Sunny	66.7	69.5	62.2	68.2	67 Measured ≤ Baseline			
17 Aug 2023	13:54	Cloudy	67.2	69.6	63.7	68.2	67 Measured ≤ Baseline			
23 Aug 2023	9:15	Sunny	67.3	69.7	63.0	68.2	67 Measured ≦ Baseline			
29 Aug 2023	12:51	Sunny	62.4	64.6	59.1	68.2	62 Measured ≤ Baseline
