Trunk Road T2 Monthly Environmental Monitoring and Audit Report (under EP-458/2013/C) October 2025 (Version 1.0)

**Re: Agreement No. EDO 01/2019
Independent Environmental Checker for
Contract No. ED/2018/04 – Trunk Road T2 and Infrastructure Works for
Developments at the Former South Apron**

Monthly EM&A Report (October 2025) for EP-458/2013/C

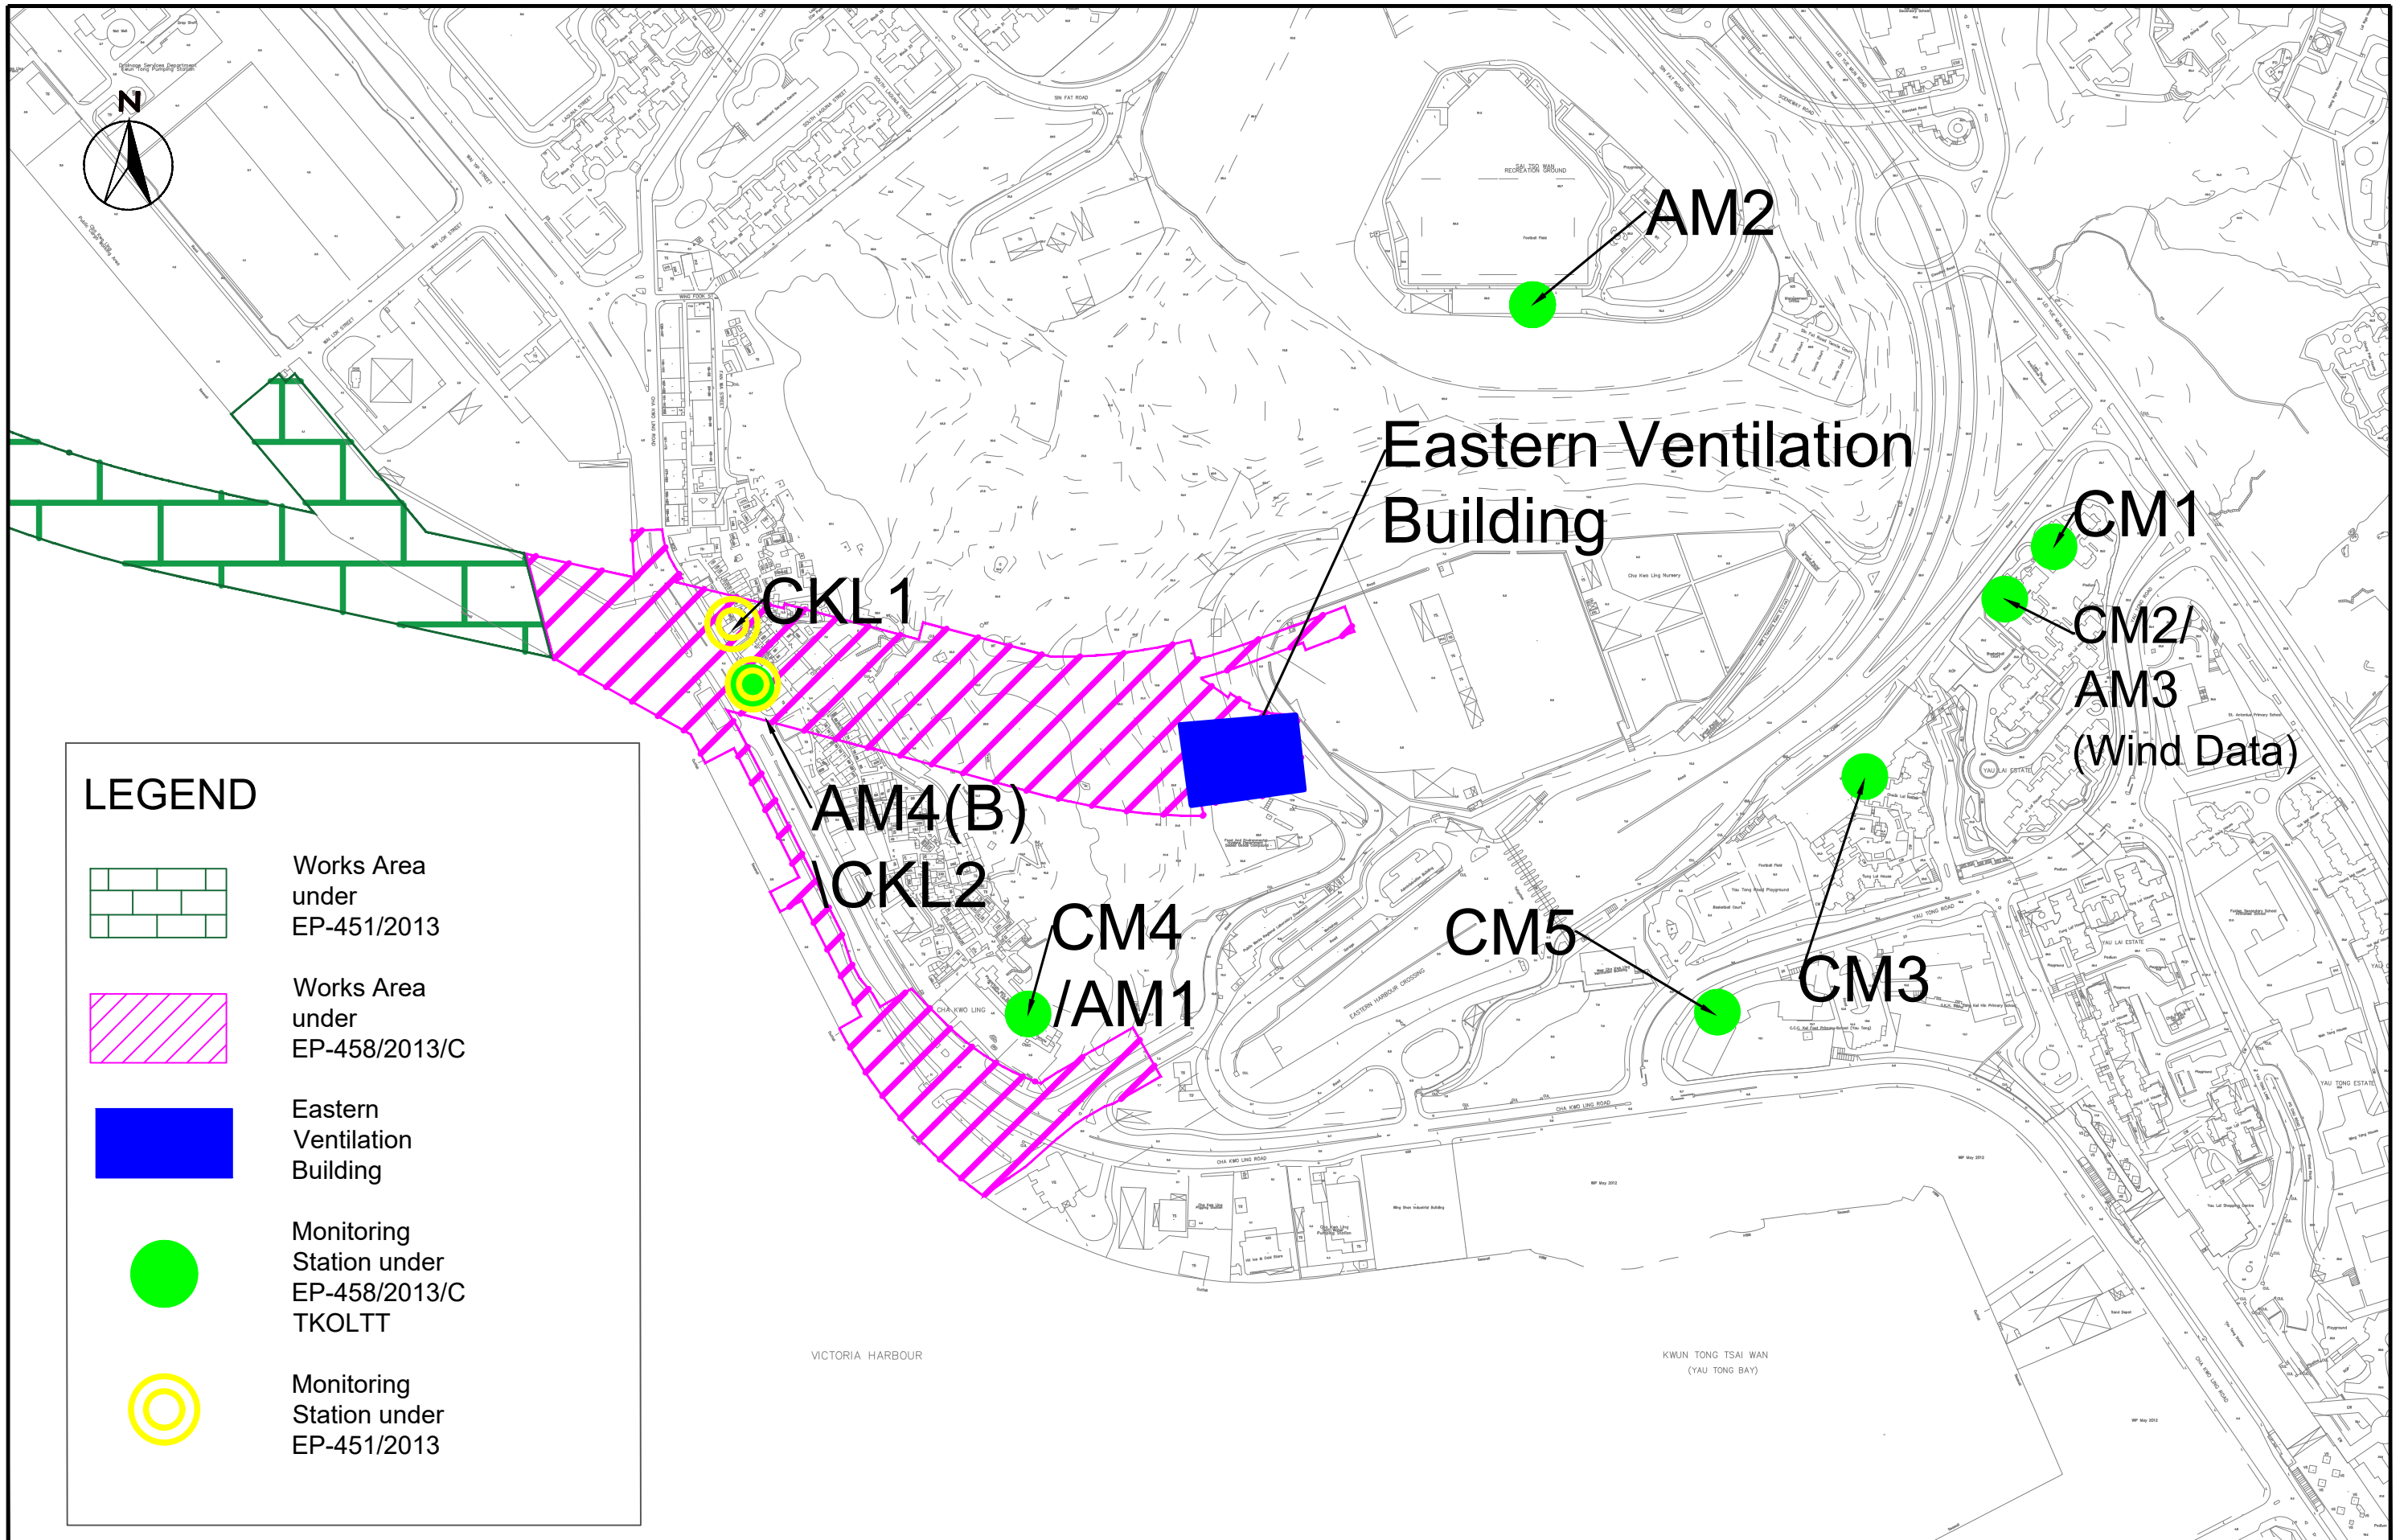
SCALE	1:4000@A3	DATE	Jul 22
CHECK	KC	DRAWN	TL
JOB No.	MA20003	FIGURE No.	Fig 2b
		REV	-

- 2.2 Five designated monitoring stations were selected for air quality monitoring programme. **Table 2.1** describes the air quality monitoring locations, which are also depicted in **Figure 2**.

- 3.2 Noise monitoring was conducted at five designated monitoring stations, namely CM1, CM2, CM3, CM4 and CM5 in the reporting period. **Table 3.1** and **Figure 2** show the locations of these stations.

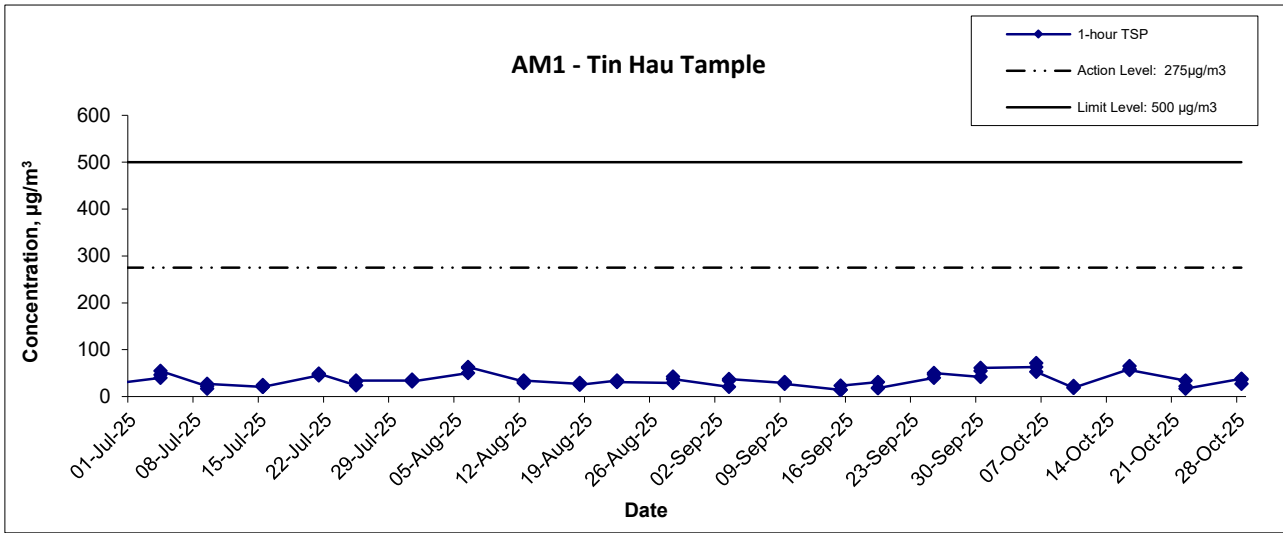
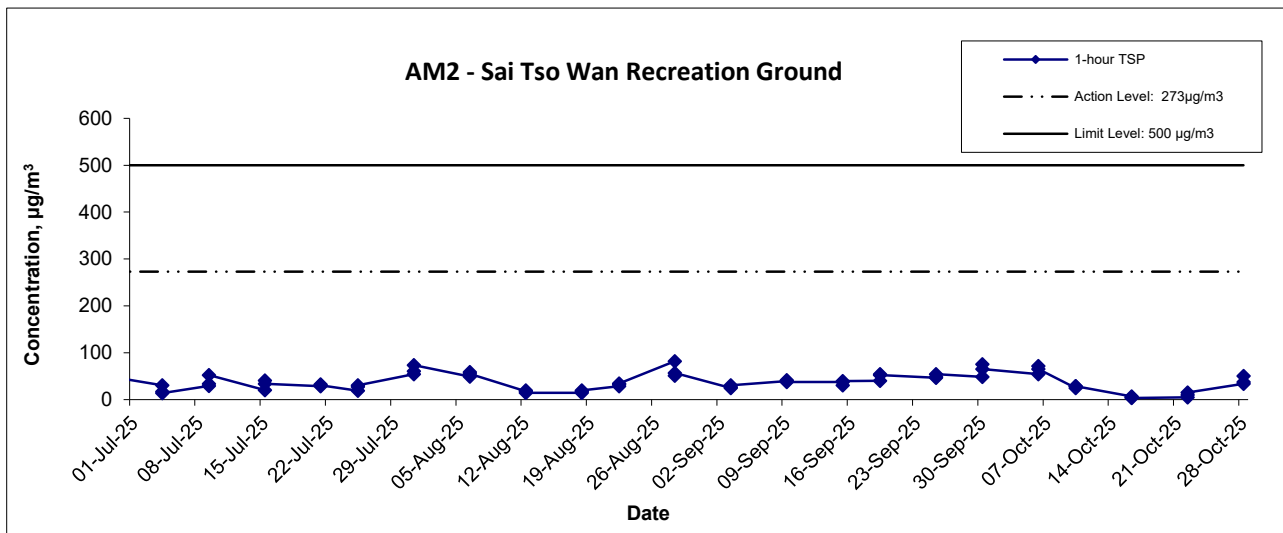
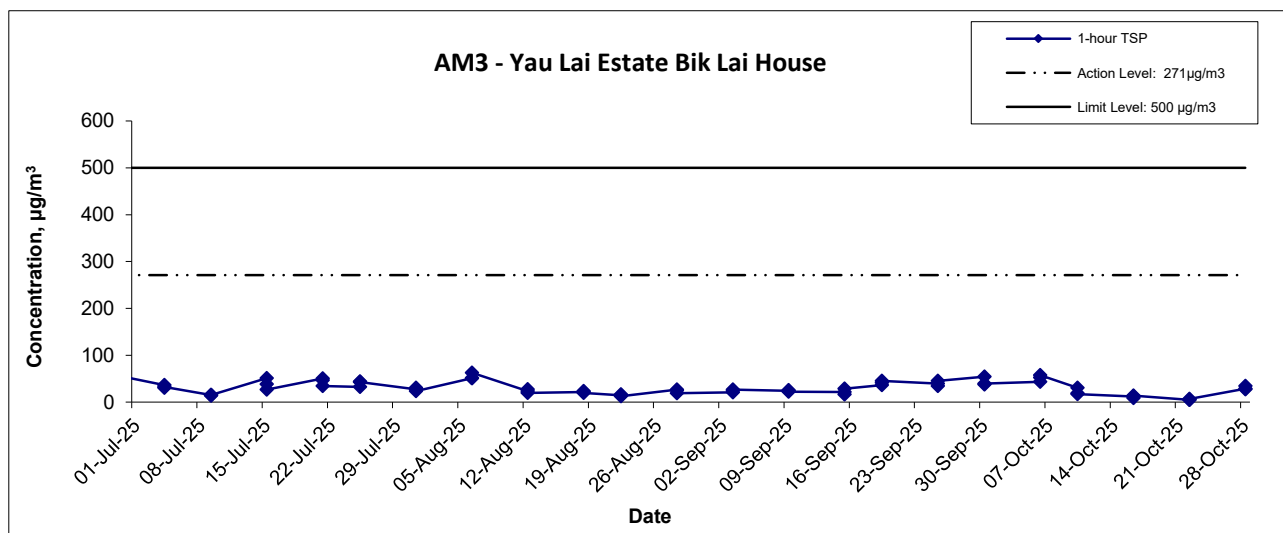
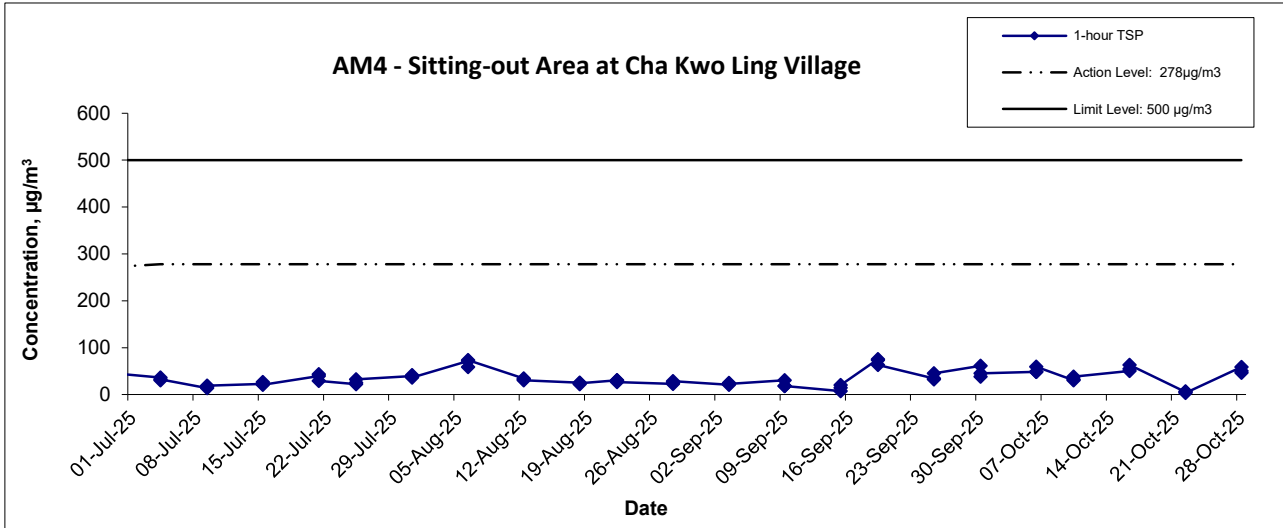
1-hr TSP Concentration Levels

Contract No. ED/2018/04
 Trunk Road T2 and Infrastructure Works for Developments at the Former South Apron
 Graphical Presentation of 1-hour TSP Monitoring Results

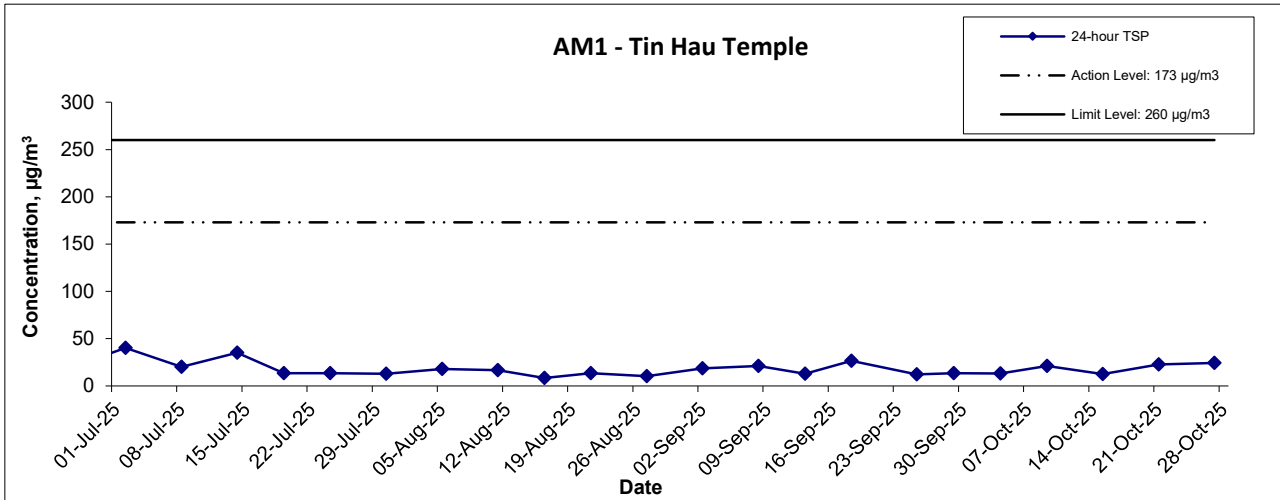
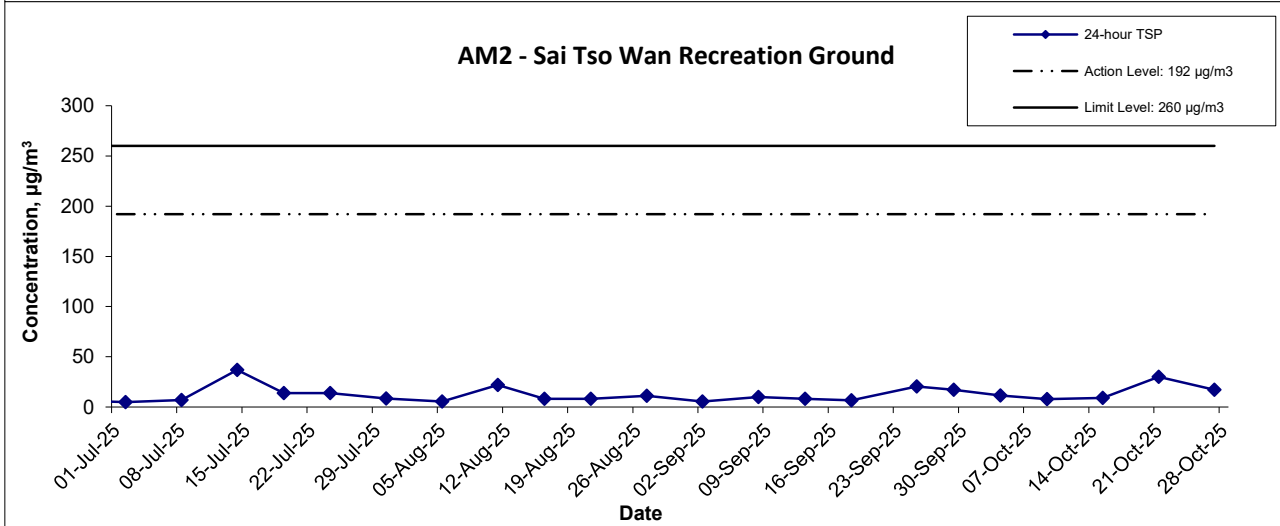
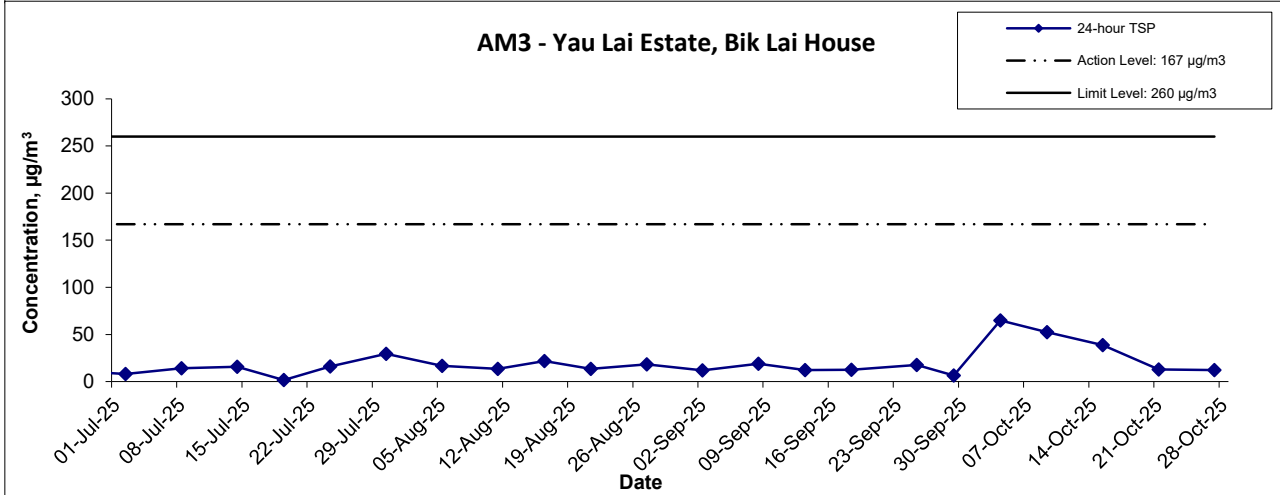
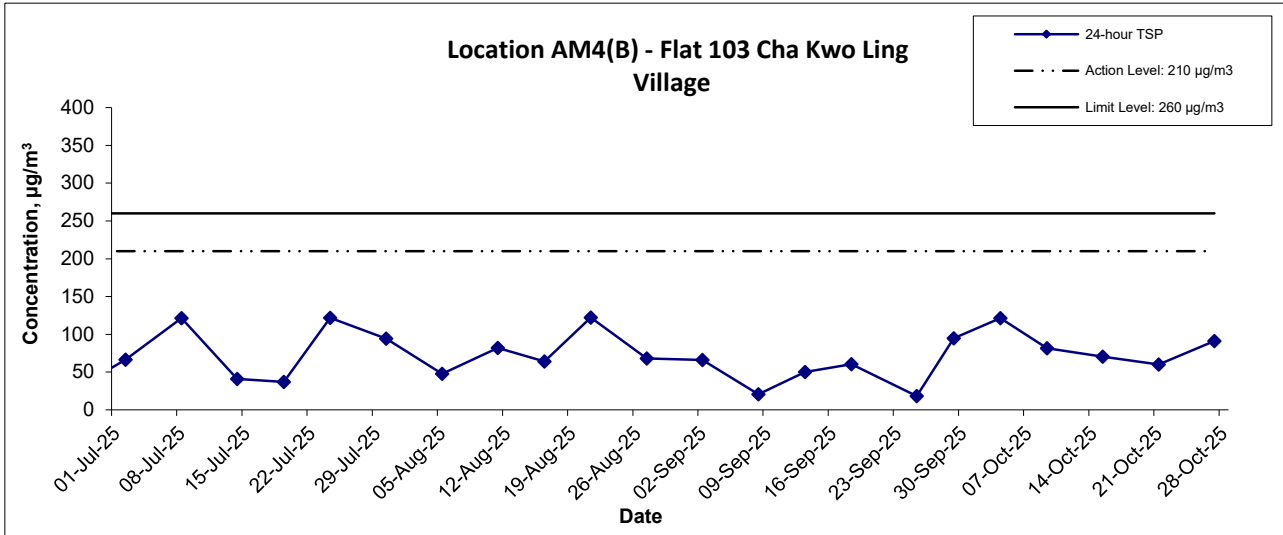
24-hr TSP Concentration Levels

Contract No. ED/2018/04 Trunk Road T2 and Infrastructure Works for Developments at the Former South Apron Graphical Presentation of 24-hour TSP Monitoring Results	Scale N.T.S	Project No. MA20003	CINOTECH
	Date Oct-25	Appendix F

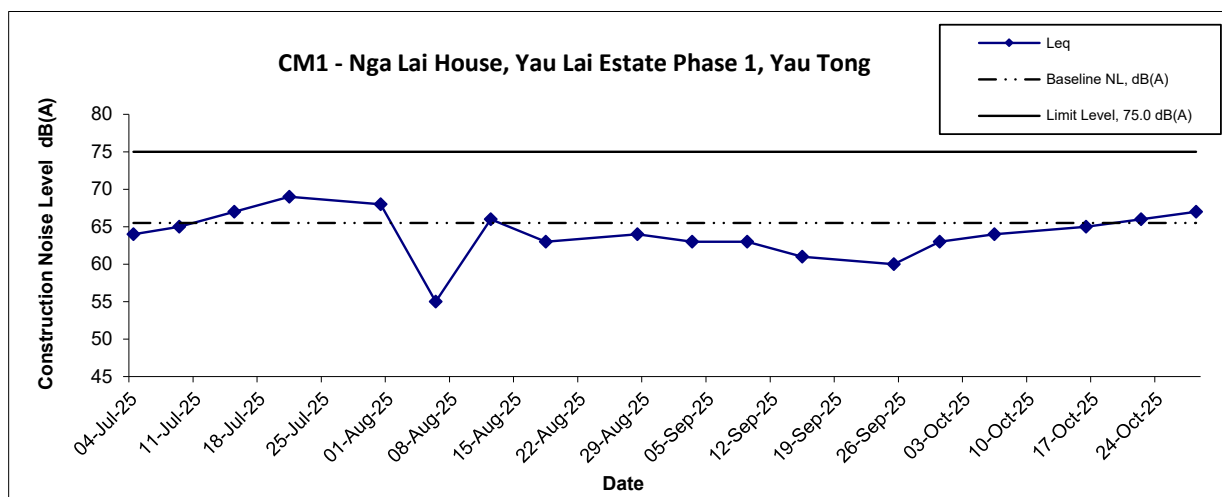
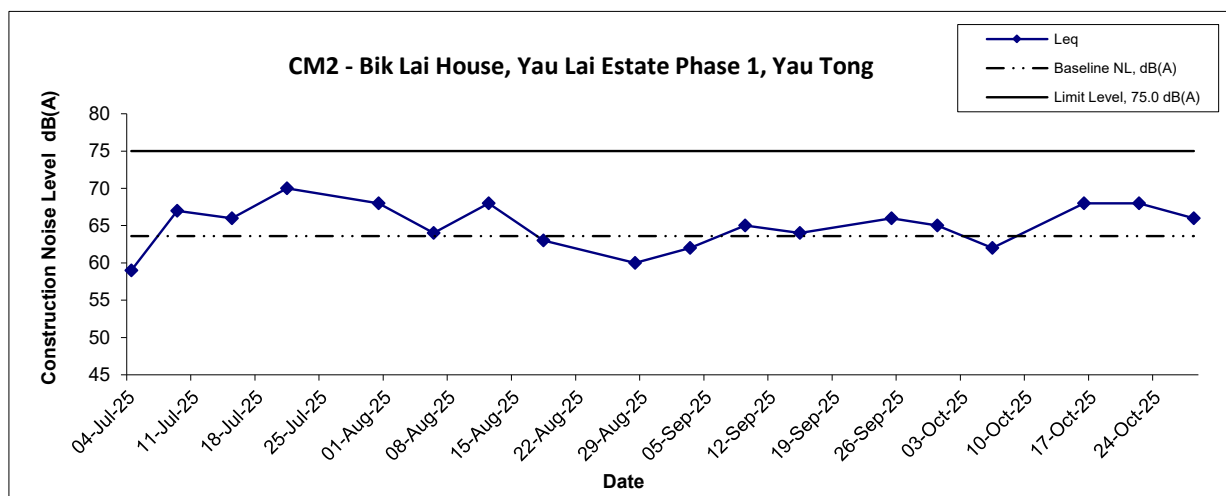
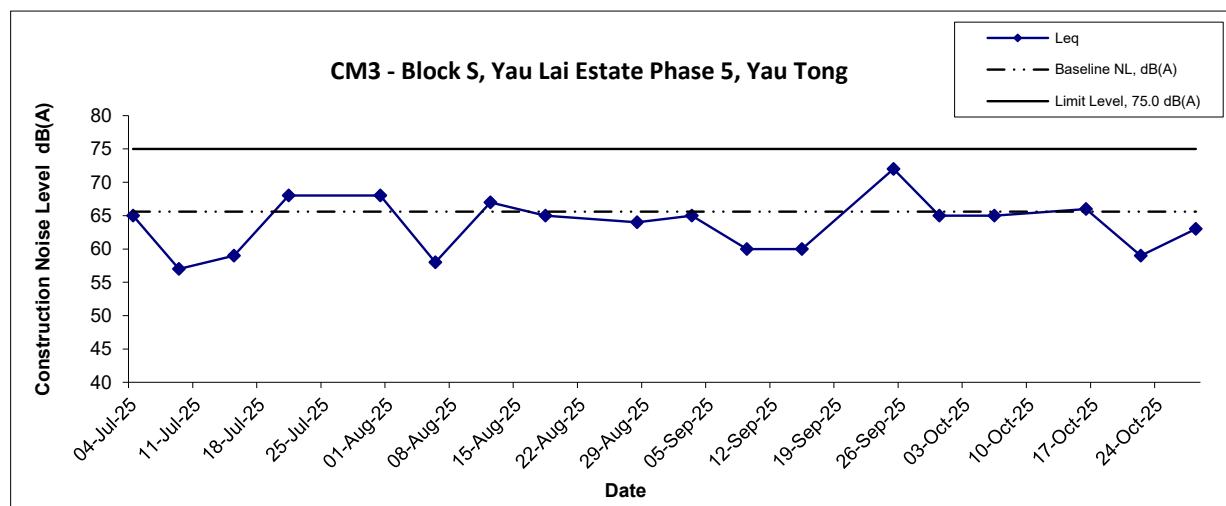
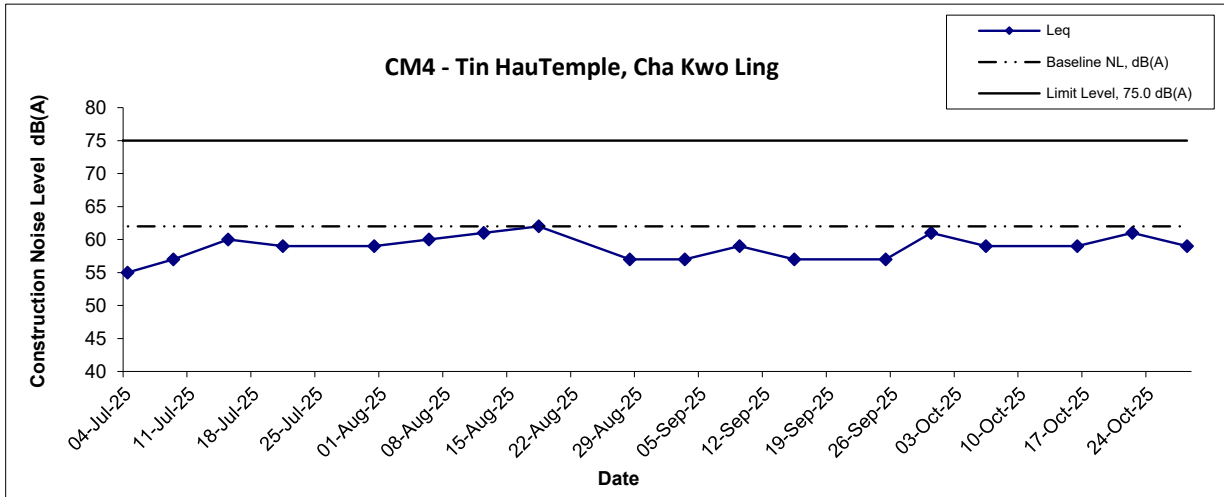
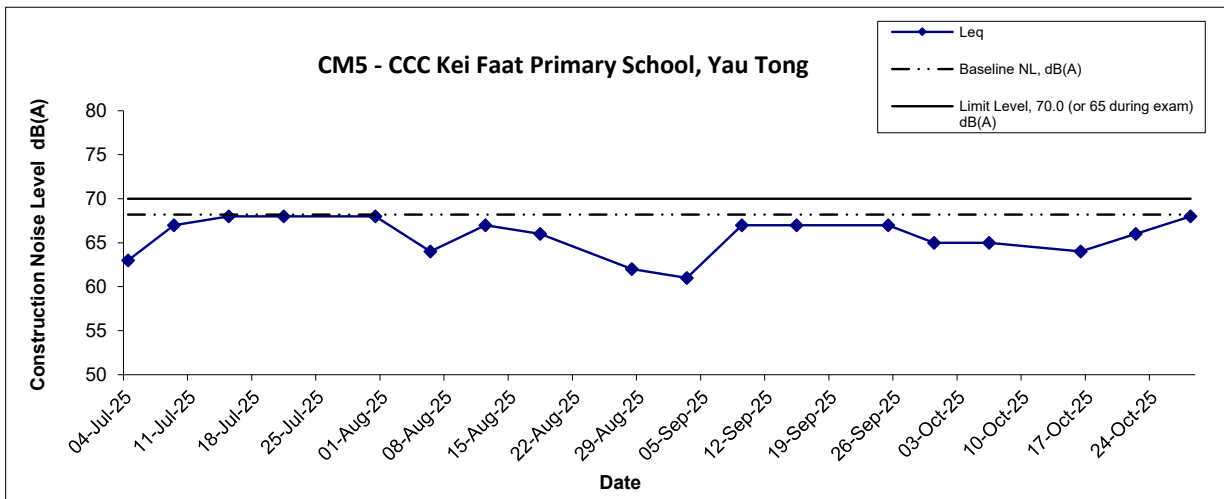
Noise Levels

Title Contract No. ED/2018/04 Trunk Road T2 and Infrastructure Works for Developments at the Former South Apron Graphical Presentation of Construction Noise Monitoring Results	Scale	Project	CINOTECH
	N.T.S	No. MA20003	
	Date Oct 25	Appendix G
