**MONTHLY EM&A REPORT**

**March 2017**

**Contract Name** : Environmental Monitoring Works for  
Contract KL/2014/03 – Kai Tak Development  
– Stage 3 Infrastructure Works for Developments  
at the Southern Part of the Former Runway

**Report No.** : 0405/15/ED/0762A

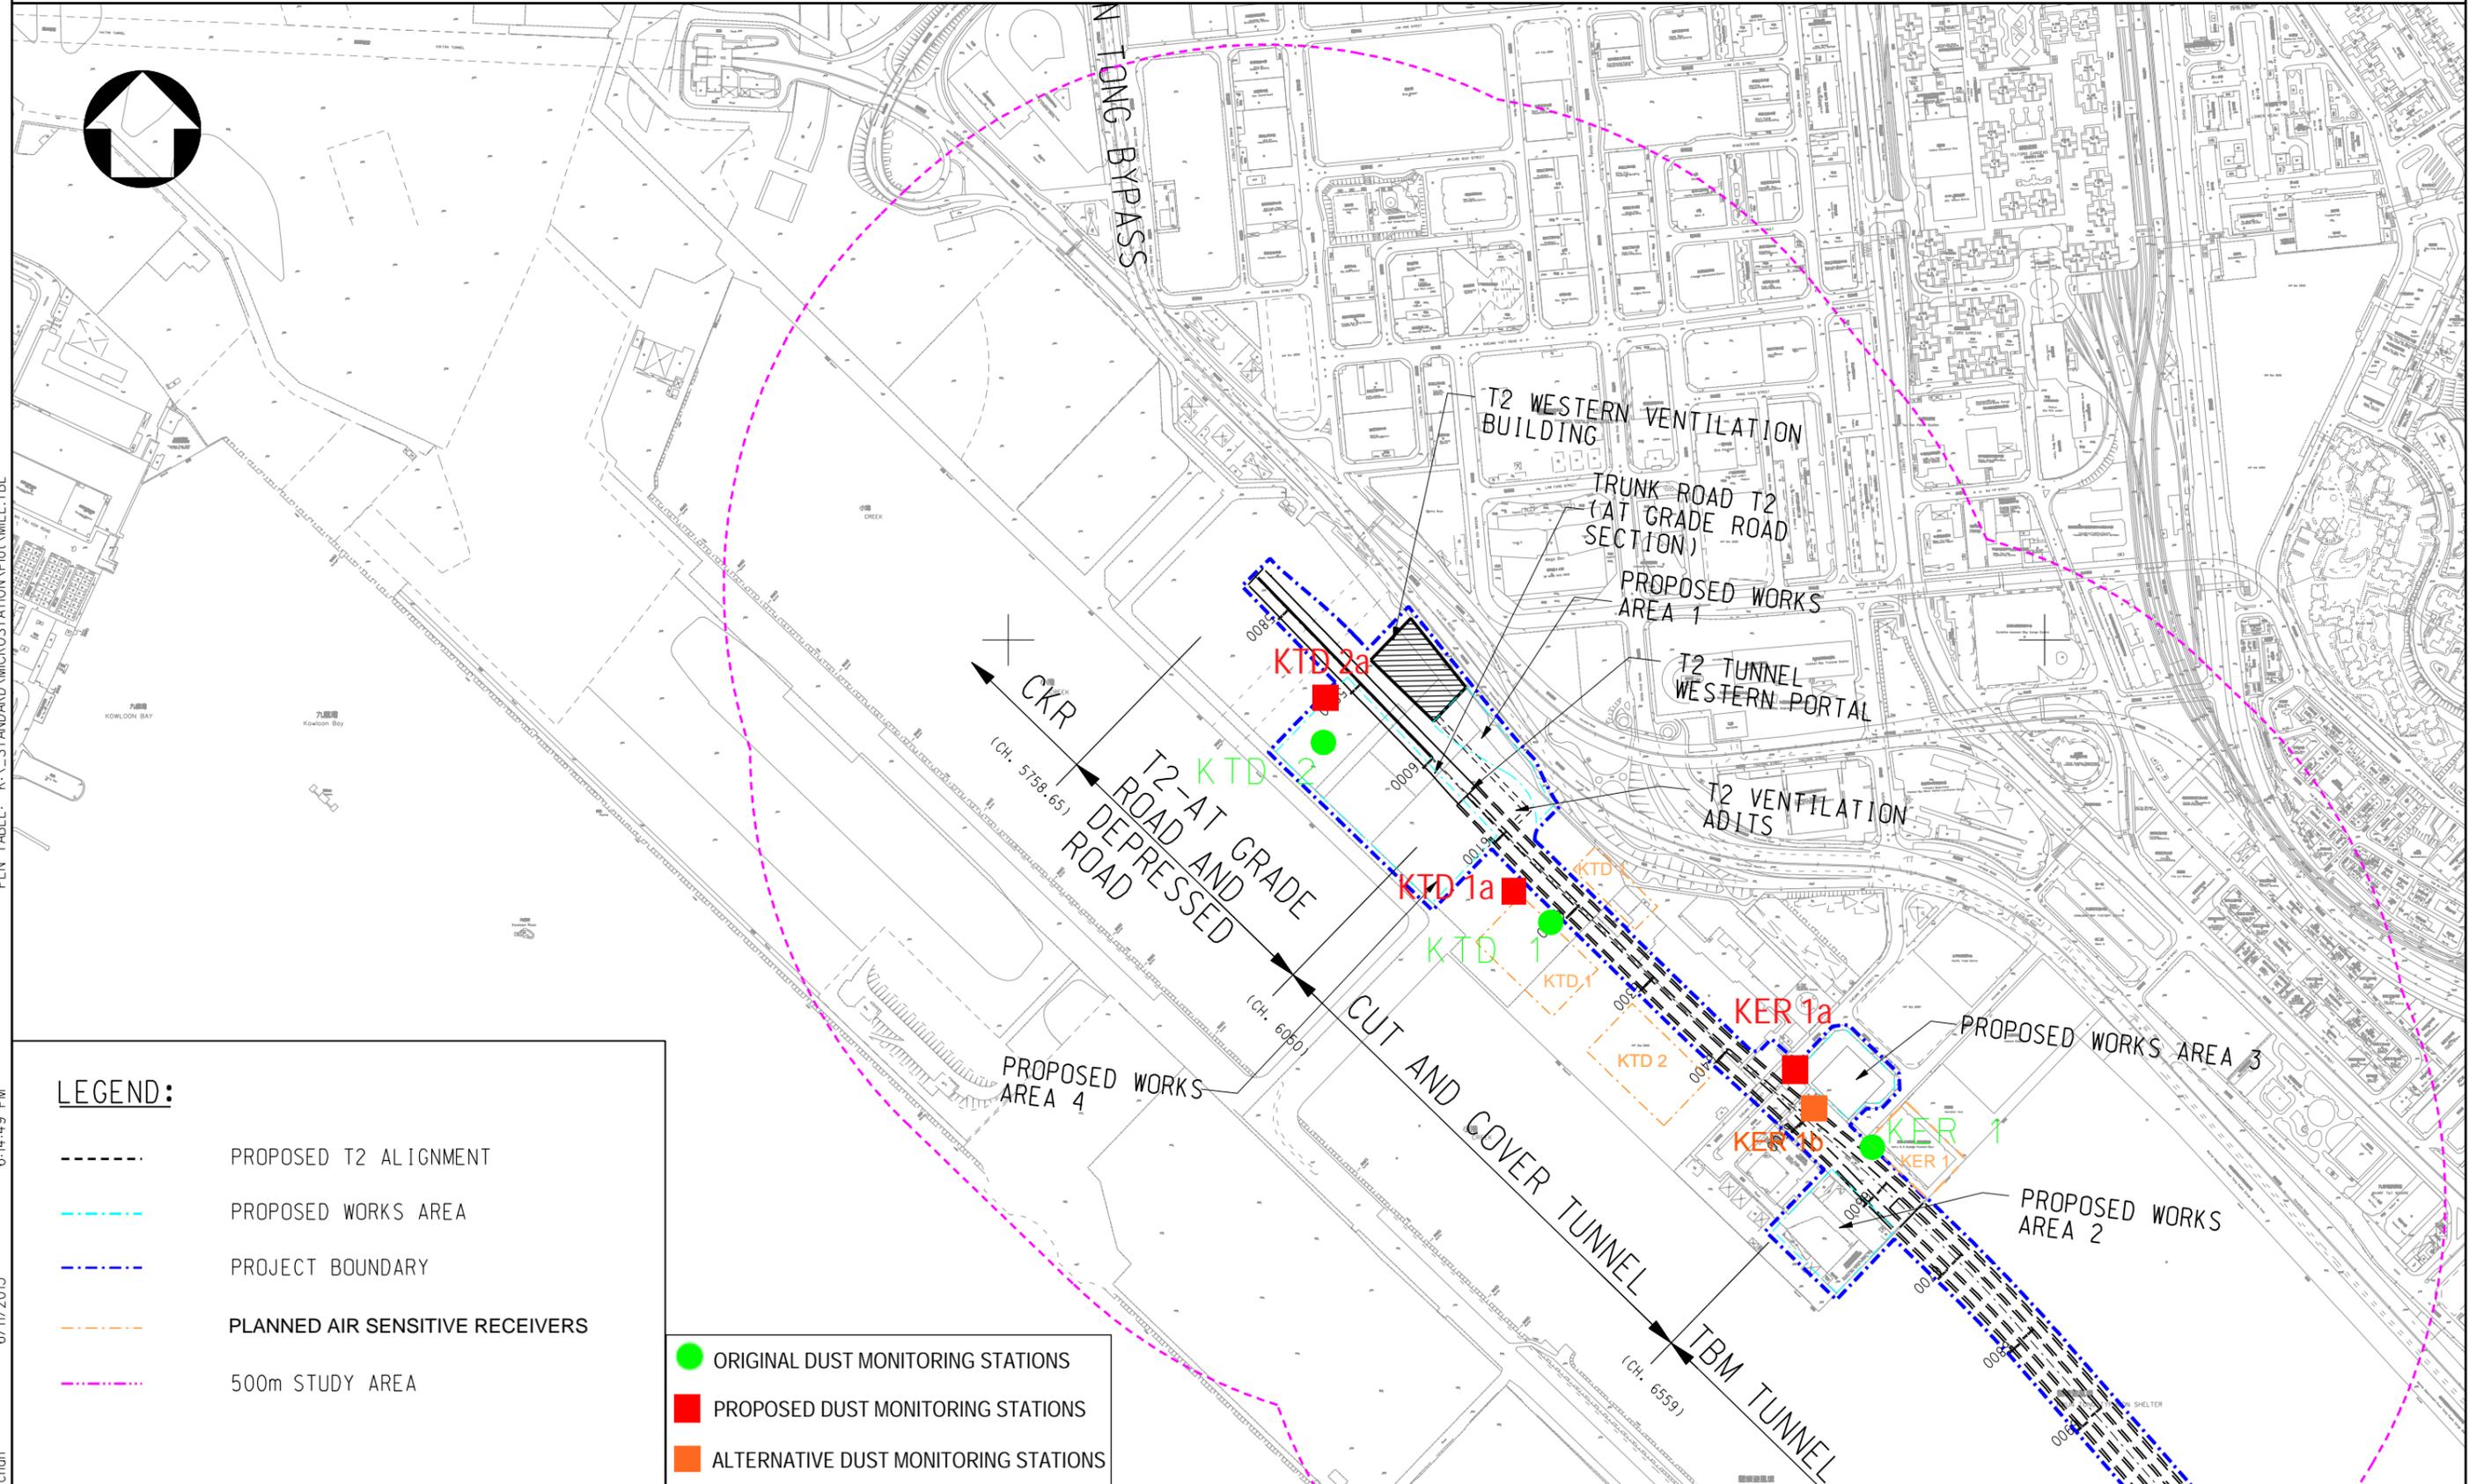
**Figure 2**

**Air and Noise Monitoring Locations**

2.5.2 According to the approved alternative baseline air quality and noise monitoring locations (EPD reference: EP2/K19/A/21 Pt.5), the original monitoring locations (KTD1, KTD2 and KER1) are proposed to be replaced by alternative monitoring locations (KTD1a, KTD2a and KER1b) for air quality monitoring, they are summarized in **Table 2.2** and shown in **Figure 2**.

3.6.2 According to the approved alternative baseline air quality and noise monitoring locations (EPD reference: EP2/K19/A/21 Pt.5), the original monitoring locations (KTD1, KTD2 and KER1) are proposed to be replaced by alternative monitoring locations (KTD1a, KTD2a and KER1b) for noise monitoring, they are summarized in **Table 3.3** and shown in **Figure 2**.
