MONTHLY EM&A REPORT

April 2017

Contract Name : Environmental Monitoring Works for
Contract KL/2014/03 – Kai Tak Development
– Stage 3 Infrastructure Works for Developments
at the Southern Part of the Former Runway

Report No. : 0405/15/ED/0780A

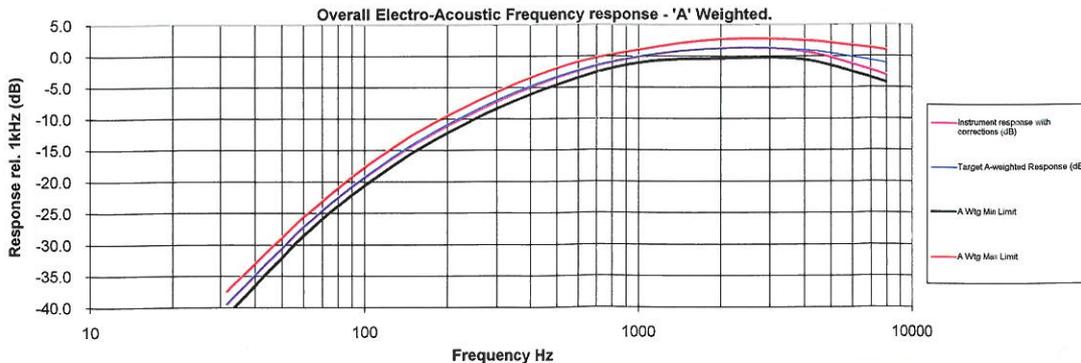
Combined Electro-Acoustic Frequency Response - A Weighted (IEC 61672-3:2006)

The following A-Weighted frequency response graph shows this instruments overall frequency response based upon the application of multi-frequency pressure field calibrations. The microphones Pressure to Free field correction coefficients are applied to pressure response. Reference level taken at 1kHz.
